# Condition Assessment: Concrete & Steel Silo

**MEDSHEL Global**  
Daytona Beach, FL  
June 2024

# **Condition Assessment: Concrete & Steel Silo**

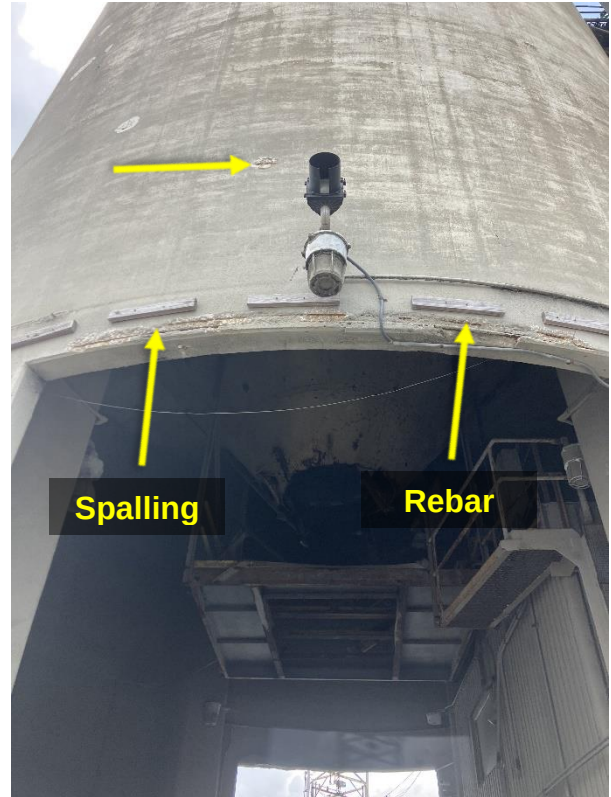
1. **Evaluation:** The overall integrity of the Cement Loadout Silo appears to be in good condition. The roof cap appears to be in **fair** condition.
2. **Exterior:** Various areas of spalling concrete with exposed rebar was discovered along the exterior. The Silo roof rim/curb was noted to have large areas with exposed rebar and missing concrete. Exposed rebar was also observed at the North and South side above the Silo entry way.

EXT 2 – Spalling present and exposed rebar south entry point

- i. Due to the large areas of exposed rebar and missing concrete, it is recommended to remove and replace the roof rim/curb entirely

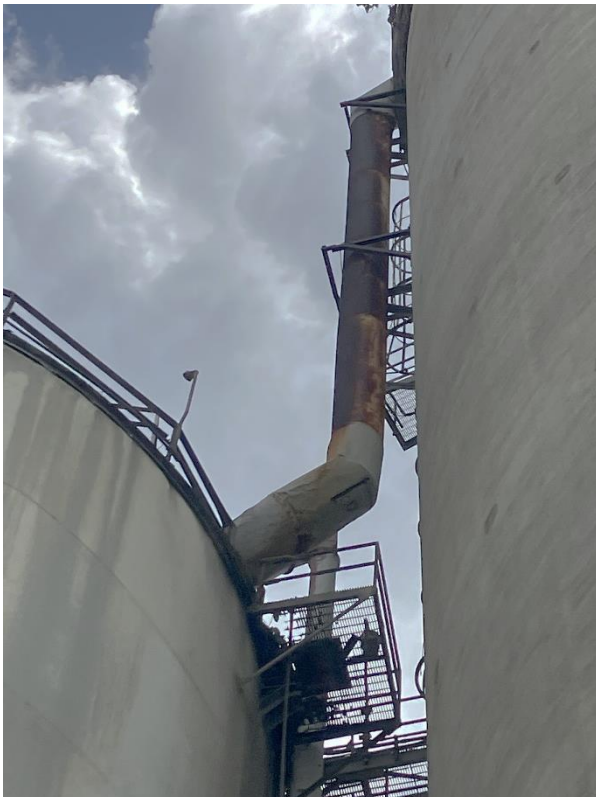
3. **Roof:** The dust collector and all associated piping has rust corrosion holes throughout.
4. **Interior:** There are multiple exposed electrical wires; rust has corroded through the conduits. These exposed wires pose a potential electrical shock hazard.

EXT 3 – Heavily oxidized duct

- i. The onset of heavy oxidation and corrosion has compromised the dust collector and associated piping. These instruments should be replaced to maintain structural integrity

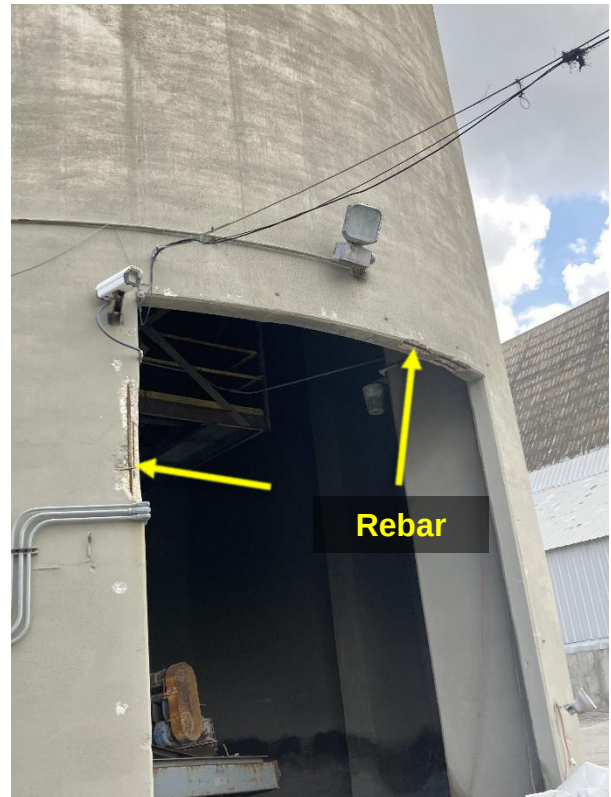
EXT 4 – Spalling and exposed rebar on north side entry point

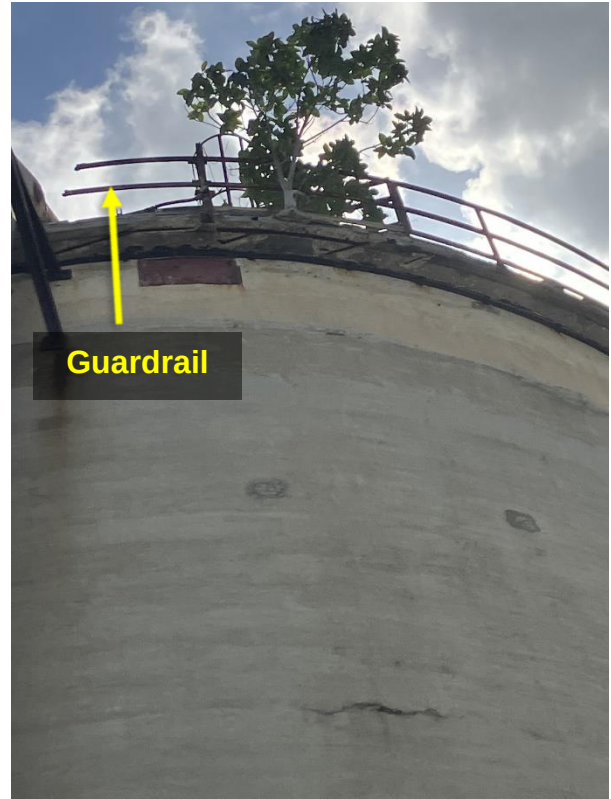
EXT 6 – Corroded/missing guardrail and vegetation

- i. The guardrails on the roof should be removed entirely and replaced. Following replacement, the guardrails should be painted with a protective coating.

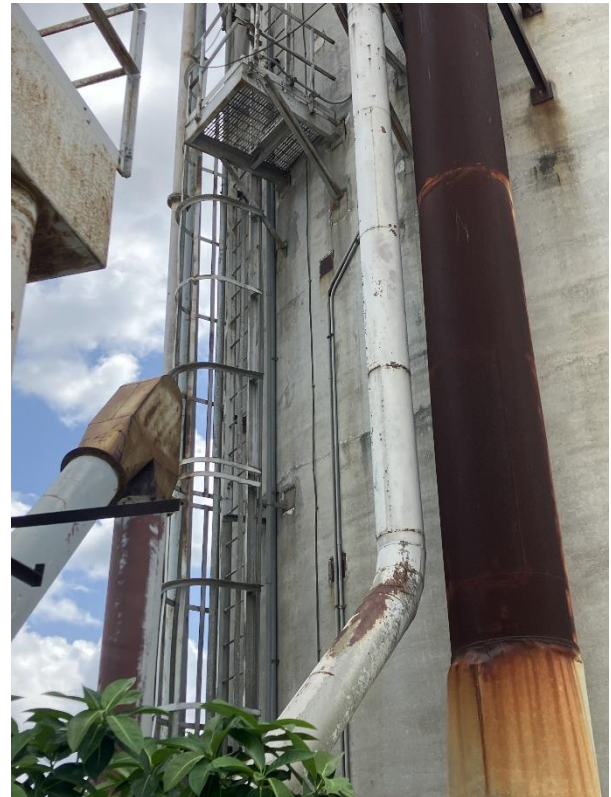
EXT 8 – Heavily oxidized duct

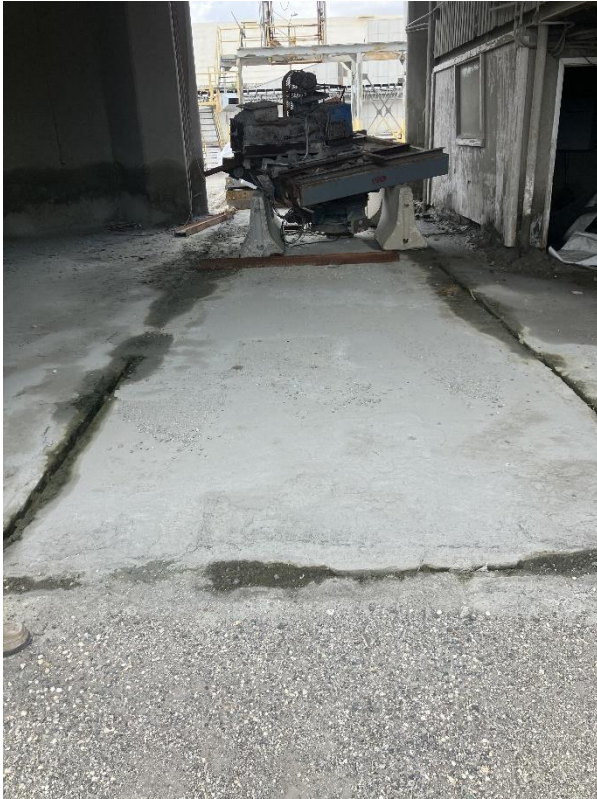
7. **Interior:** The Cement Silo Loadout scale was subject to apparent flood damage.
8. **Interior:** The 2<sup>nd</sup> elevation concrete office appears to be in fair condition. The ground elevation office shows signs of apparent water damage; this can be noted on the controls and breaker panels.

EXT 9 – Corroded loadout scale & with heavy buildup present

- i. The loadout scale should be replaced due to evident water damage.

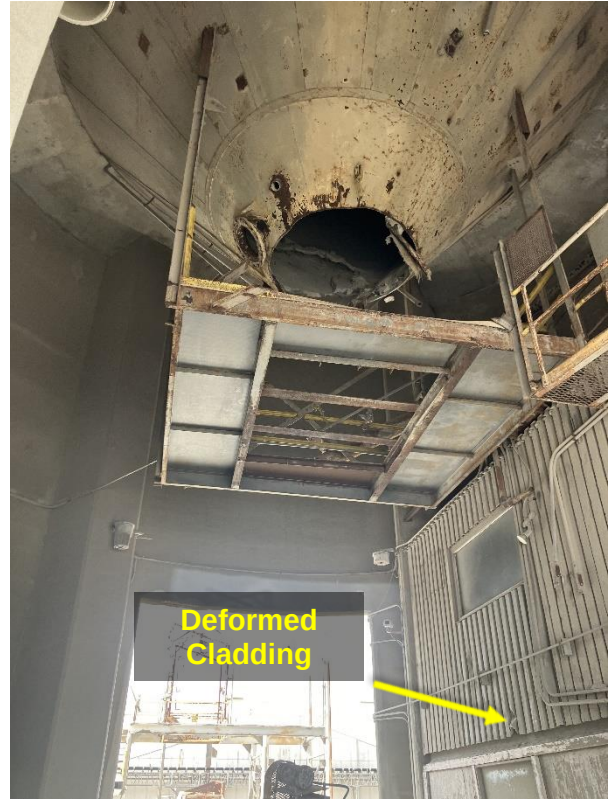
5. **Roof:** All the mounting fixtures that attach to the roof are completely corroded and are rusted through.
6. **Interior:** The Concrete Loadout Silo's hopper appears to be in poor condition due to heavy oxidation.

EXT 10 – Hopper and surrounding members suffer oxidation, cladding deformed

- i. The concrete silo hopper cone needs to be repaired to accept new loadout system

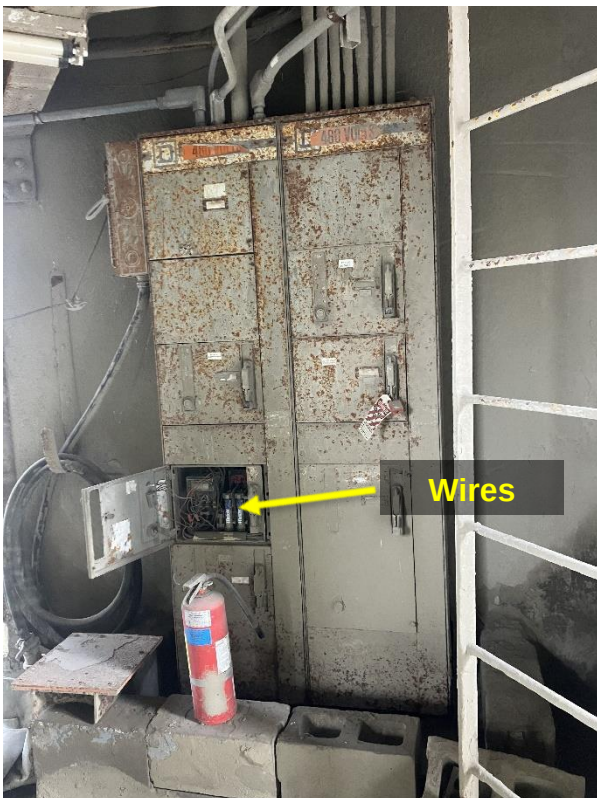
EXT 11 – Exposed wiring; heavily oxidized electrical box

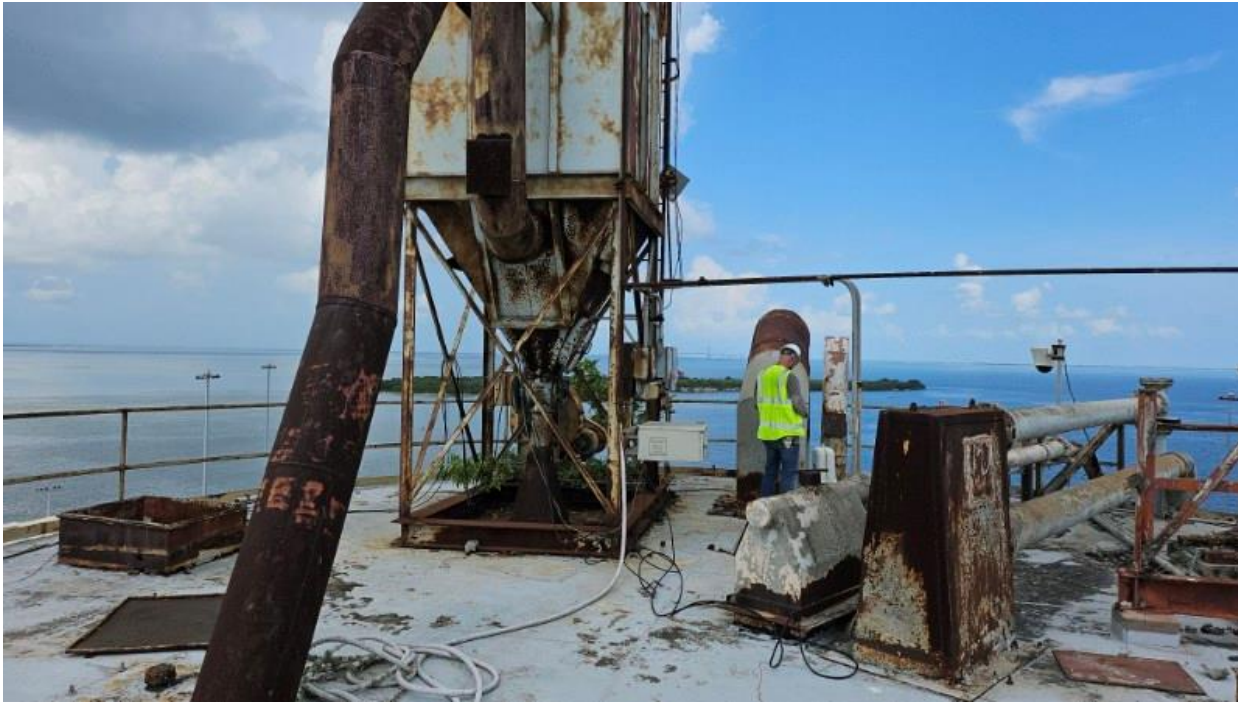
EXT 12 – Silo instruments and fixtures are heavily corroded

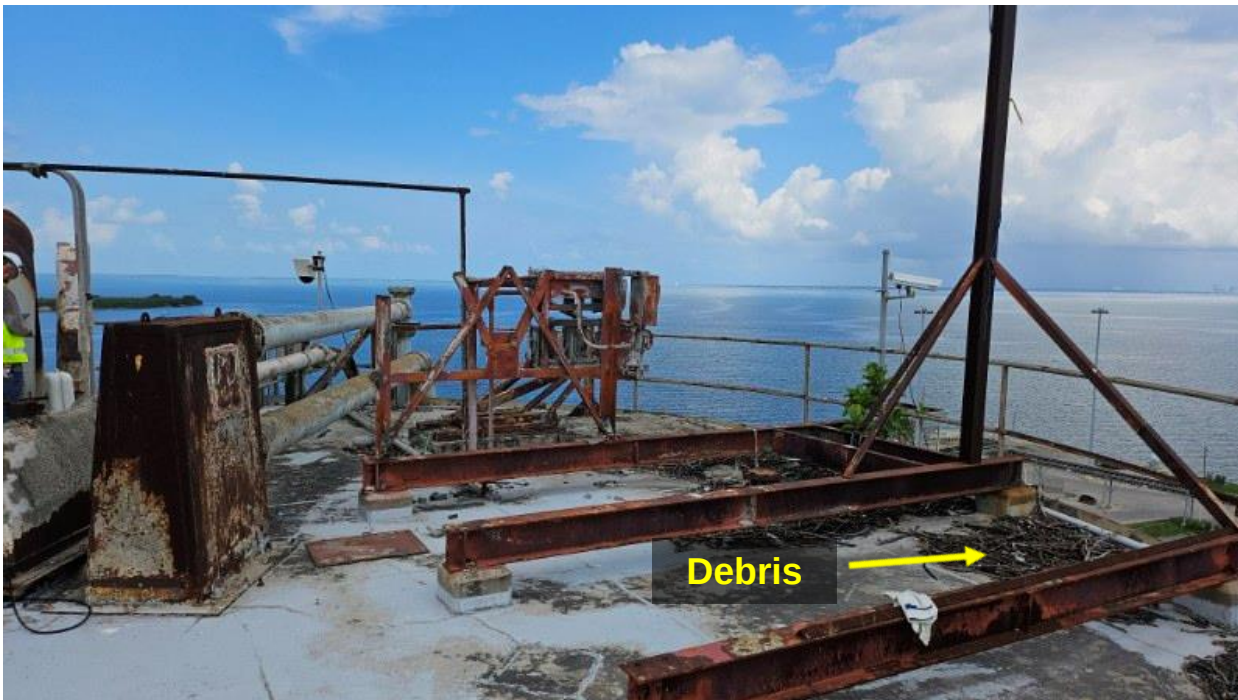
EXT 13 – Silo instruments and fixtures are heavily corroded; piles of debris present on rooftop

- i. The Cement Loadout Silo rooftop should be thoroughly cleaned, and debris removed. Any exposed entry points should be sealed with a proper sealing

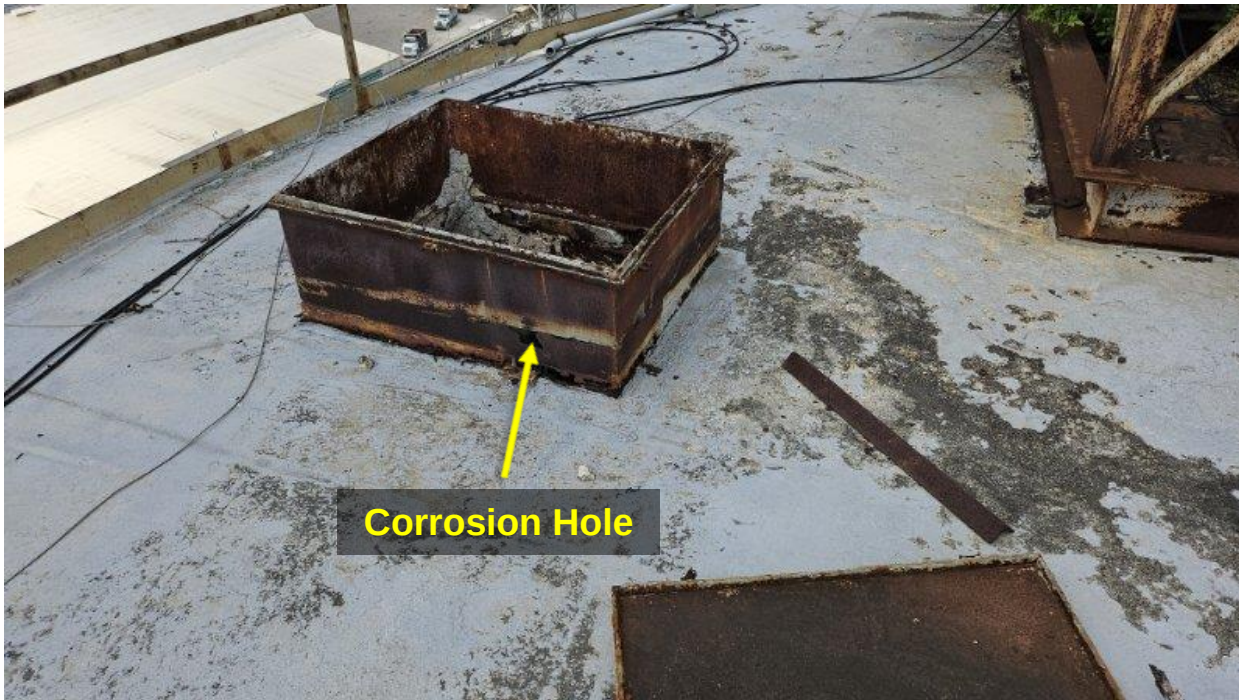
EXT 14 – Corrosion hole on dust collector

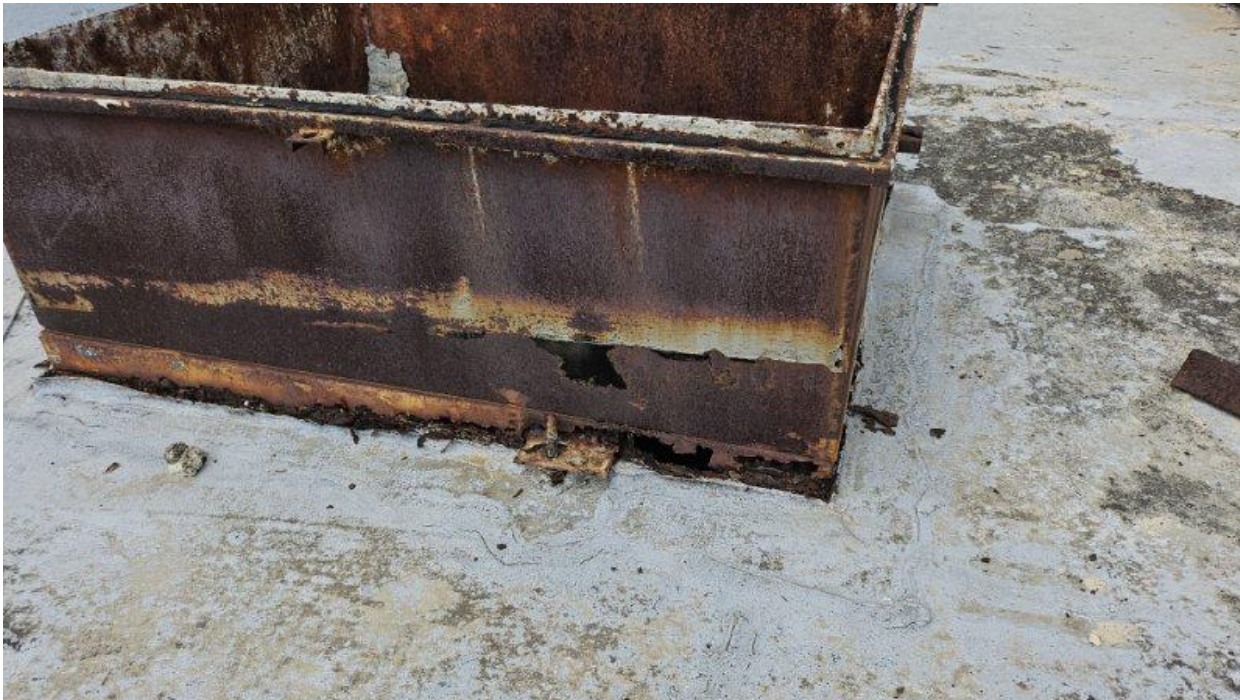
EXT 15 – Closeup on corrosion hole

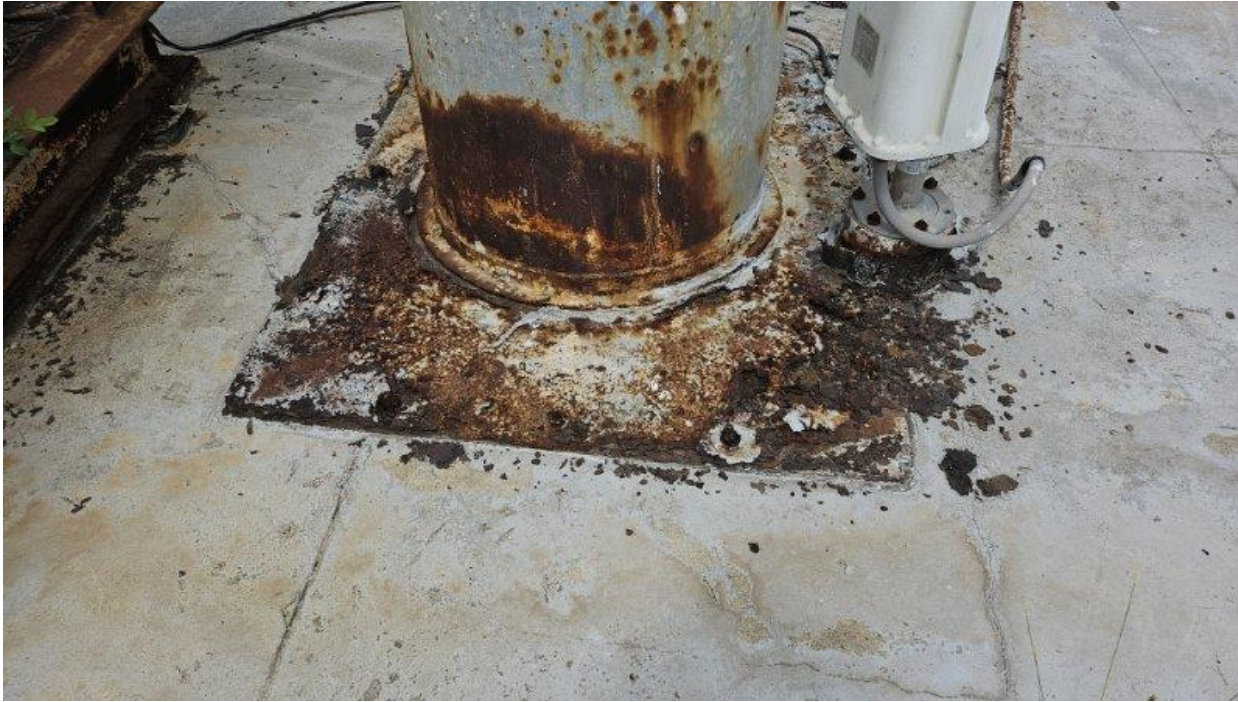
EXT 16 – Pipe base plate is corroded which could lead to falling object hazard

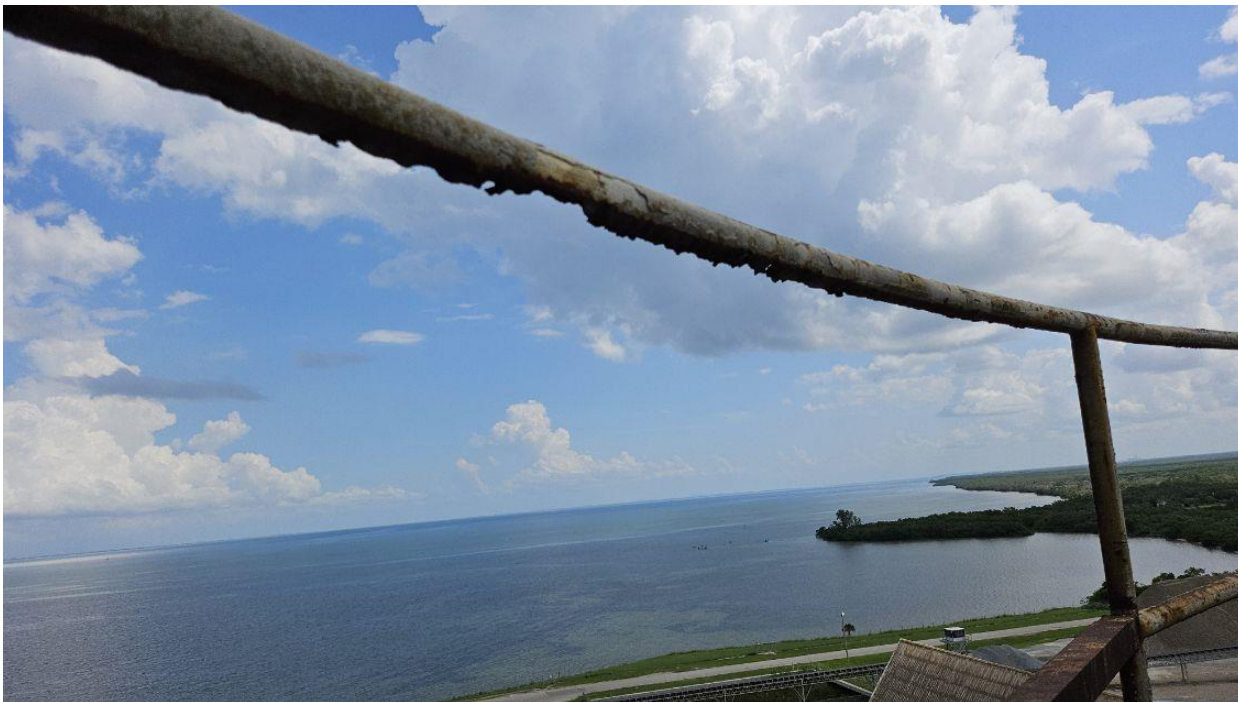
EXT 17 – The guardrail and its members suffer from heavy oxidation and corrosion

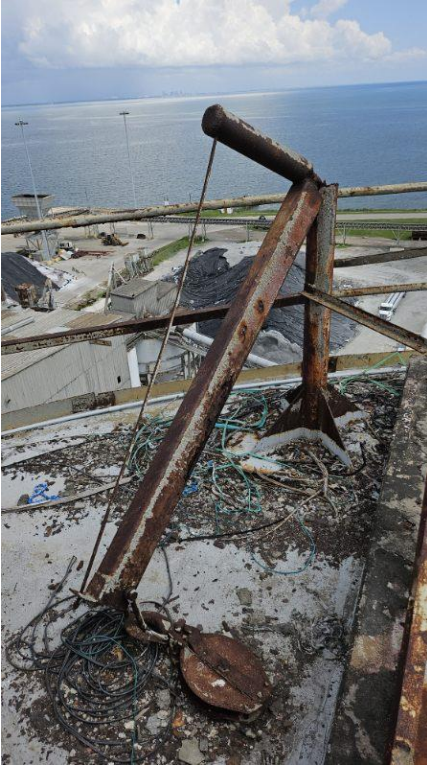
EXT 18 – Mounting fixture heavily corroded; debris present

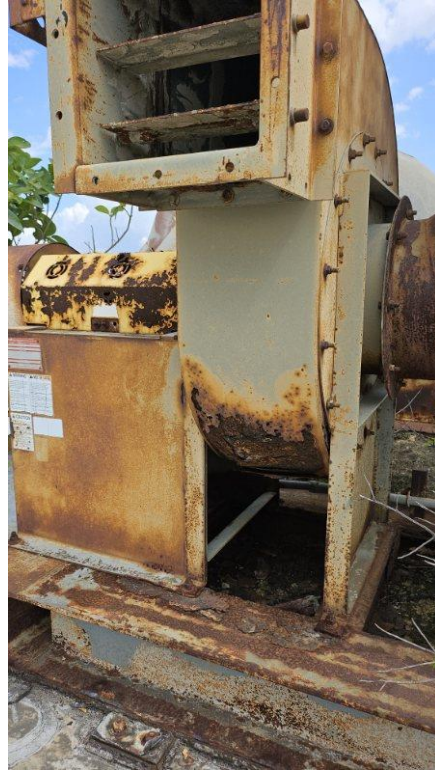
EXT 19 – Vent system is corroded

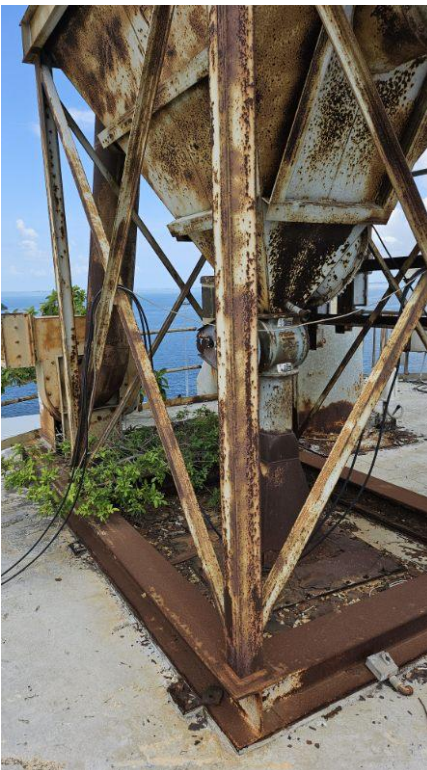
EXT 20 – Hopper suffers heavy oxidation and onset corrosion

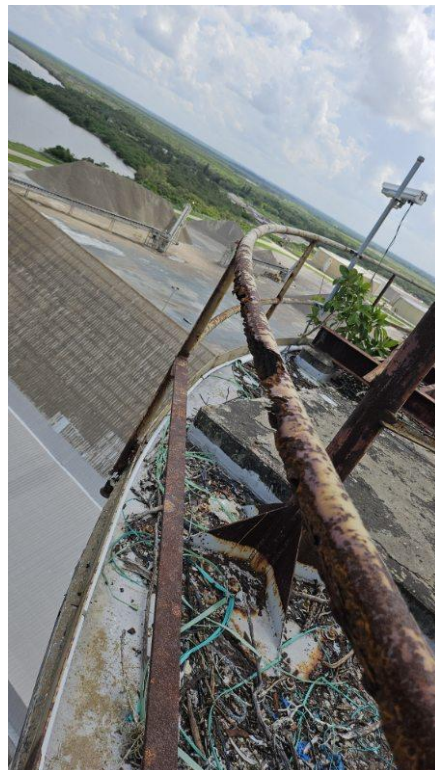
EXT 21 – Guardrail is heavily oxidized and corroded

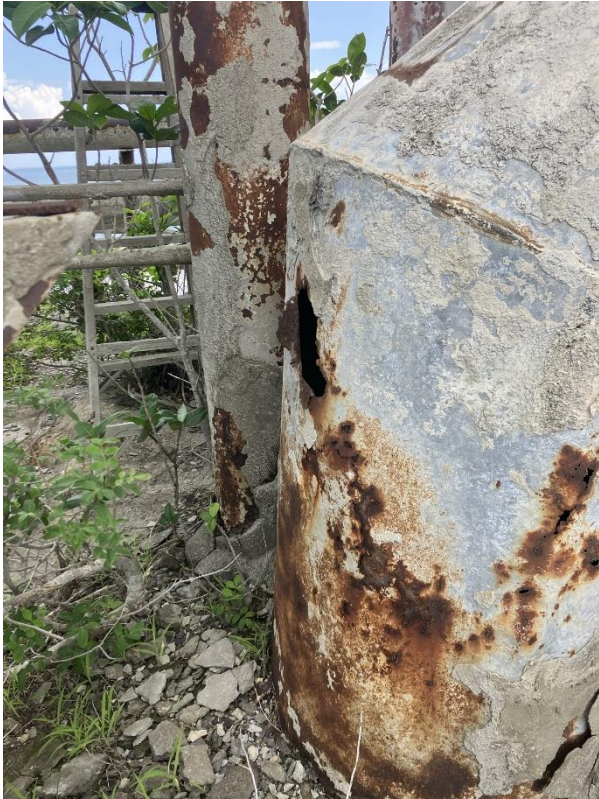
6. **Rooftop:** The ladder connection have rust and corrosion damage and need t
7. **Rooftop:** All the 8" and 10" fill pipes appear to be intact.
8. **Rooftop:** All attachment points to the roof of the silo are corroded through. In some instances, the base components are corroded which could cause members to fail and fall over.

EXT 22 – Attachment points is corroding away

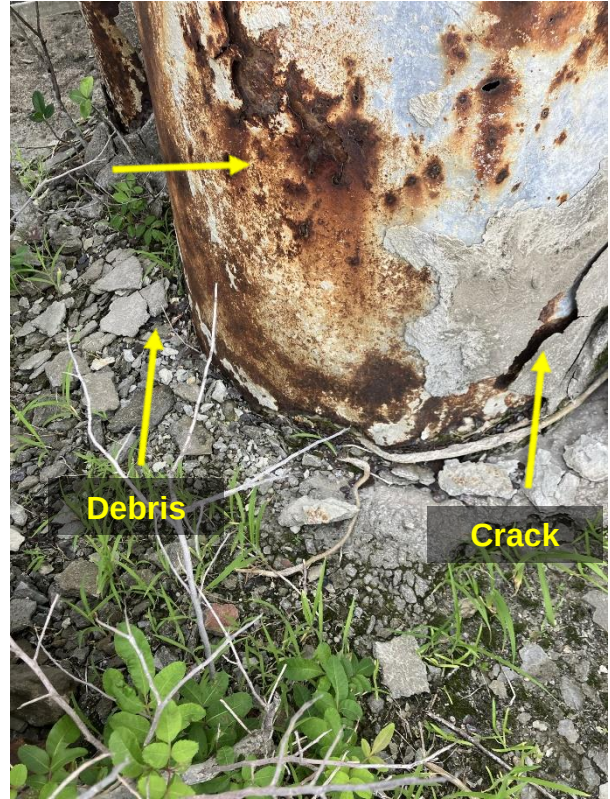
EXT 23 – Attachment is corroding away

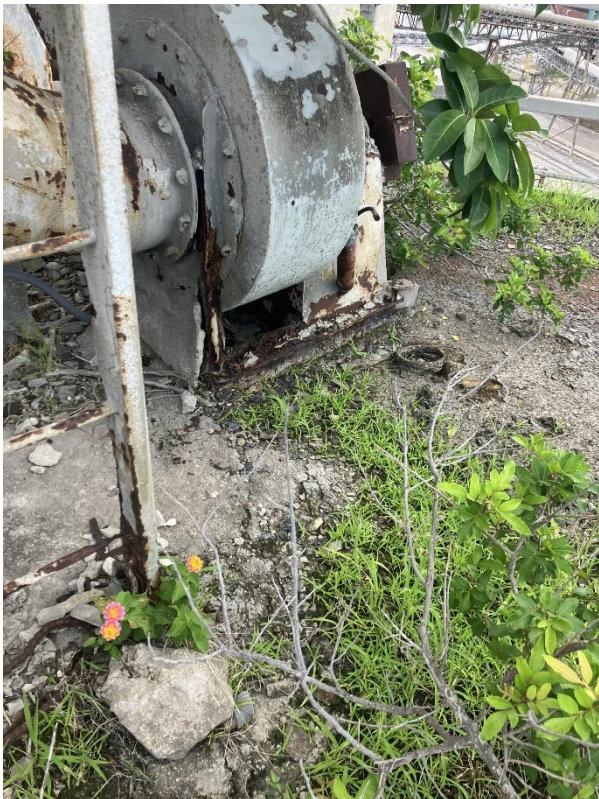
EXT 24 – Corroding components; ladder component corroding

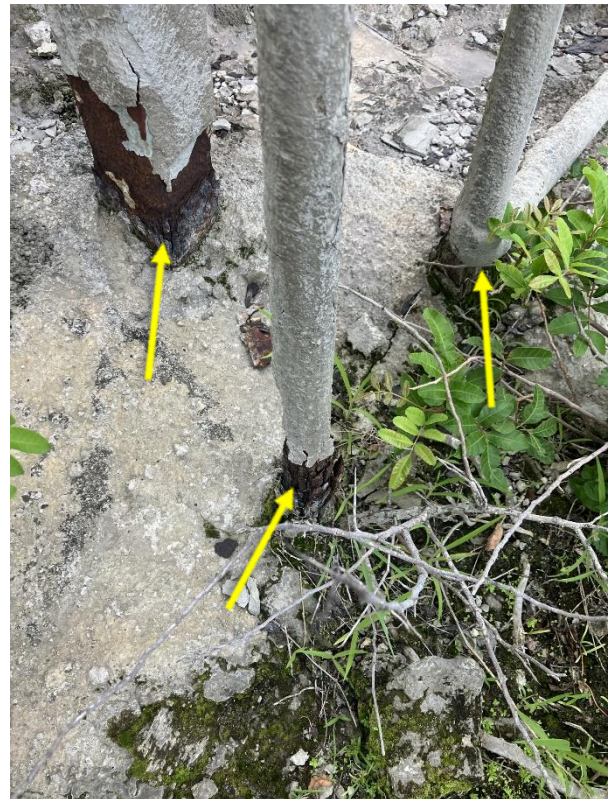
EXT 25 – Post base components have corroded; hazardous

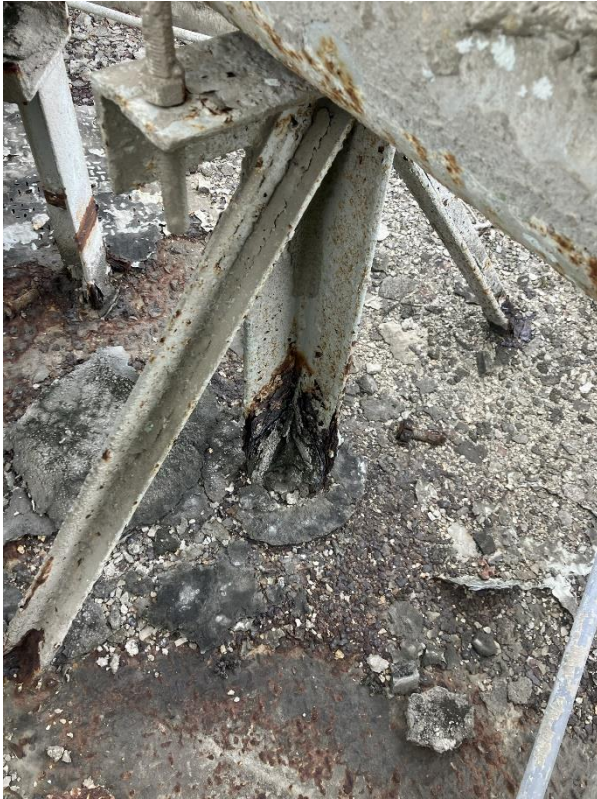
EXT 26 – Base of structure members are corroding

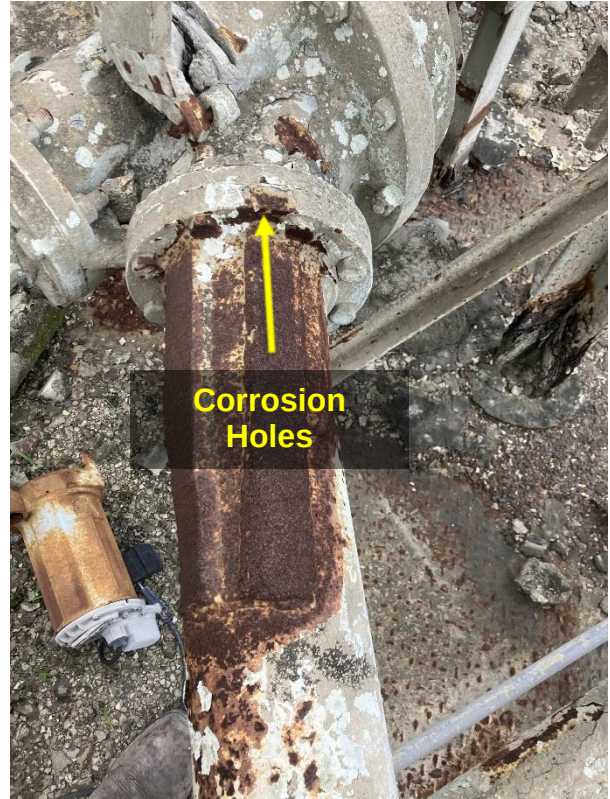
EXT 27 – Rusty through

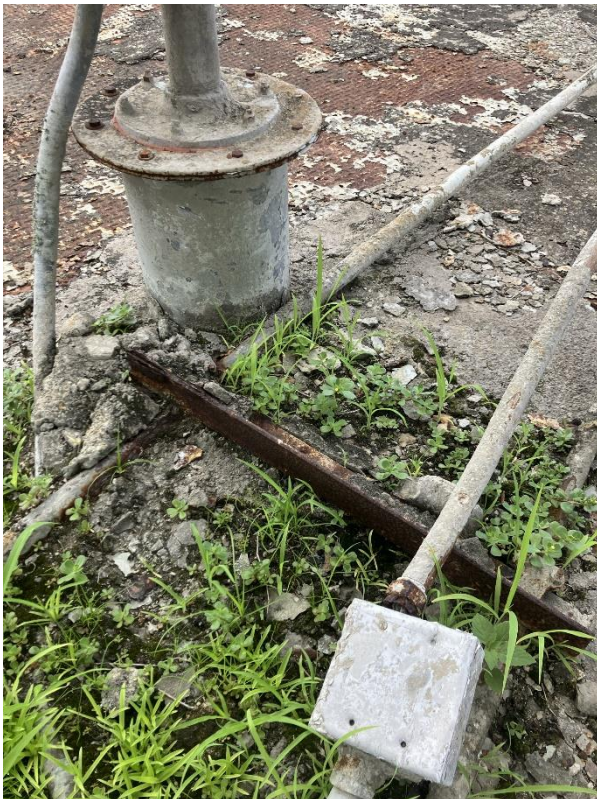
EXT 28 – Conduit components show heavy oxidation and corrosion

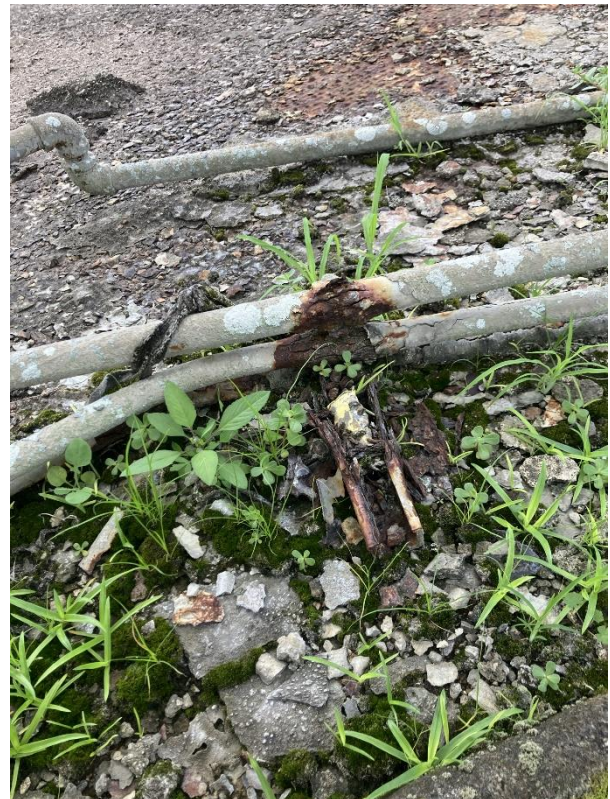
EXT 29 – Conduit components show heavy oxidation and corrosion

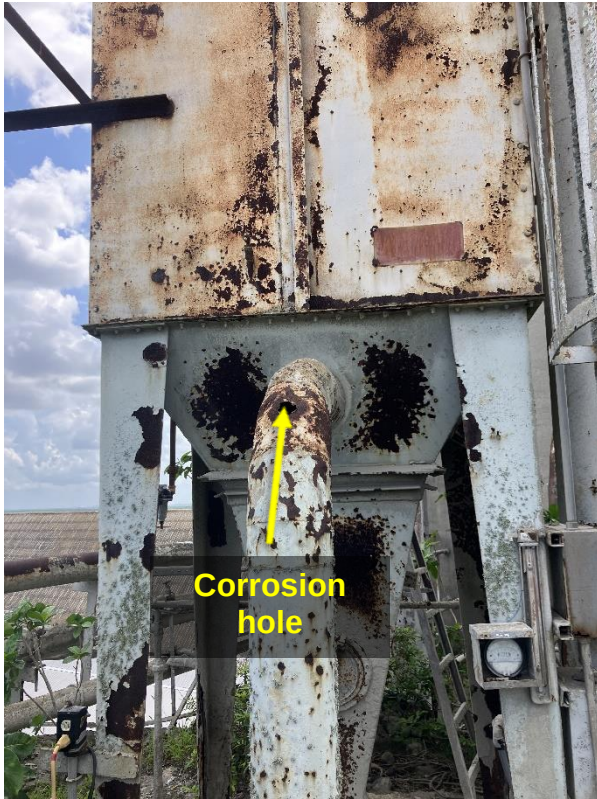
EXT 30 – Corrosion hole in present in hopper

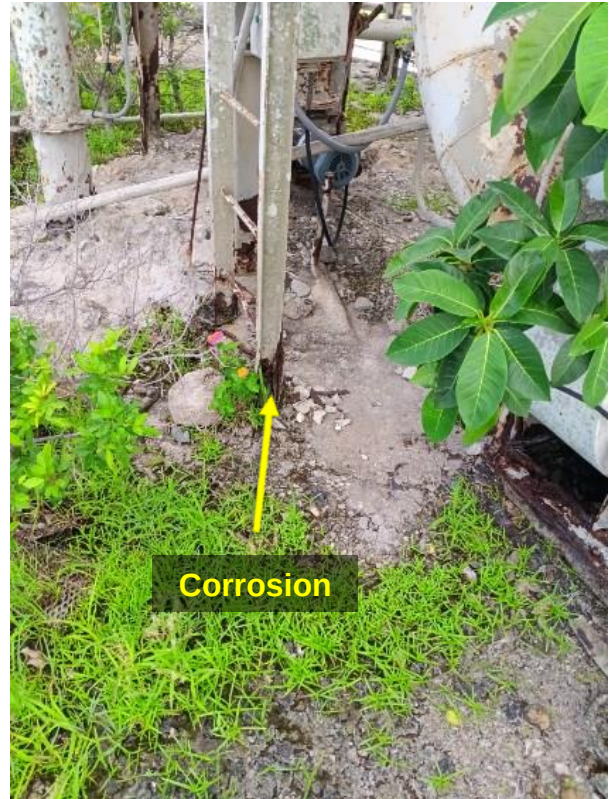
EXT 31 – Ladder base has started to corrode

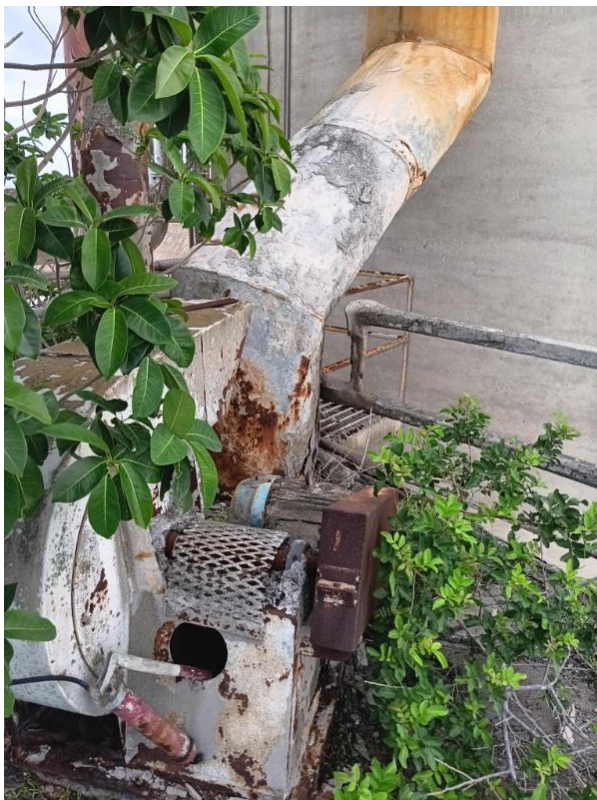
EXT 32 – Heavy corrosion on components

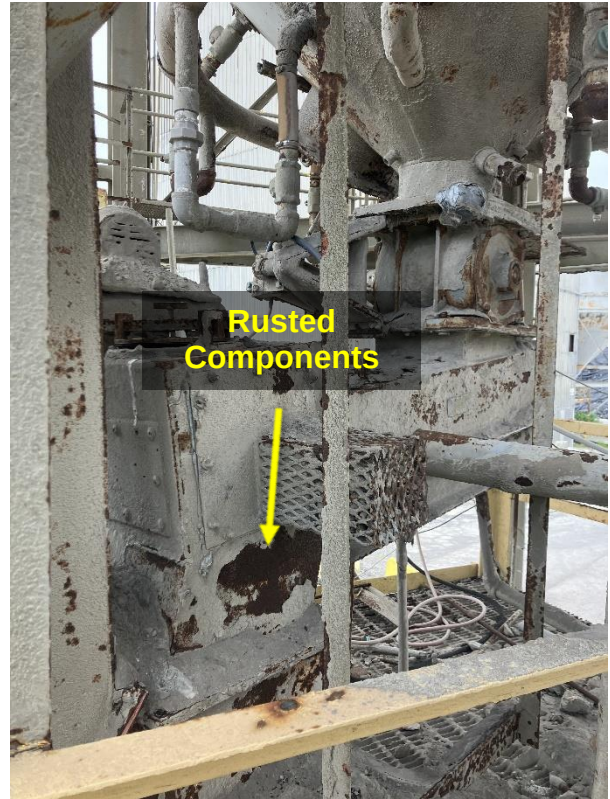
EXT 34 – Rusted components

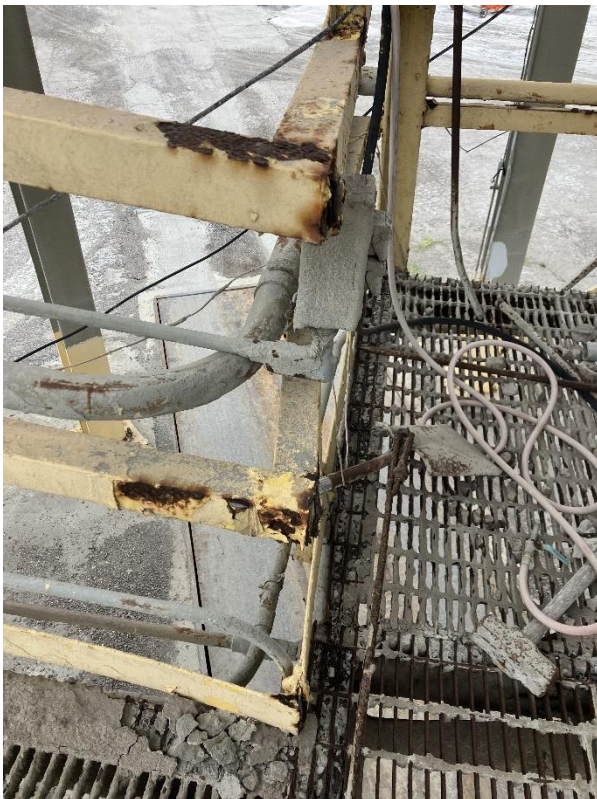
9. **Hopper Level:** Numerous guardrails and guardrail members coating has failed and suffer from onset corrosion, including the guardrail stair access.

EXT 35 – Guardrails are heavily corroded

- i. Due to the onset of heavy oxidation and heavy rusting, the bar grating and handrails should be replaced from the grating and handrails on the Hopper Level Platform to the stairs and handrails leading to the platform.

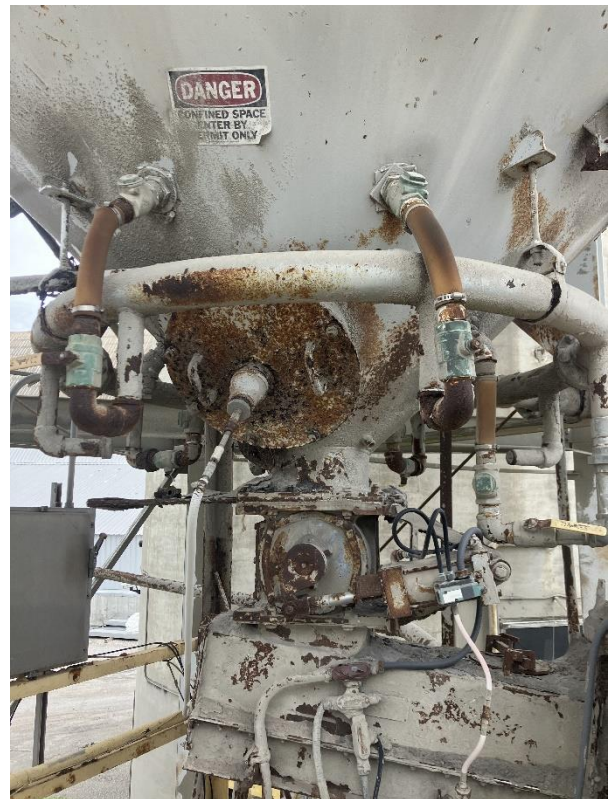
12. **Hopper Level:** There is heavy material in the low cone of the hopper. The cone also have heavy oxidation. Present on its steel components
13. **Hopper Level:** The slide gate, feeder, air slides, load out chutes, and air piping and air pads were found to be in poor condition.

EXT 36 – Hopper components are corroded

- i. Various components have been compromised due to corrosion and should be replaced. The slide gate, feeder, air slides, loadout chute, and all air piping and air pads should be replaced.

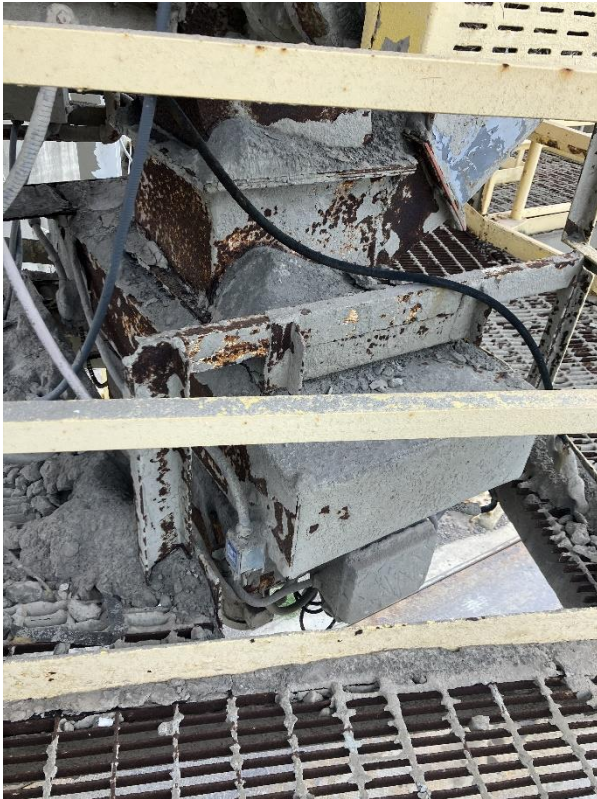
EXT 37 – Base of structure members are corroding

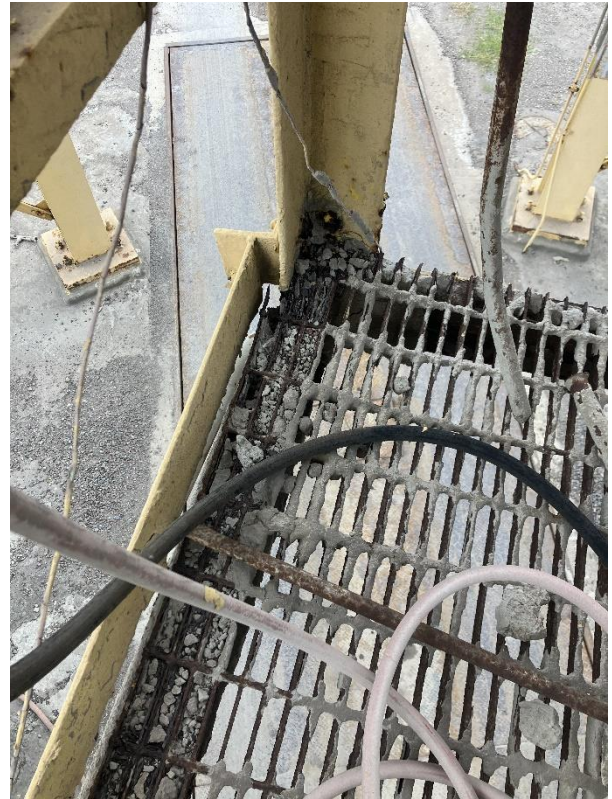
10. **Hopper Level:** The electrical boxes were noted to have an onset of heavy oxidation
11. **Hopper Level:** The platform grating was found to have heavy oxidation and buildup present on the grating.

EXT 38 – Grating has heavy buildup and corrosion

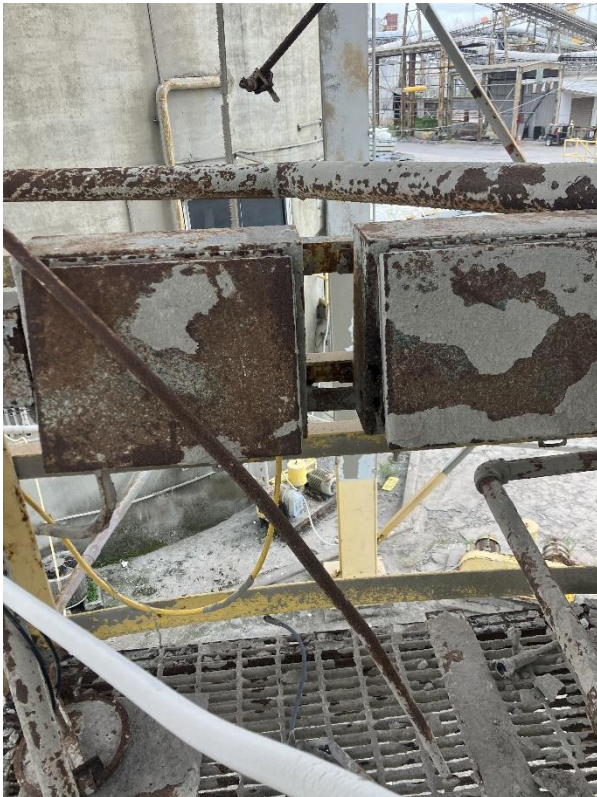
EXT 39 – Heavy oxidation on electrical boxes

- i. The highly oxidized electrical boxes should be replaced as well as any electrical components that have succumb to corrosion. The entire electrical system should be tested for functionality.

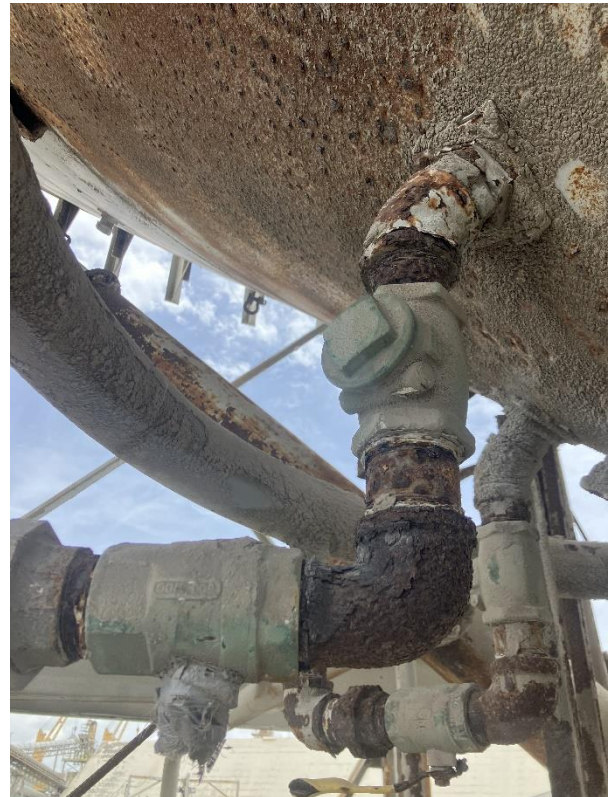
EXT 40 – Corroded pipes

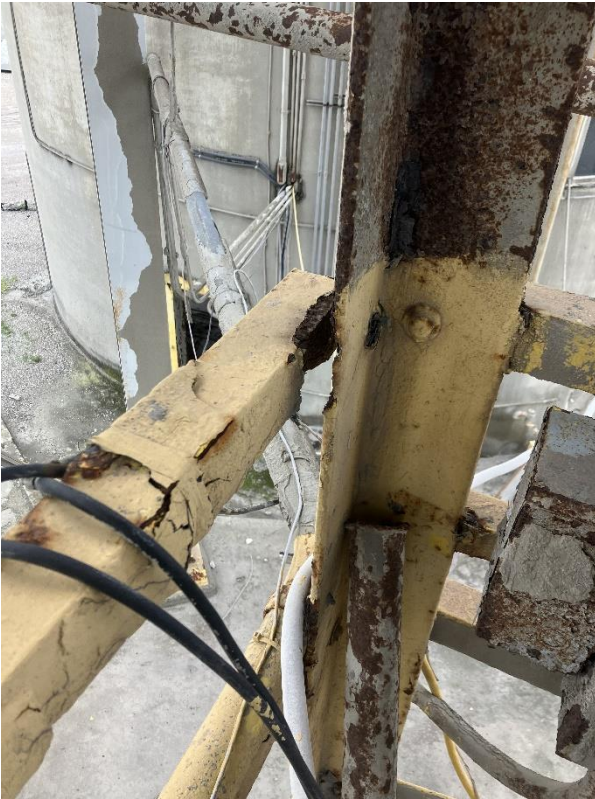
EXT 41 – Guardrail and components are corroding

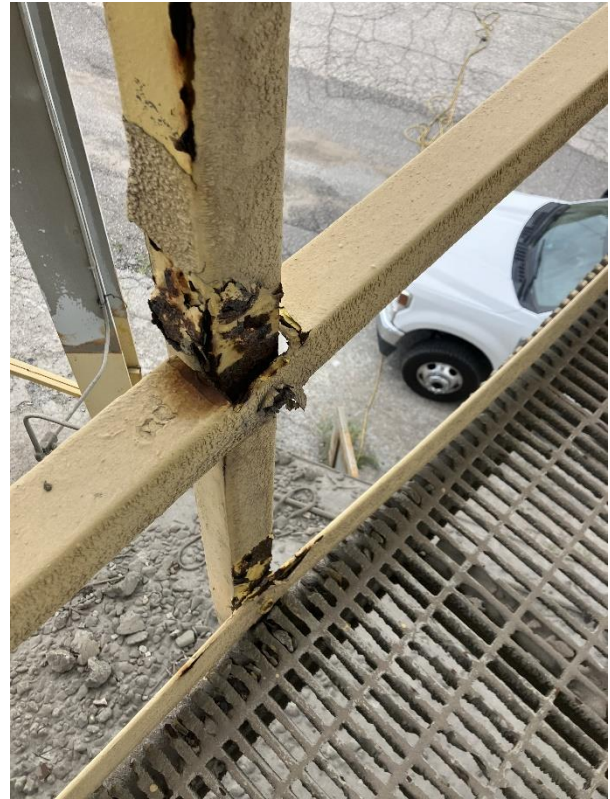
EXT 42 – Post is rusting through

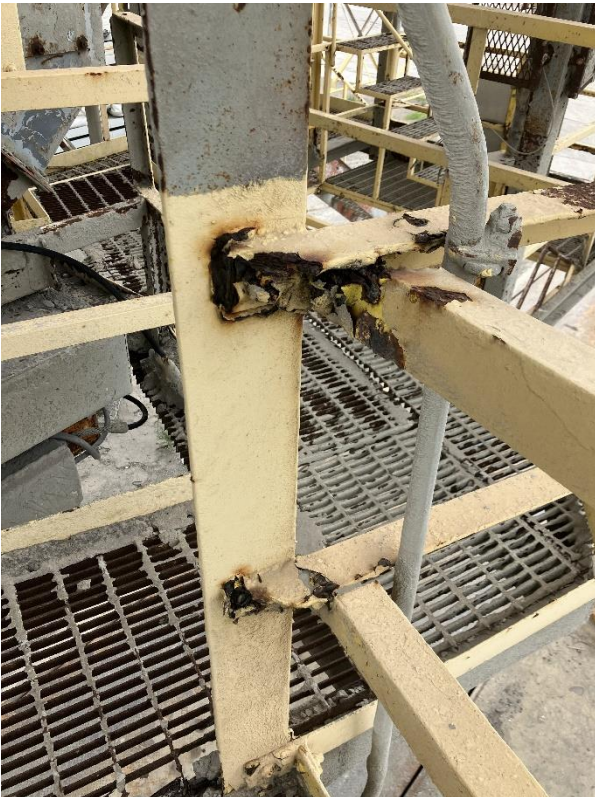
EXT 43 – Heavy oxidation on guardrail

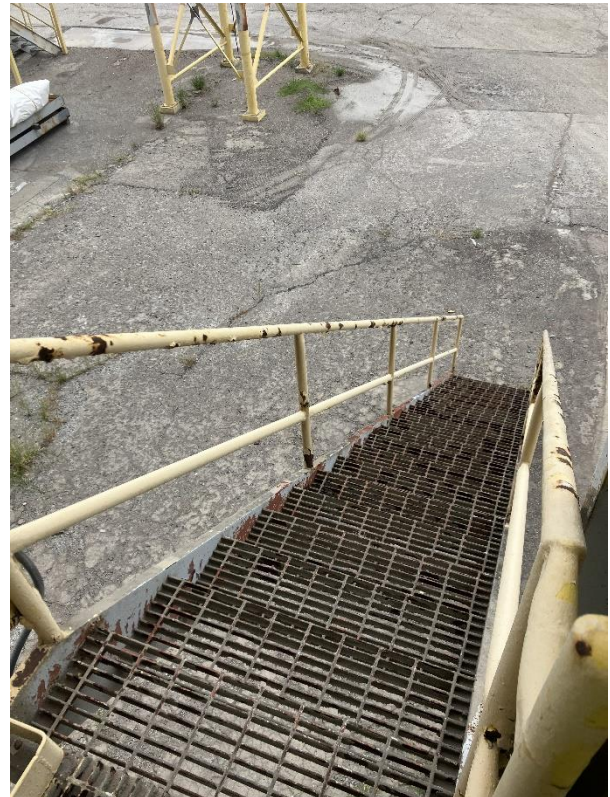
EXT 44 – Stairs and guardrail exhibit heavy oxidation
