# Condition Assessment: Concrete & Steel Silo

**MEDSHEL Global**  
Daytona Beach, FL  
June 2024

# **Condition Assessment: Concrete & Steel Silo**

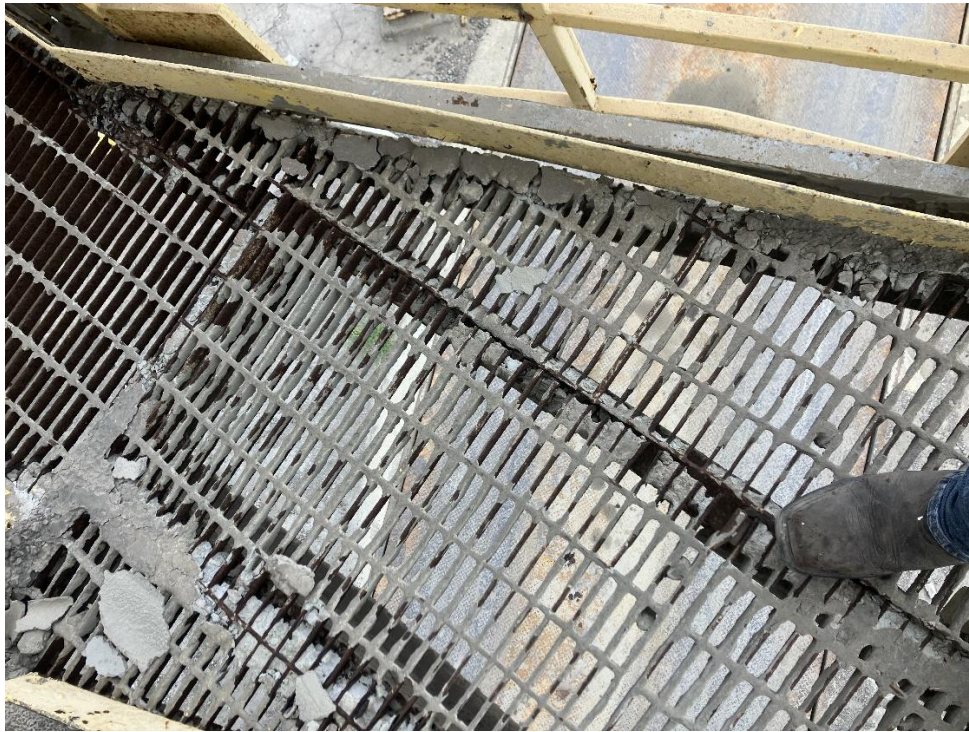
EXT 45 – Heavy buildup and oxidation on grating

- i. Due to the onset of heavy oxidation and heavy rusting, the bar grating and handrails should be replaced from the grating and handrails on the Hopper Level Platform to the stairs and handrails leading to the platform.

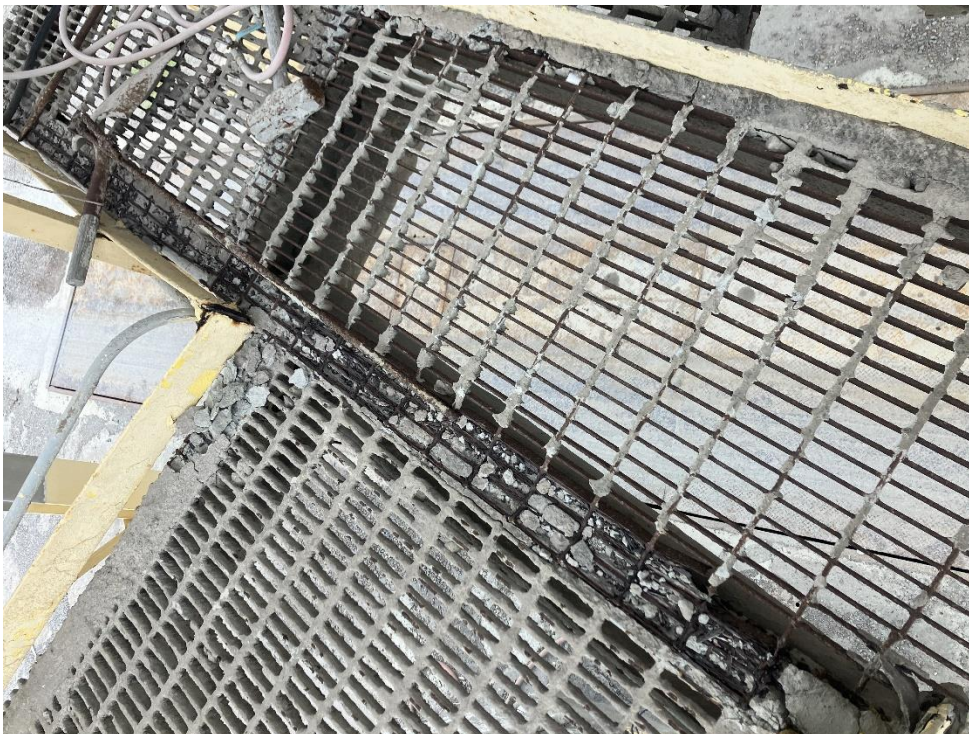
EXT 46– Heavy buildup and oxidation on grating
