# **C. Cement Fireport Plant**

Buffalo, NY

**Kiln Stack Inspection and  
Repairs**  
March 2024

Subject: Kiln Stack Inspection and Repairs

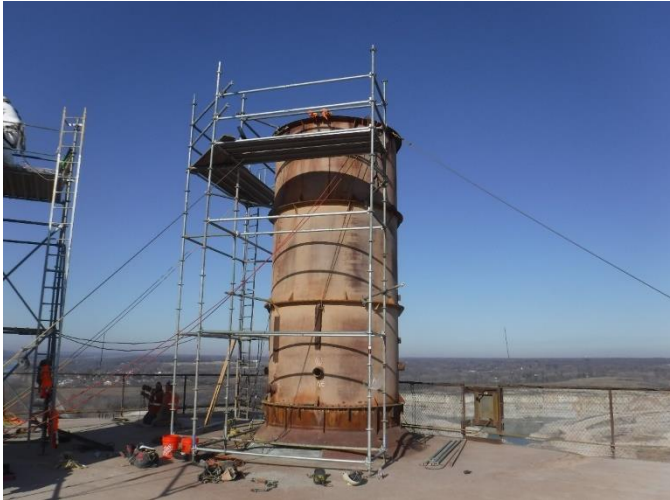
EXT 1 – View of the stack above the roof.

1. Stack has heavy oxidation throughout the exterior. This can be seen at the top of the stack (EXT 1 & 2) and throughout the stack on each floor. Much of the oxidation throughout the stack is the cause of leakage from the flue gasses.

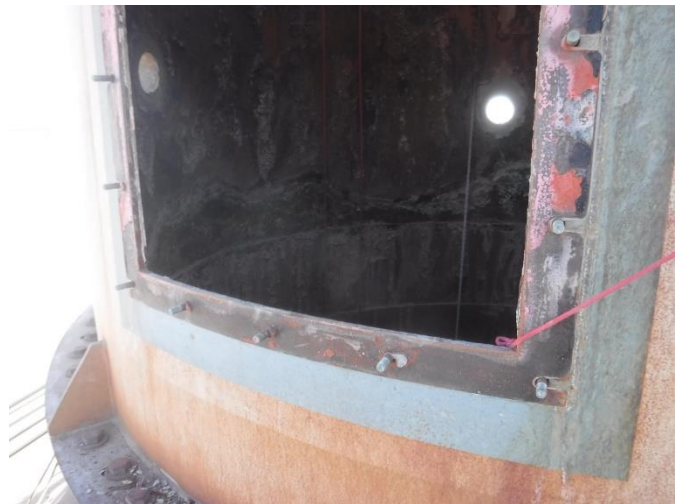
EXT 4 – EL. 200± – View of access door opening

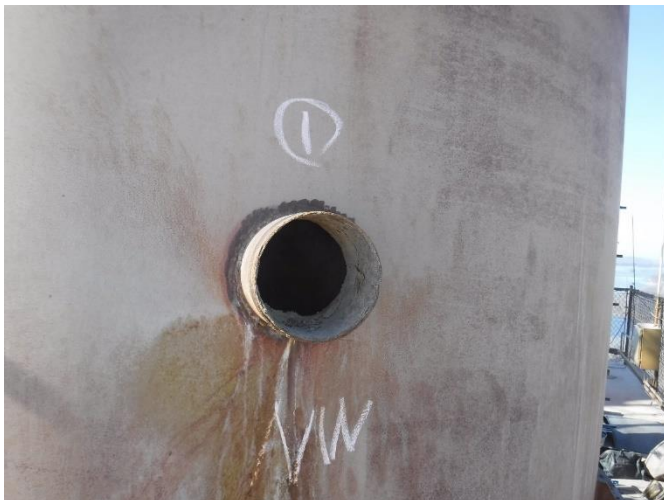
EXT 7 – EL. 200± – Roof port showing signs of corrosion.

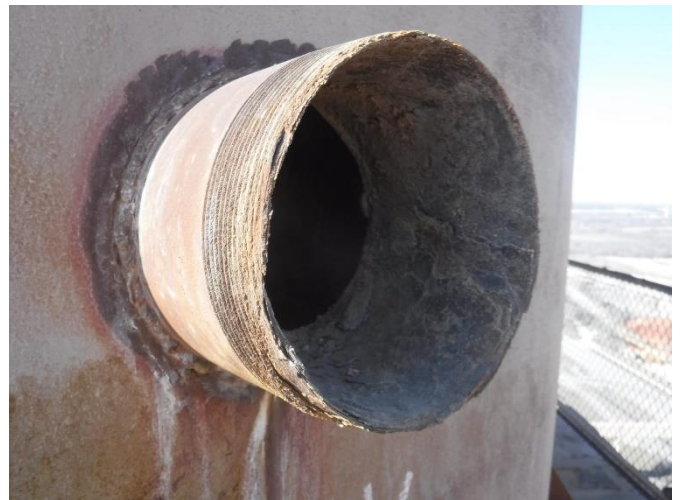
EXT 8 – Drop #1 EL. 70'± – Closeup on port

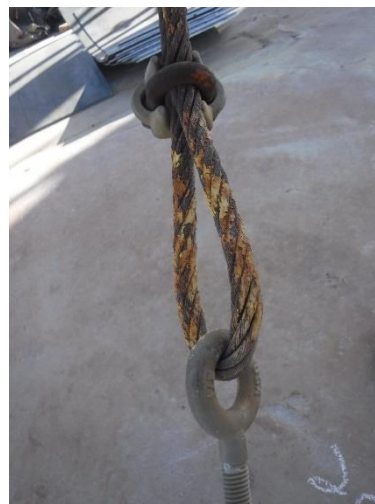
EXT 10 – EL. 200± – Failed coating on guy wire

2. Cracks were found in various areas along the curb of the rain hood (EXT 14, 15, &19). \*
3. The guy wires around the anchors on the stack appear to be oxidizing and the coating present are failing. (EXT 10 & 11).

A structural analysis should be performed to determine the requirements of the guy wires and they should be removed if deemed unnecessary as the stack seems to be experiencing excessive compression due to thermal growth, demonstrated from the damaged grout at the base. If they were deemed essential to support the stack, the designs of the existing guy wire anchors without proper anchor plates should be reviewed and revised. The guy wires with corrosion and fray should also be replaced with new ones.

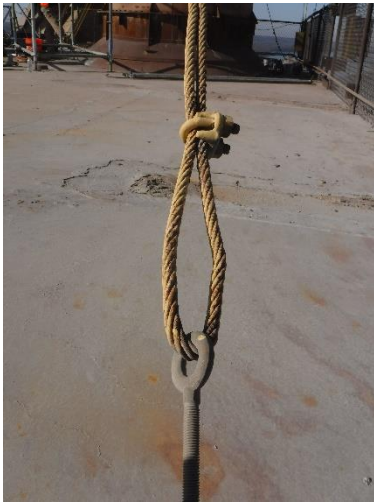
EXT 11 – EL. 200± – Failed coating on guy wire

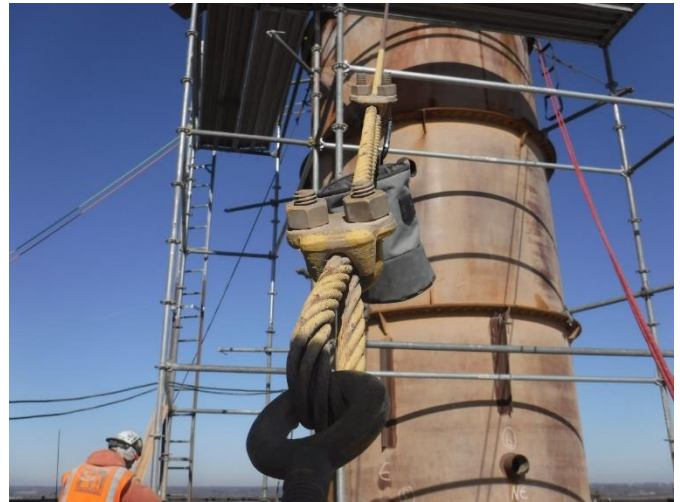
EXT 12 – EL. 200± – Guy wire.

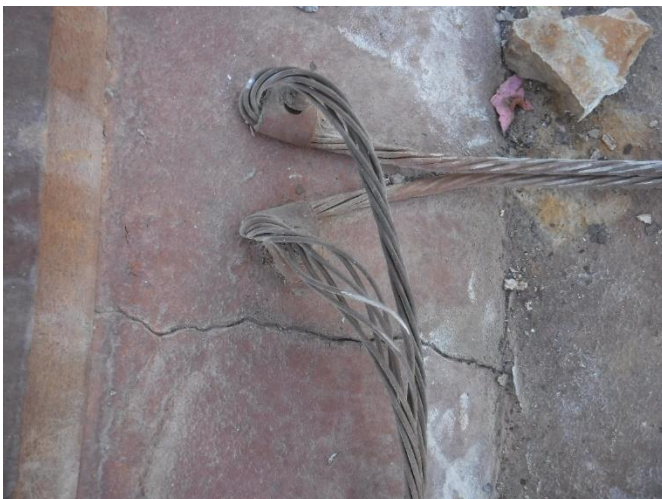
EXT 15 – Frayed LPS conductor, crack on curb. Debris present on rooftop

4. The LPS conductor near the roof is fraying (EXT 14 & 15).
5. There are flue leakage stains and oxidation around almost all splice flanges, but most noticeably on floors 7, 8, 9 , & 10. This is due to the gaps discovered on the splice flanges. (EXT 20, 21, 22, 23, 24, 25, 26, & 27).

The Lightning Protection System (LPS) conductors are exhibiting signs of fraying, which poses a significant risk to safety of the stack. Frayed conductors compromise the effectiveness of the LPS, increasing the likelihood of lightning-induced damage and subsequent failure. It is crucial to repair or replace the frayed conductors and ensure the LPS is properly installed.

The cracks on the curb above the roof penetration should be repaired with a suitable epoxy product after removing any loose material and prepping the surface.

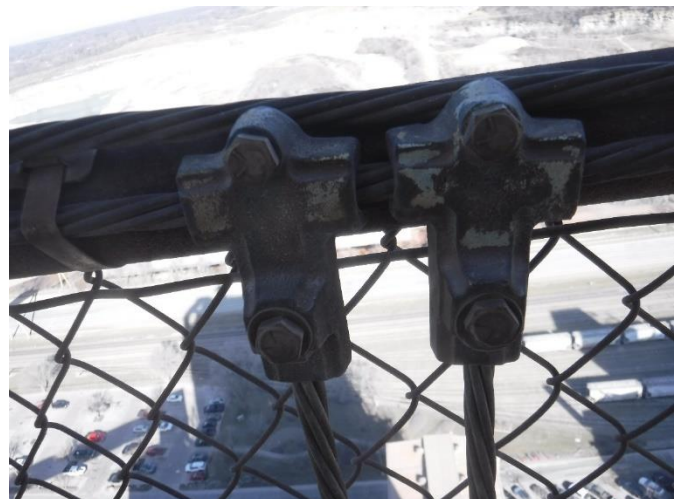
EXT 16 – Roof – Conductors connected to the building's LPS

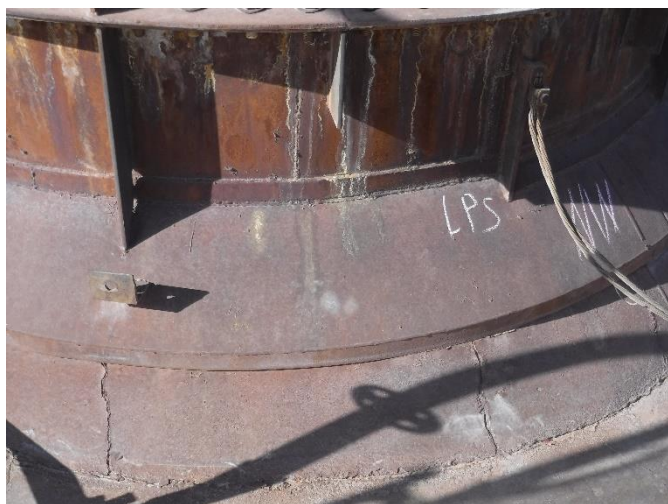
EXT 19 – Roof – Cracks present on curb **before** [repairs](#)

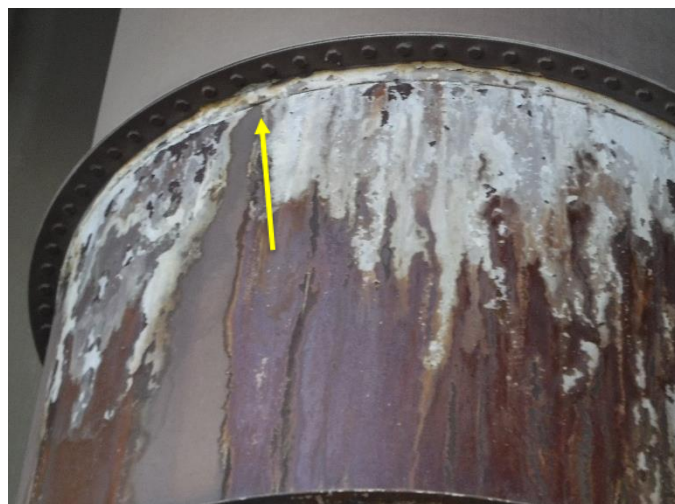
EXT 20 – 10<sup>th</sup> Floor – Roof penetration, leakage through flanged joint. Gaps are present in splice flanged **before** [repairs](#)

To remediate the warped flanged joints, the flanged joints at EL. 180'±, 170'±, 127'±, 102'±, and 60'± should be repaired with properly sized splice rings on the interior to allow proper load transfer. Any gaps at other flanged joints should also be sealed properly to prevent leakage of flue gases and corrosion of the steel. Any gaps present on the exterior should be welded shut.

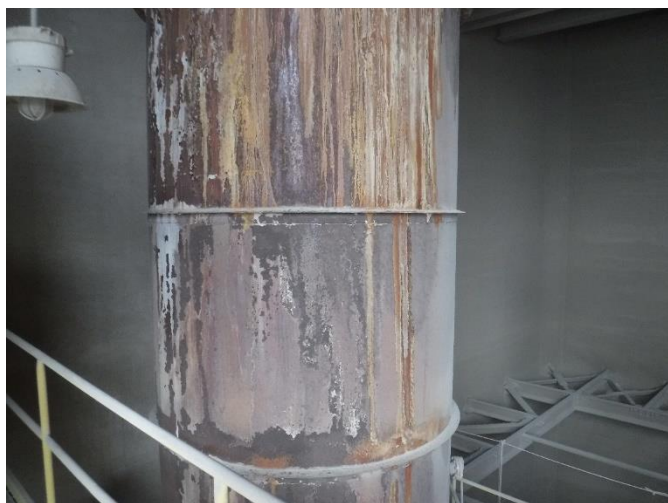
EXT 21 – 10<sup>th</sup> floor – Stack showing oxidation and stains from leaking

Extensive oxidation is evident on the stack's exterior, largely attributed to flue gas leakage through the splice flanges. It is strongly recommended to clean and coat these areas promptly to prevent oxidation from progressing into corrosion.

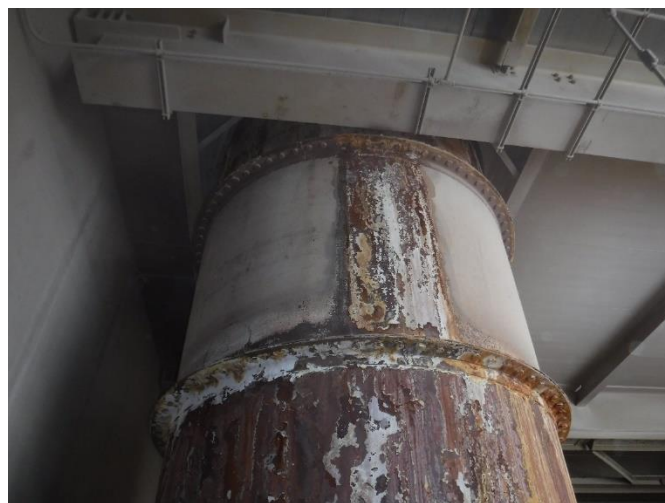
EXT 22 – 10<sup>th</sup> floor – Oxidation and stains from leakage

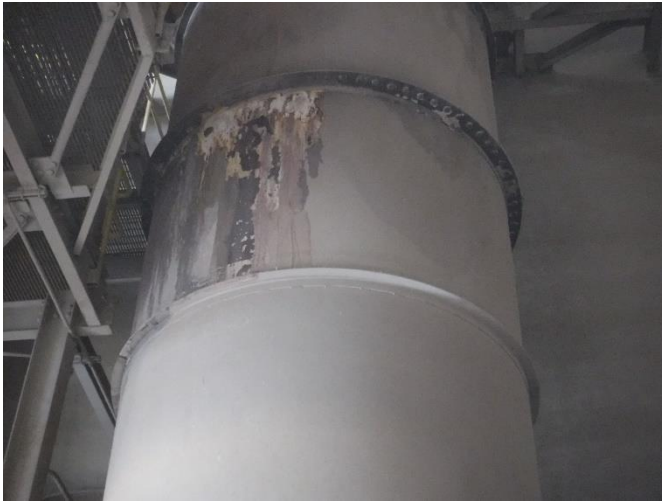
EXT 23 – 9<sup>th</sup> floor – showing stains from leakage

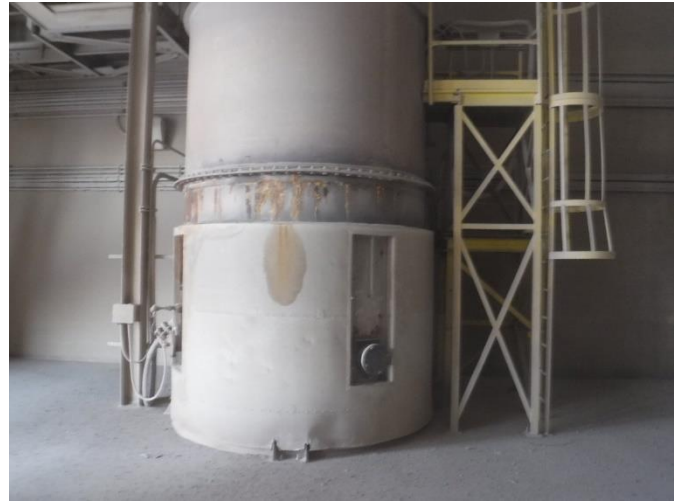
EXT 24 – View stack and test port

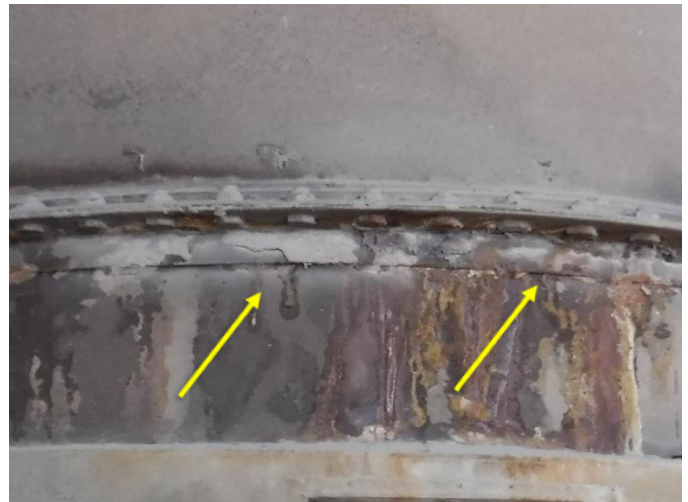
EXT 26 – 9<sup>th</sup> Floor – Cracked weld on splice flanged before [repairs](#)

The cracked weld on the splice flange above the 9<sup>th</sup> floor should be with new plate rings.

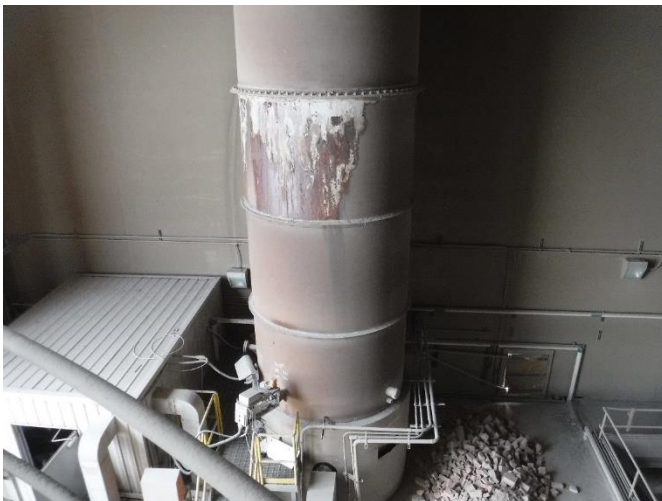
EXT 27 – 8<sup>th</sup> Floor – Leakage stains through flanged joint

8. 8<sup>th</sup> floor – There is a pile of bricks and debris present on the floor (EXT 27 & 28)
9. 8<sup>th</sup> floor – An instrument on the test platform is missing both side covers, and the wires are exposed (EXT 31). This could pose a potential electrical hazard.

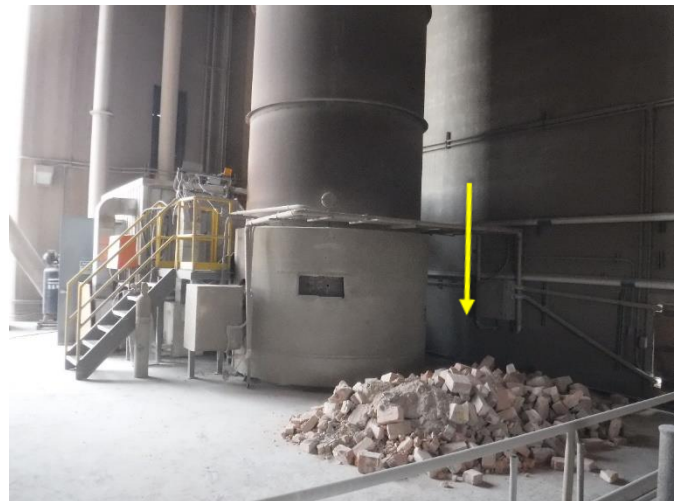
EXT 28 – 8<sup>th</sup> Floor – Debris on Floor

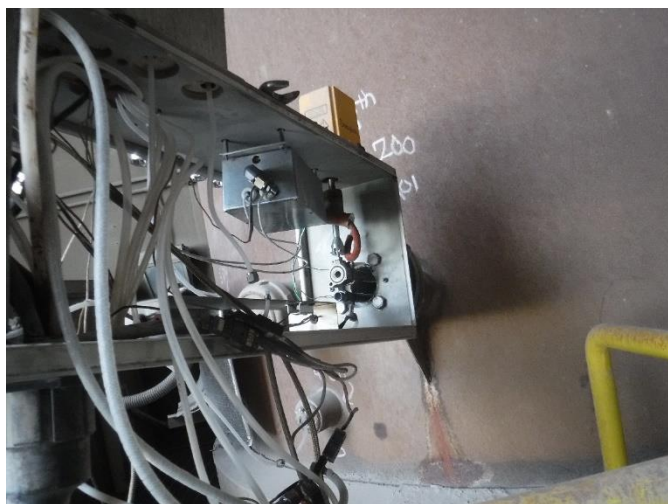
EXT 31 – Instrument missing covers

The instrument located on the test platform of the 8<sup>th</sup> floor requires immediate attention due to its exposed wiring, which poses a potential electrical hazard. The functionality of the instrument should be investigated, and it should be repaired, replaced, or removed to mitigate the risk of electrical accidents.

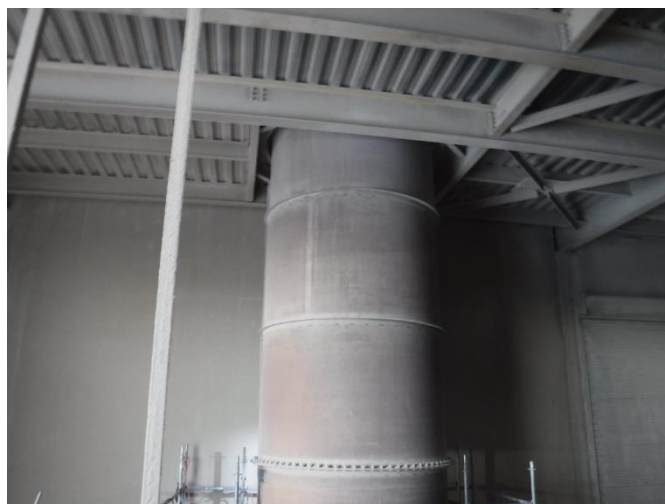
EXT 32 – 7<sup>th</sup> Floor – Floor penetration point

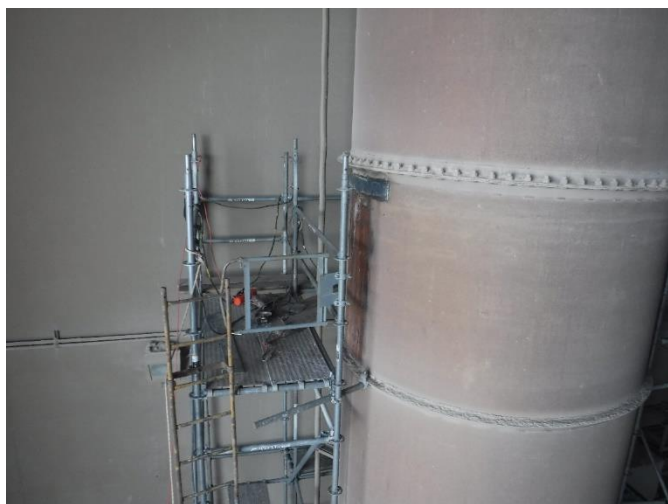
EXT 33 – 7<sup>th</sup> Floor – Leakage stains from cracked flanged joint; scaffolding and repairs in progress

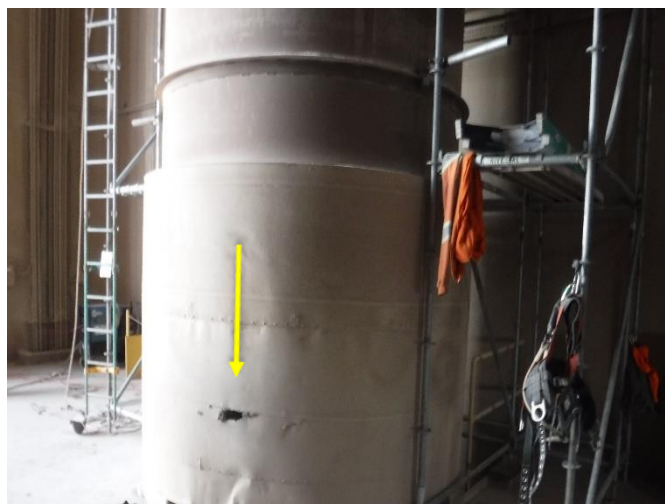
EXT 34 – 7<sup>th</sup> Floor – Heat shield with perforation

The cause of the hole in the heat shield should be further investigated. Following assessment, prompt repairs are recommended to facilitate the optimal performance of the heat shield in safeguarding adjacent structures from the stack's excessive heat emissions.

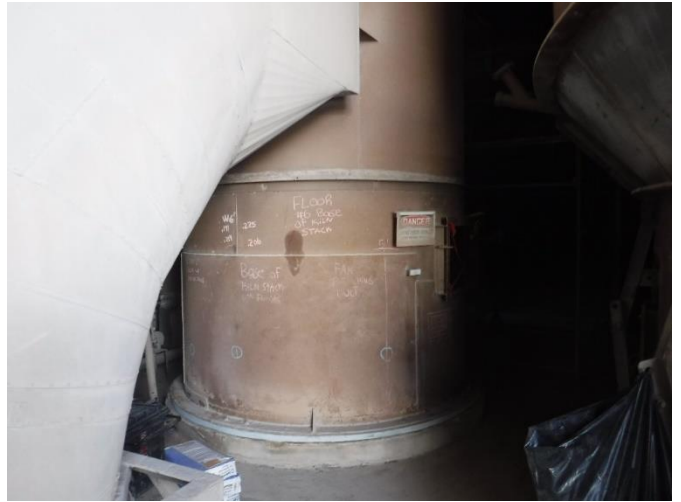
EXT 36 – View of stack base

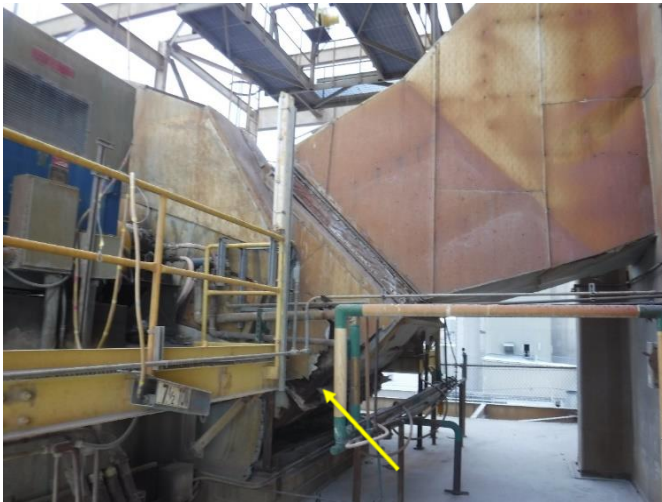
EXT 43 – Breeching showing oxidation and damaged cladding

12. Breeching duct area – The cladding on the breeching duct joint is damaged and missing in various areas. The breeching duct has succumbed to heavy oxidation.

Repair the torn and damaged cladding on the breeching duct found.

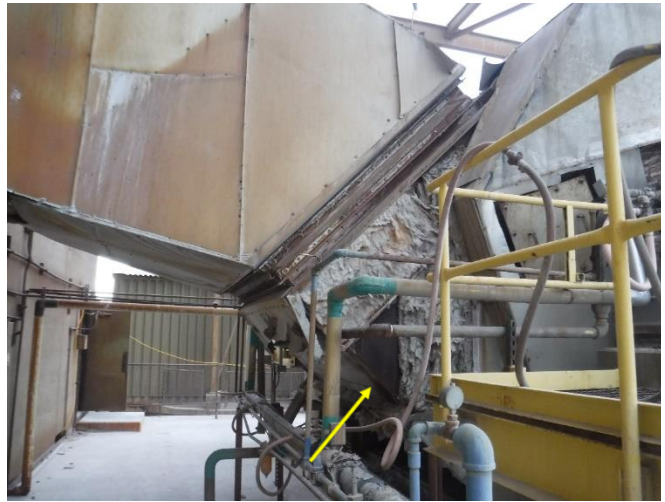
EXT 44 – Breeching showing oxidation and torn cladding

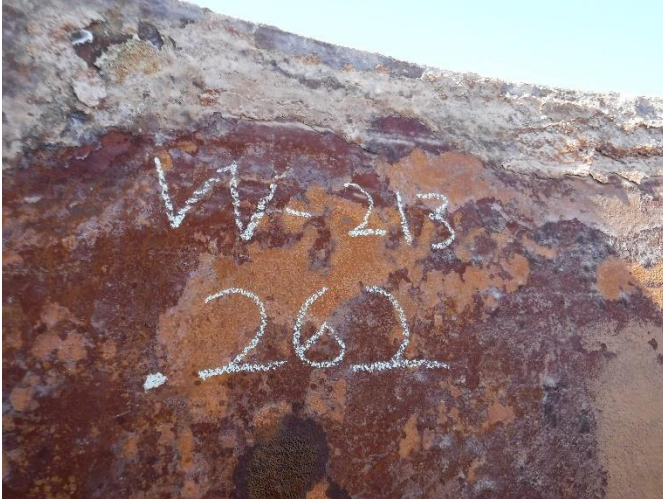
INT 1 – W EL. 213'± – Top of the stack, buildup heavy oxidation present

1. There is heavy buildup present at the top of the stack (INT 1 – 8)
2. Oxidation was found throughout the stack, mainly at the top (EL 213'± – 180'± and from EL 40'± to 0'±).

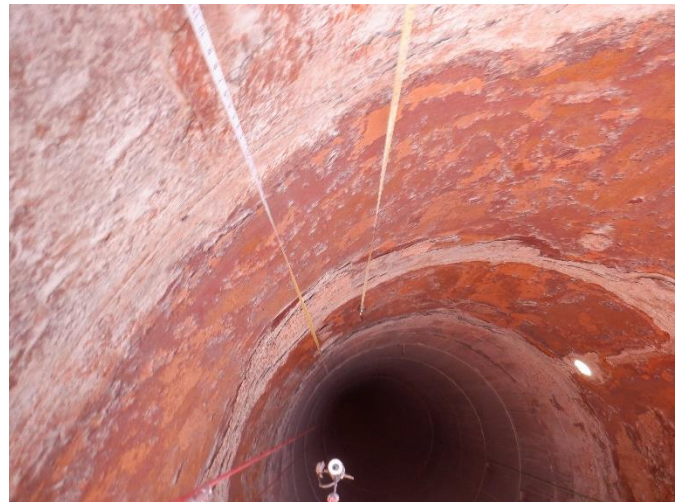
INT 4 – EL. 213'± – Top of the stack, buildup

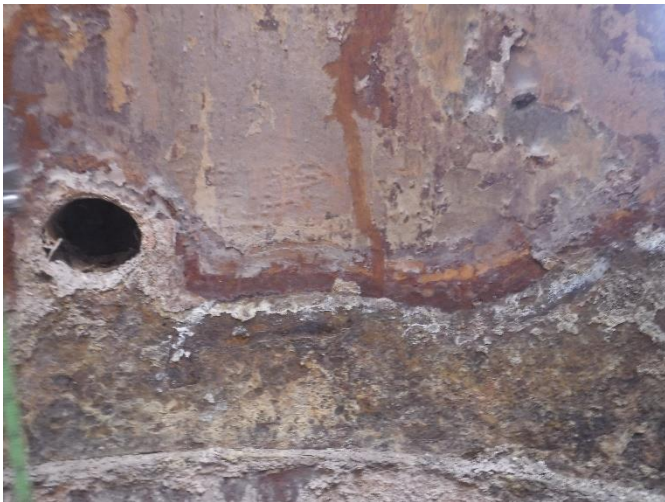
INT 7 – W EL. 190'± – Corrosion and buildup on stack

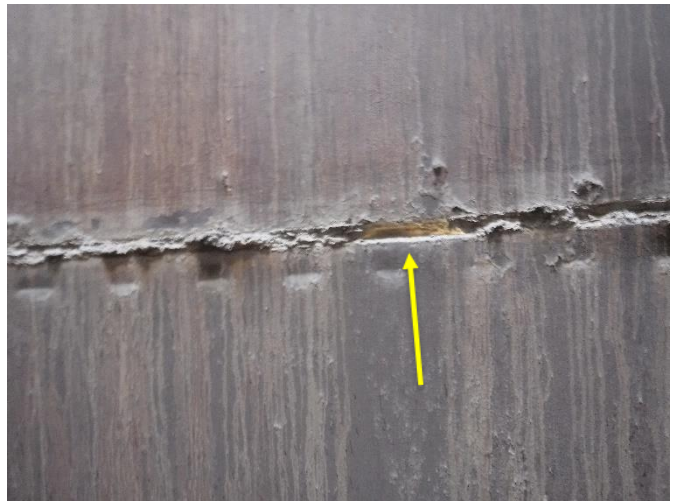
INT 8 – W EL. 180'± – Gap in flanged joint

3. Gaps were found at various flanged joints at EL 180'±, 170'±, 127'±, 115'±, 102'±, 60'±, (INT 8, 12, 13, 14, 15, 16, 28, 30, 32, 35, 36, 37, & 42).
4. Holes were discovered from the interior of the stack, noticeably around flanges (INT 14, 16, 26, 27, 33, & 34).

5. Warped stack plates were seen around the flanged joints and buildup has intruded into the space between the plates and flanges. This can be observed at EL. 180'±, 170'±, 160'±, 150'±, 140'±, 127'±, 80'±, 40'±. (INT 8, 15, 16, 20, 21, 23, 25, 39, & 43,). The flanged angles at each joint are intermittently welded to the stack plates, resulting in the warping, and upward bending of the top section of the splice. This poses a risk of failure in the intermittent weld and, consequently, in the splice itself. Such a potential structural compromise warrants attention and remedial action to enhance the integrity of the stack.

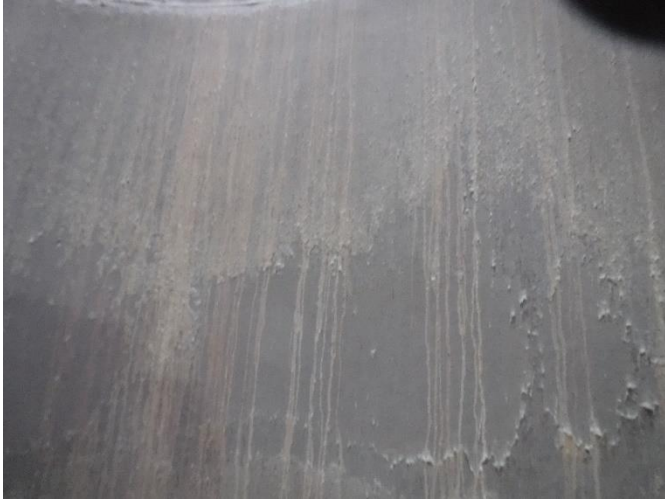
INT 11 – W EL. 170'± – Buildup and stains present on surface of interior

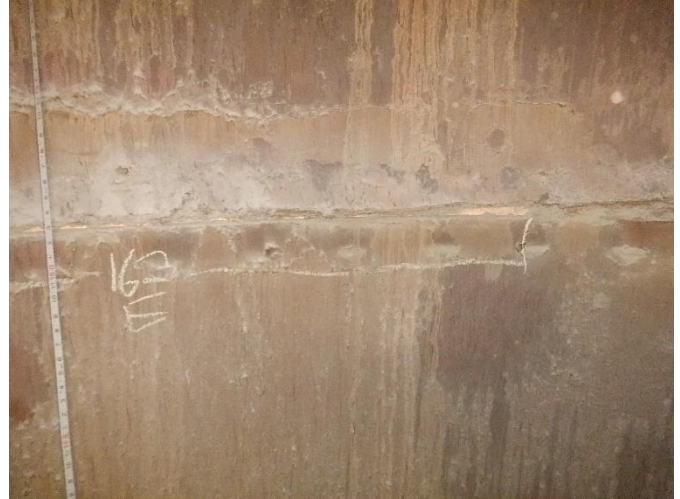
INT 12 – E EL. 170'± – Gap in flanged joint

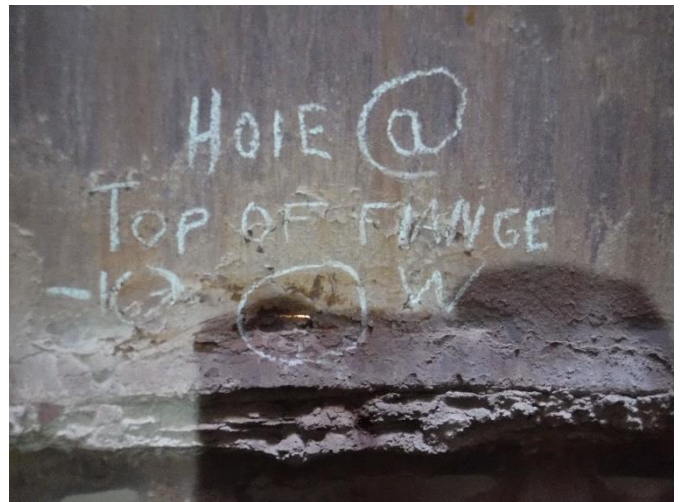
INT 16 – W EL. 170'± – Hole in top of flange

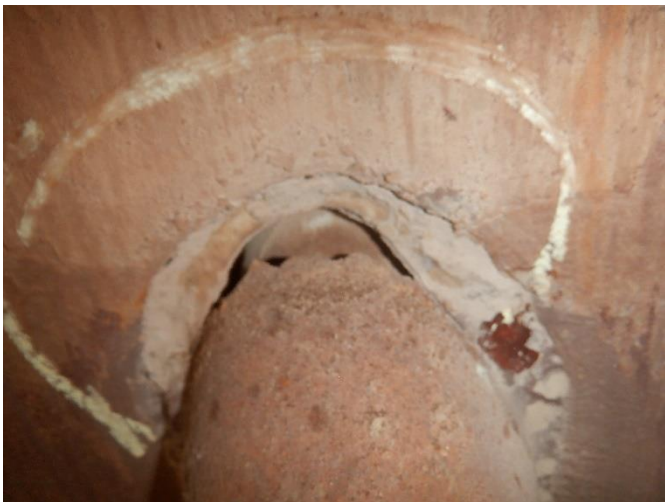
INT 27 – E EL. 140'± – Corrosion hole present in instrument port nozzle

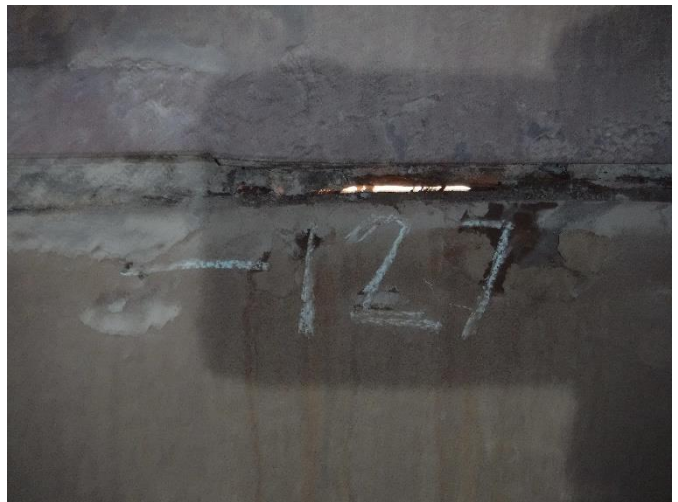
INT 28 – W EL. 127'± – Gap in flanged joint

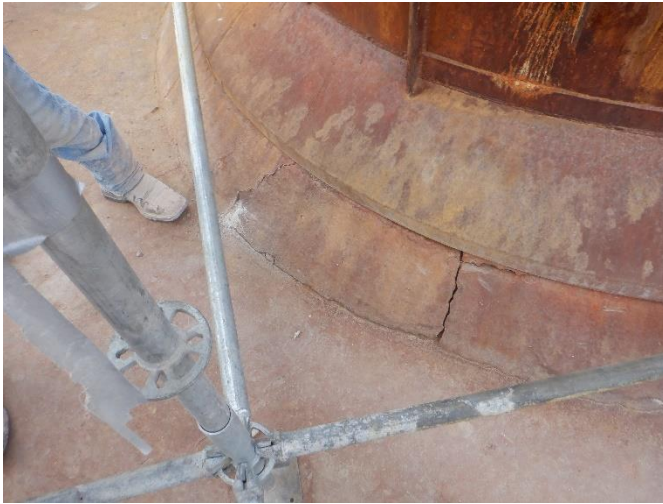
IMG 1 – Typical view of cracked curb before repair

The IA team repaired the cracks in the curb above the roof penetration. The IA team began by removing a significant section of the damaged curb and installing new reinforcement steel (rebar) for added strength. Afterward, fresh mortar was applied, smoothed, and finished to complete the repair. Subsequently, any remaining cracks were addressed with repair mortar, followed by a final layer to seal and revitalize the curb.

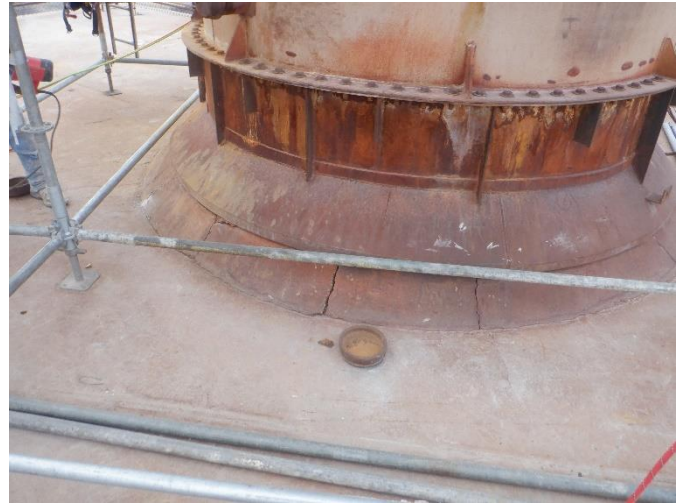
IMG 2 – Typical view of cracked curb before repair

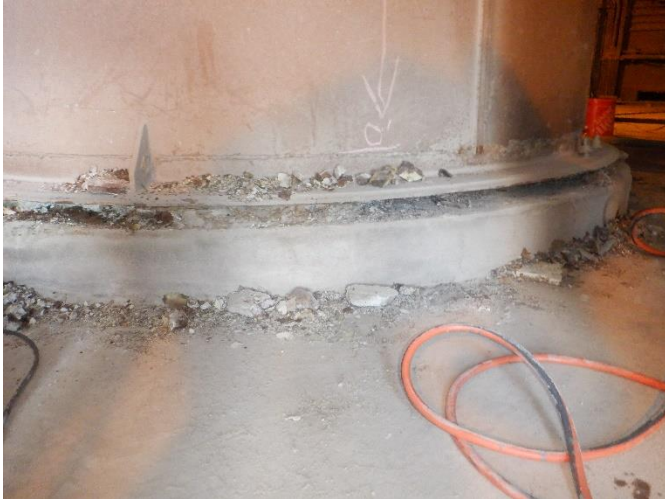
IMG 9 – The base before repair process

The grout at the base of the stack on floor 6 was significantly damaged and some sections were missing altogether. The IA team repaired it by removing the damaged concrete and applying new repair mortar.

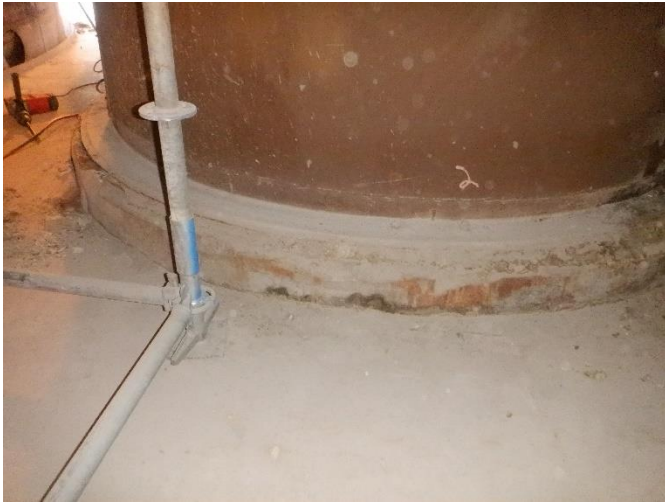
IMG 13 – The base before repair process

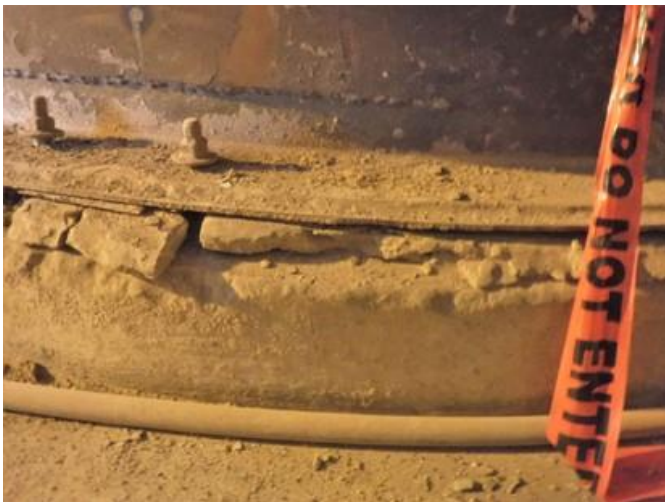
IMG 15 – The base before repair process

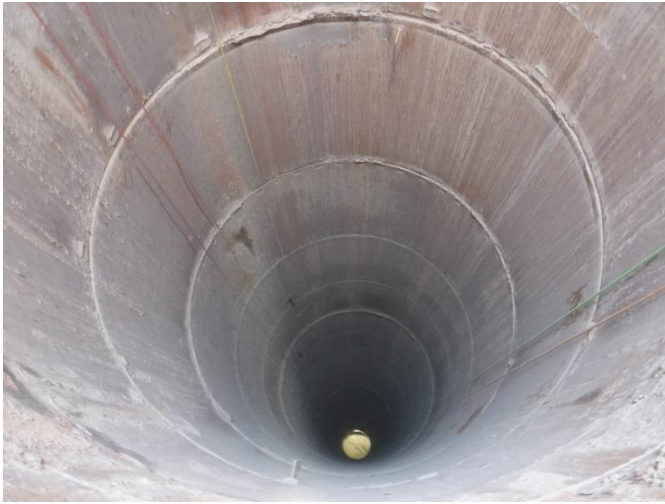
IMG 17 – View of interior before plate installation

The IA team installed new reinforcement rings around the roof penetration at EL. 190'± due to the presence of heavy corrosion.

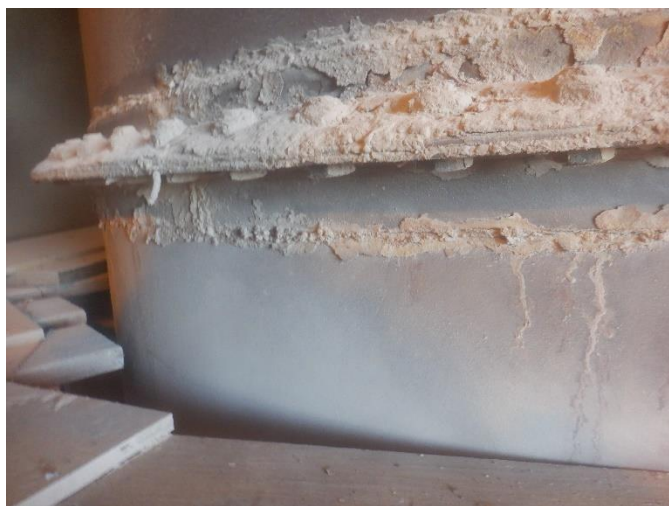
IMG 25 – View of hole with buildup present (caused by flue leakage)

After inspecting the kiln stack, we discovered horizontal holes at every bolt flanged throughout the entire stack. Repairs were made on the outside of the bolt flanges on the 7th and 10th floor. Further repairs are required on the remaining floors to ensure the structural integrity of the stack. For more details, refer to the [recommendations](#) section.

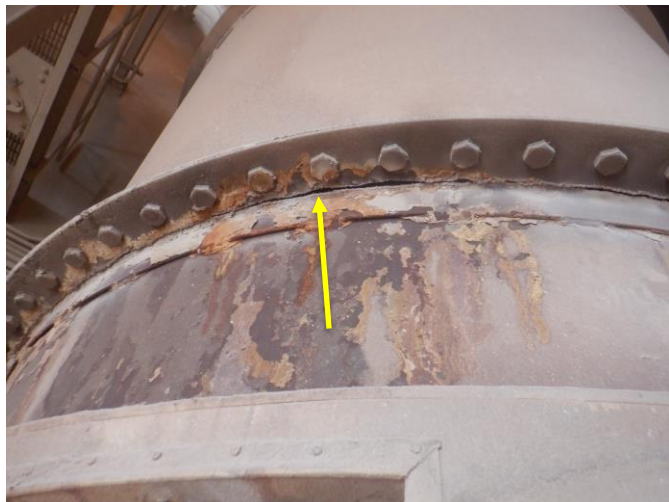
IMG 33 – View of cracked weld on splice flanged

The IA team repaired the cracks present on the exterior of the stack at the splice flanged on the 9<sup>th</sup> floor.

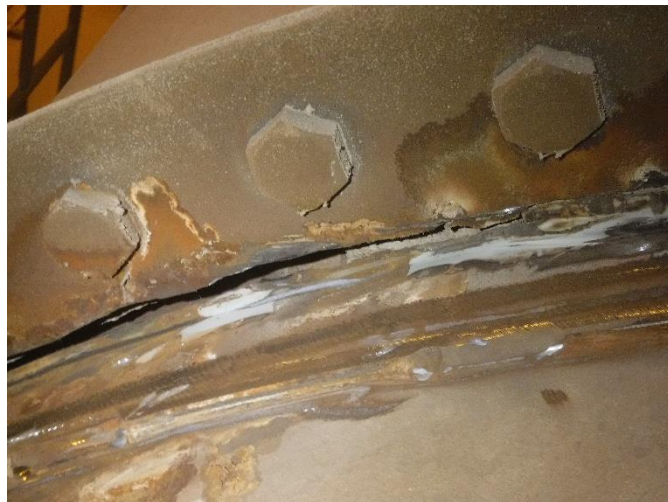
IMG 34 – Closeup of cracked weld
