**F. Concrete Company  
Fayden Plant  
Lancaster, OH**

**D13 Duct  
Inspection Report  
April 2024**

Subject: D13 Duct Inspection

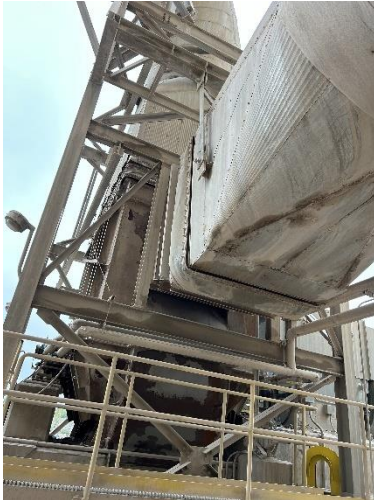
EXT 1 – Buildup on the outside sections of duct; oxidation on expansion joint.

1. Light buildup is present on the exterior of the duct, both indoors and outdoors (EXT 11, 12, 13, 18, & 19)
2. Mild oxidation is present on most of the exterior (EXT 1, 2, 16, 17, 21, 22, 23, 25, 26, 27, & 28).
3. The expansion joints are severely oxidized. This should be addressed to prevent further deterioration (EXT 26, 27). In the expansion joint outside, there is a missing bolt (EXT 3).
4. Several holes were discovered in the cladding which may allow flue gas to leak (EXT 5, 6, & 8).
5. The cladding was found to be damaged in some areas, notably around the ladder access opening. This can lead to flue gas leaks (EXT 1, 5, 8, 9, & 30)

The interior and exterior of the duct should be hydro washed to remove the accumulated buildup. This will prevent deterioration due to corrosive buildup.

(2B) **Tool-clean the oxidation on the interior and exterior of the duct**

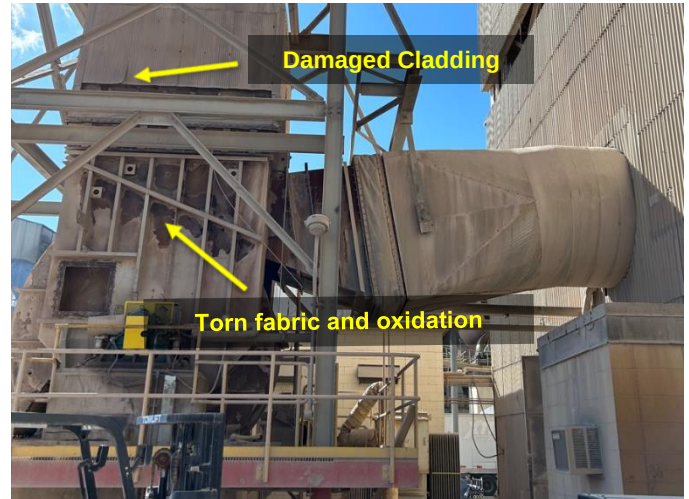
EXT 2 – Oxidation present behind torn fabric and damaged cladding

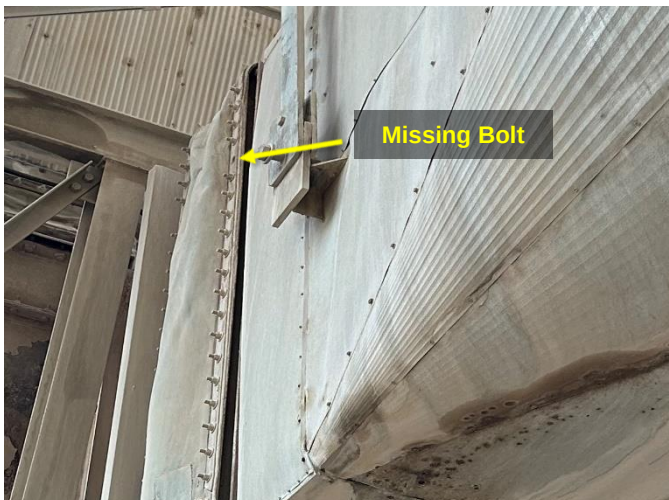
EXT 3 – Missing bolt on expansion joint

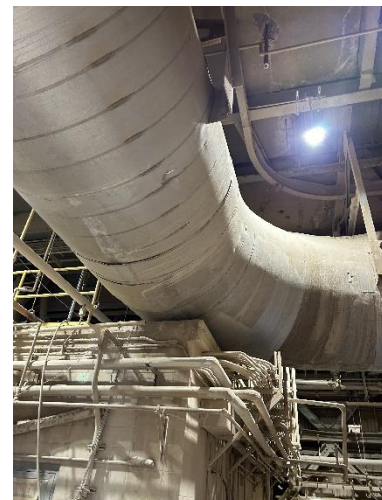
EXT 4 – Several holes in duct and cladding is falling apart

The holes in the duct should be patched to prevent flue gas leaks within the confined space of the building.

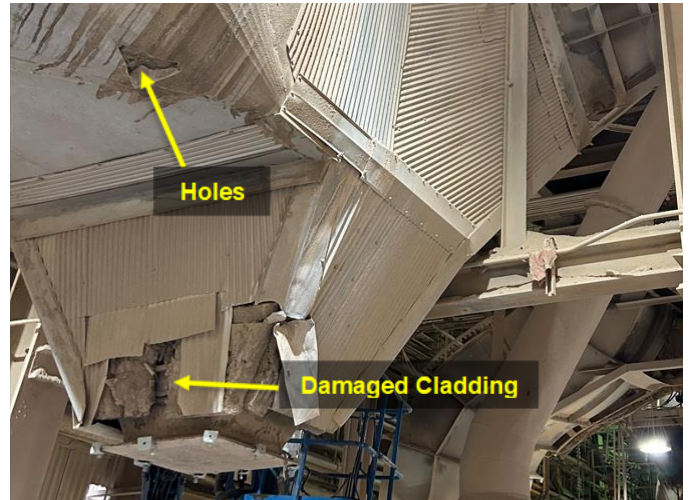
EXT 8 – Holes in duct and cladding is falling apart

The cladding around the ladder access door has failed and is exposing the interior of the duct to the room. This should be repaired to prevent flue gas leaks within a confined space, which poses a hazard to workers.

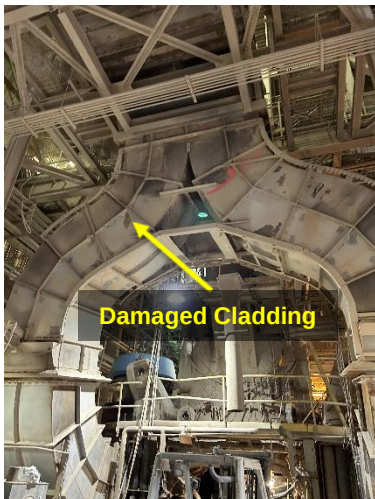
EXT 9 – Damaged cladding

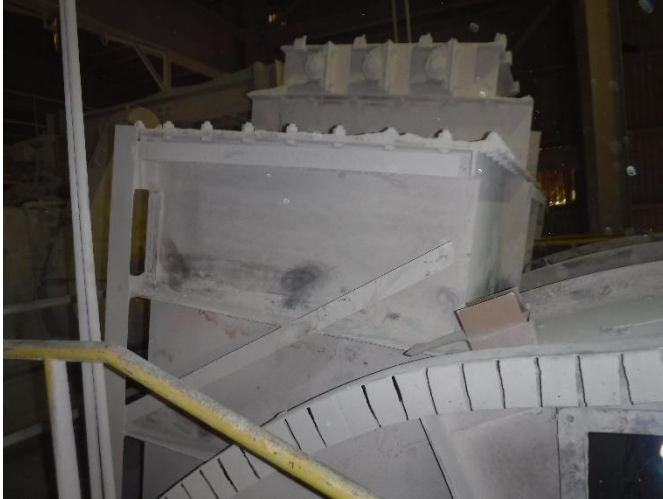
EXT 11 – Light buildup on top of duct

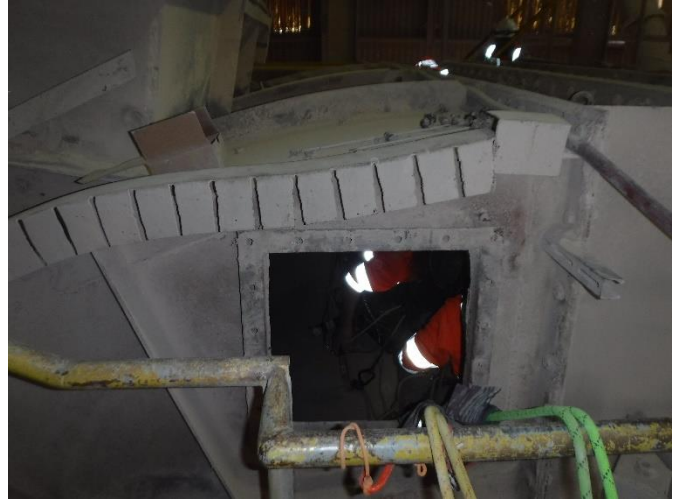
EXT 12 – Access door to the duct

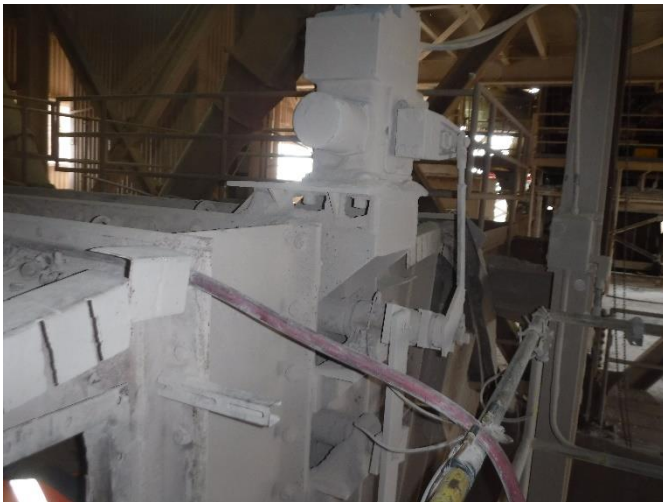
EXT 13 – Light buildup on top of duct

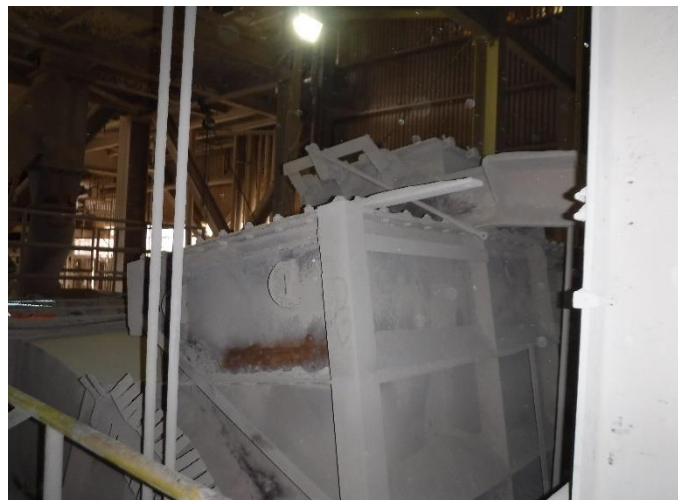
EXT 16 – Oxidation present

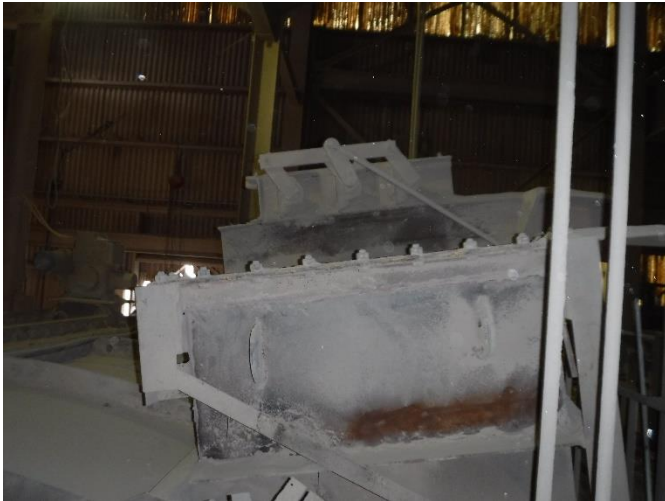
EXT 17 – Heavy oxidation

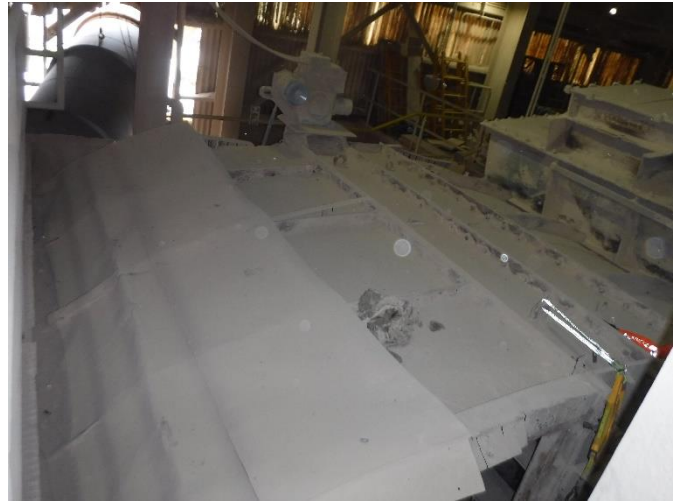
EXT 18 – Debris and buildup on duct

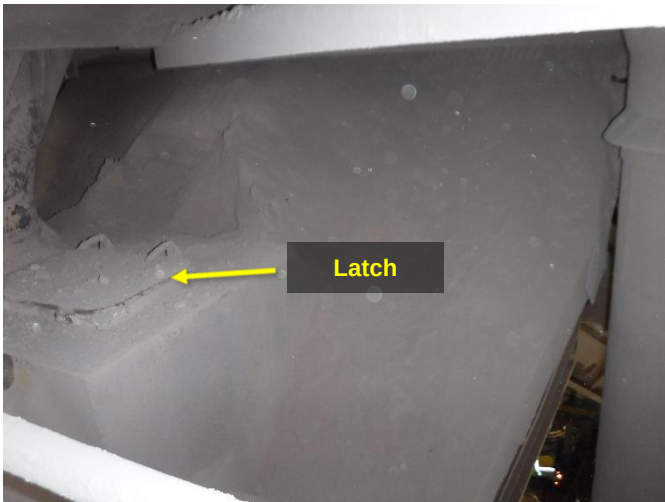
EXT 19 – Oxidation around the latch and buildup present

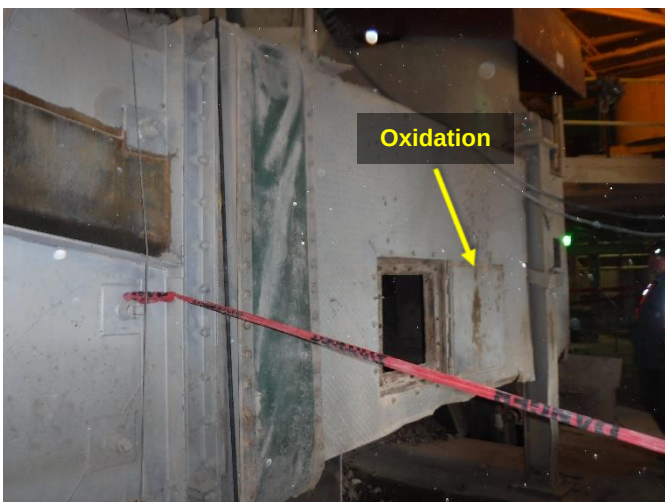
EXT 21 – Side of the east pant leg; oxidation on access door

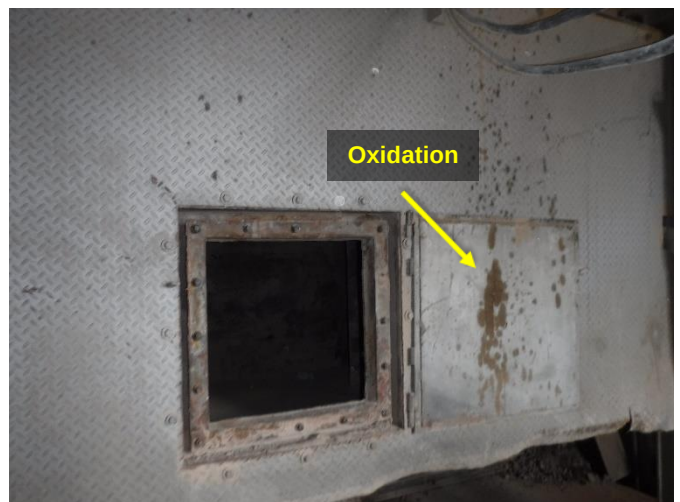
EXT 22 – Oxidation on door

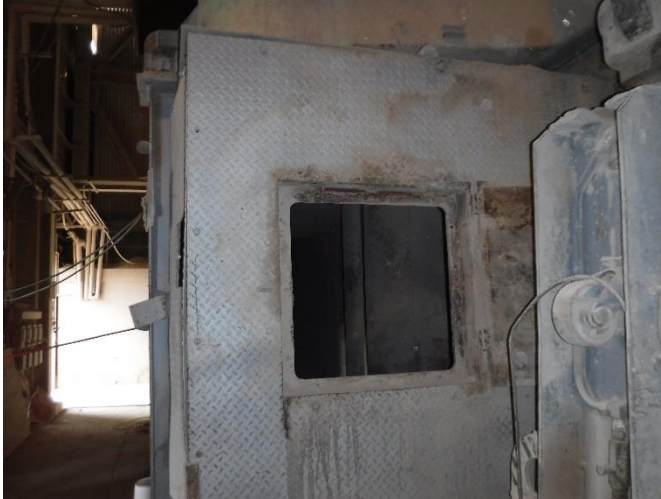
EXT 23 – Oxidation on the access door at the end of the east pant leg

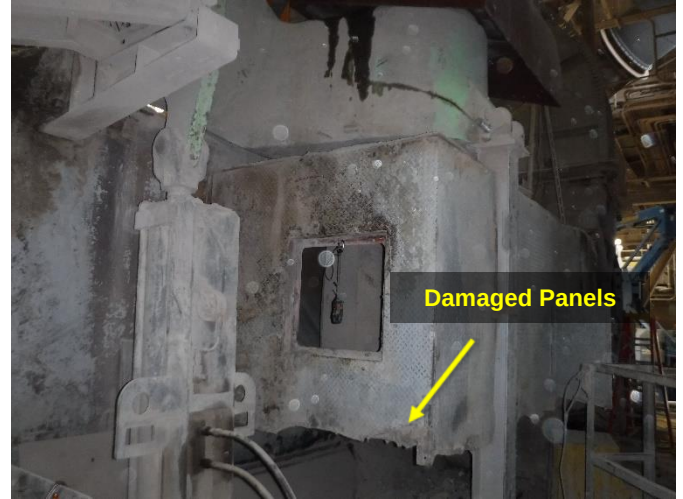
EXT 24 – Damaged panels

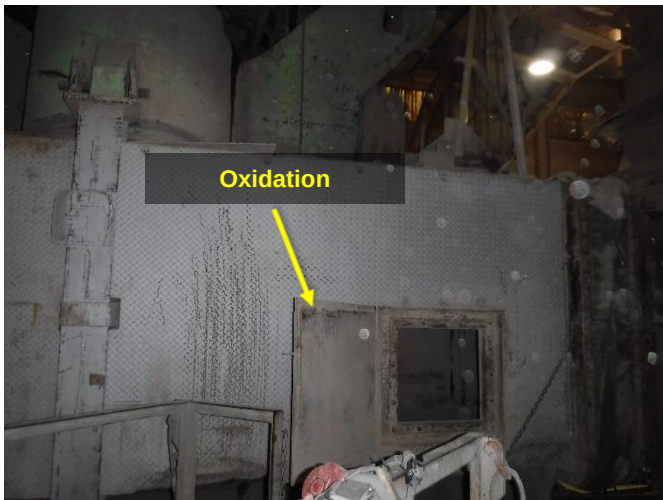
EXT 25 – Oxidation on the access door on the west pant leg

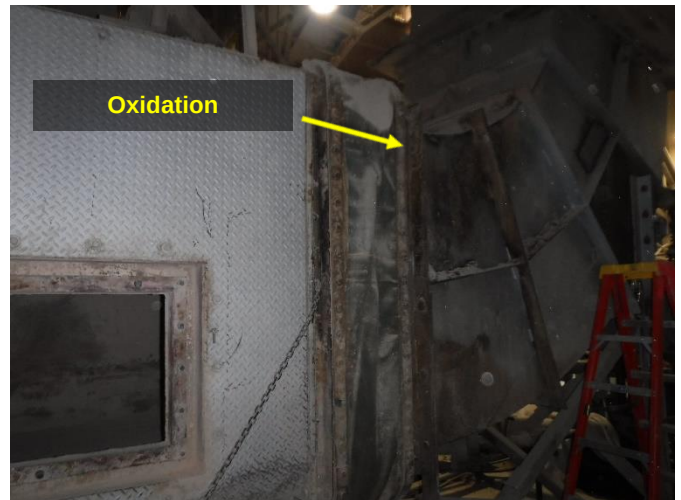
EXT 26 – Severe oxidation on the expansion joint and closest stiffener of the west pant leg

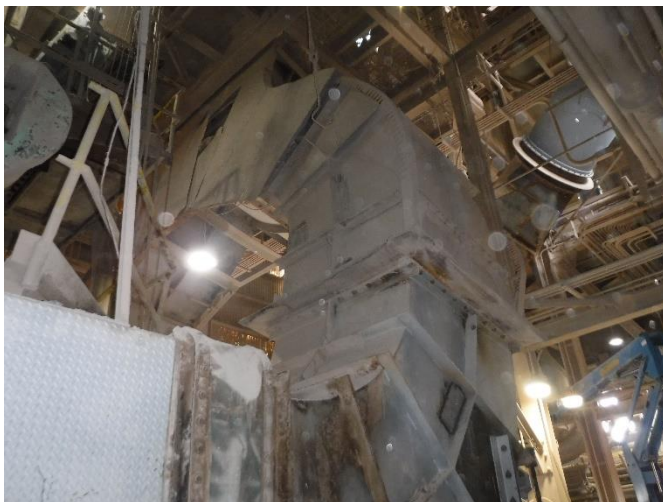
EXT 27 – Oxidation present on vent

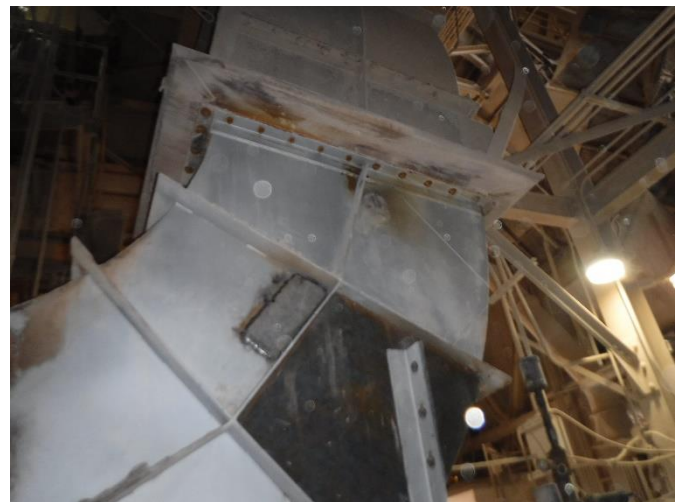
EXT 28 – Mild to severe oxidation on the side of the west pant

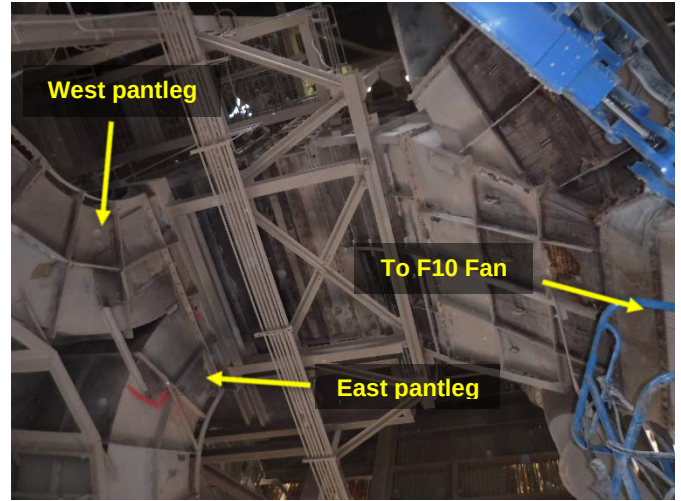
EXT 30 – Underside of duct

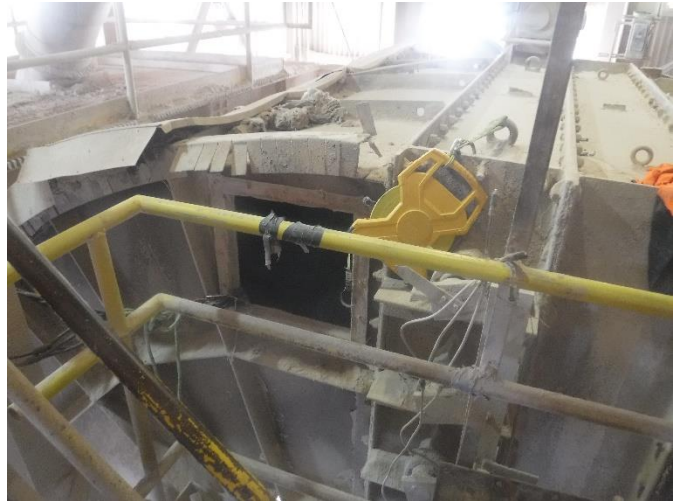
INT 2 – Opening to duct

1. Moderate to heavy buildup is present throughout the interior of the duct (INT 2, 3, 4, 7 9, 10, 38, 41, 51,123, & 139).
2. Several holes were discovered in the cladding, allowing light into the duct (INT 14, 15, 16, 57, 58, 63, 64, & 70, 71, 139, 140, & 145).
3. A buckle was found in the corner of the duct (INT 12 & 13).
4. At several locations in the duct, panels were damaged, torn, or peeling away from the rest of the duct (INT 17, 18, 19, 20, 21, 22, 23, 24, 28,91, 92, 93, 94, 95, 96, 97, 128, 129, 130, & 134).
5. The pipes within the pantlegs are clogged (INT 105, 106, 143, & 144).
6. Inside the horizontals section of the pantlegs, trash and debris are scattered around the duct (INT 151 & 152).

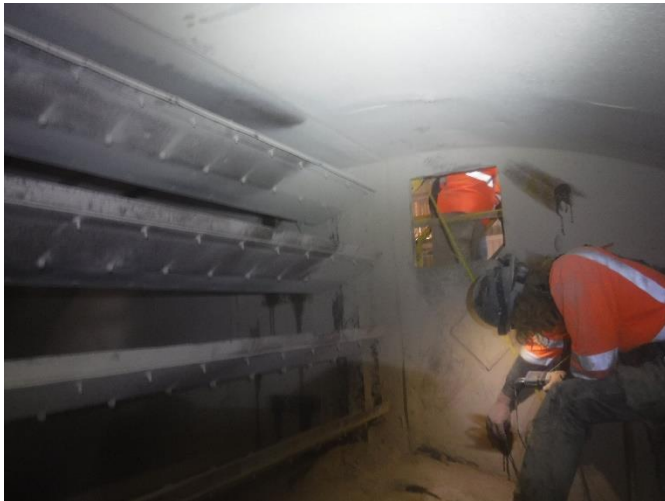
INT 3 – Damper blades

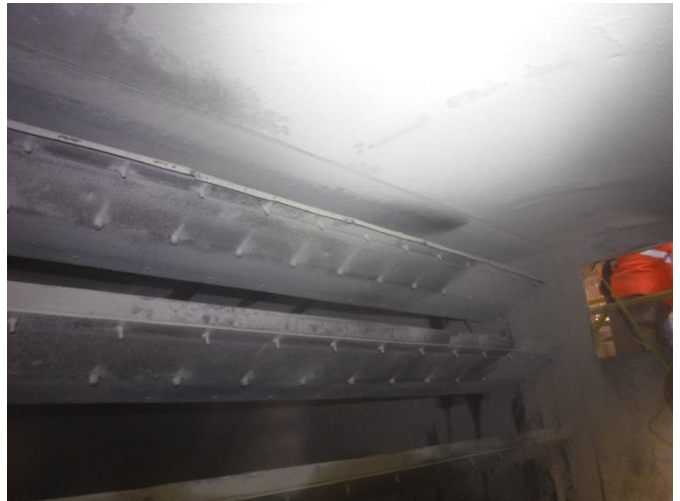
INT 4 – Damper blades

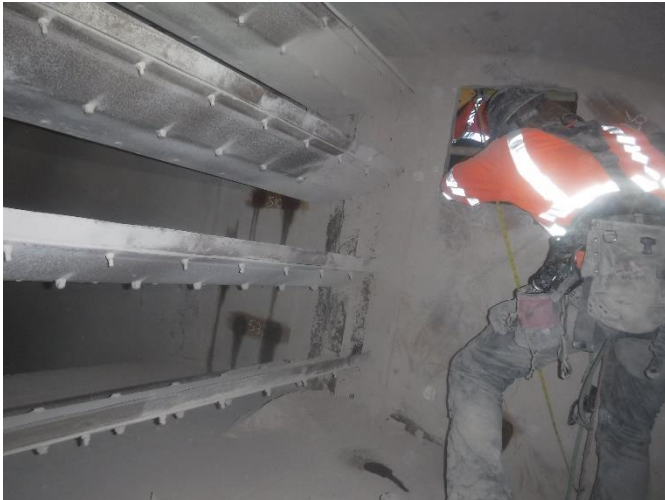
INT 7 – Buildup on damper blades

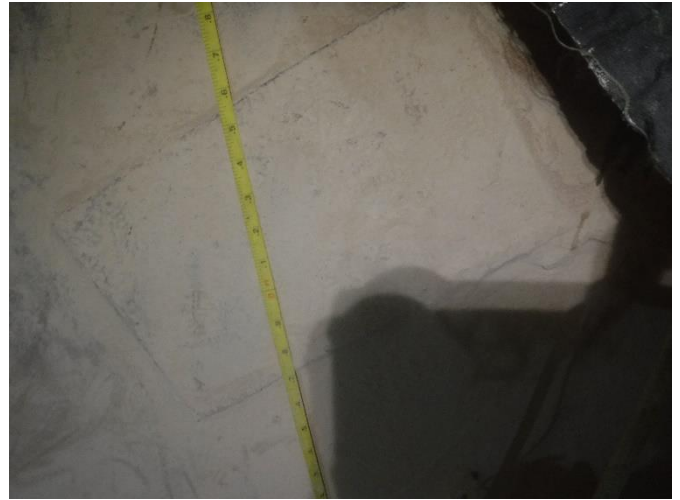
INT 8 – Previous patchwork

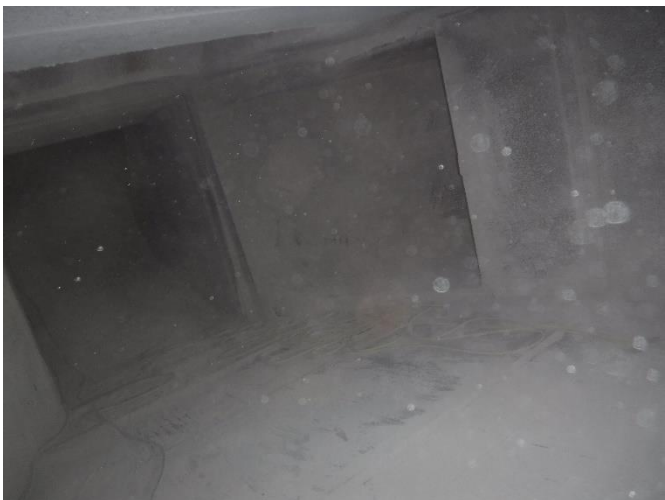
INT 9 – View of duct

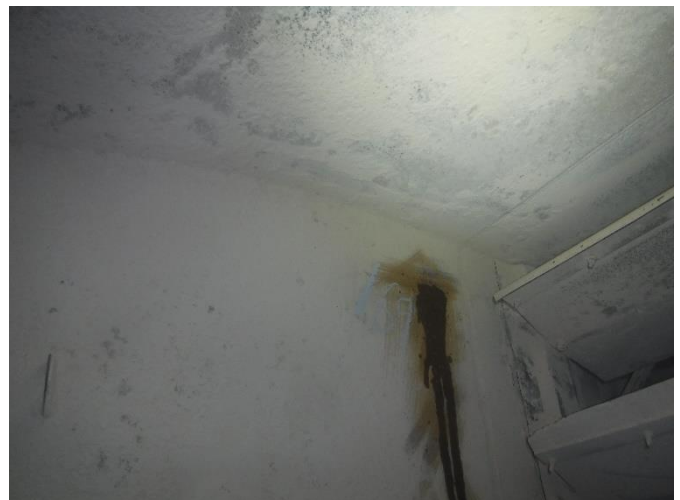
INT 10 – Corner of damper blades

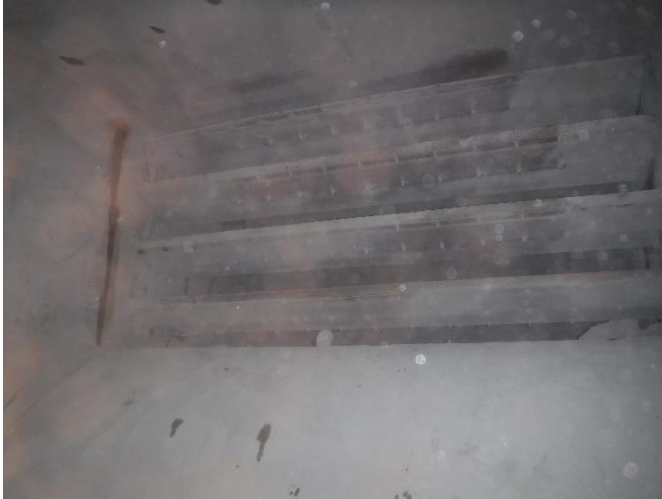
INT 11 – Buildup on damper blades

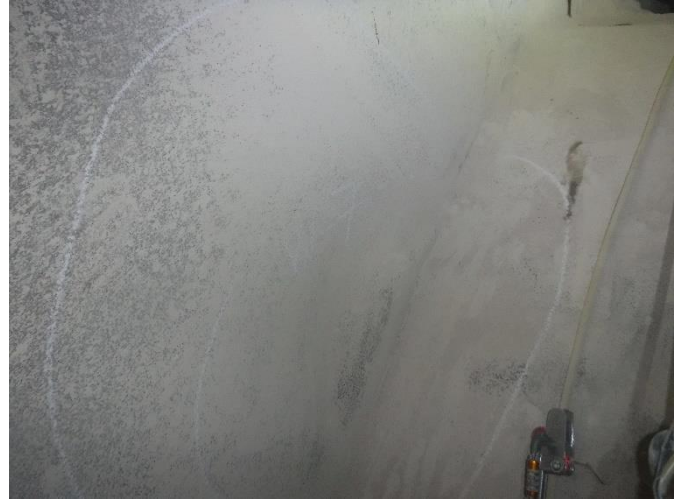
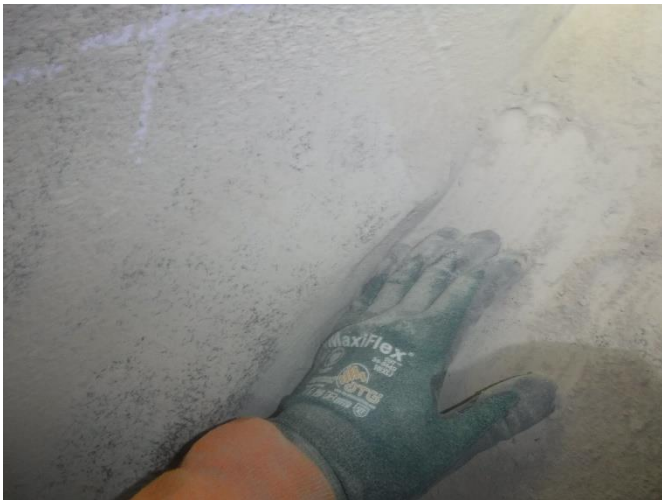
INT 12 – Buckling in the corner of duct

INT 13 – Buckling in the corner of duct

Exterior reinforcement should be installed around the buckled section within the duct to facilitate the structural integrity of the section.

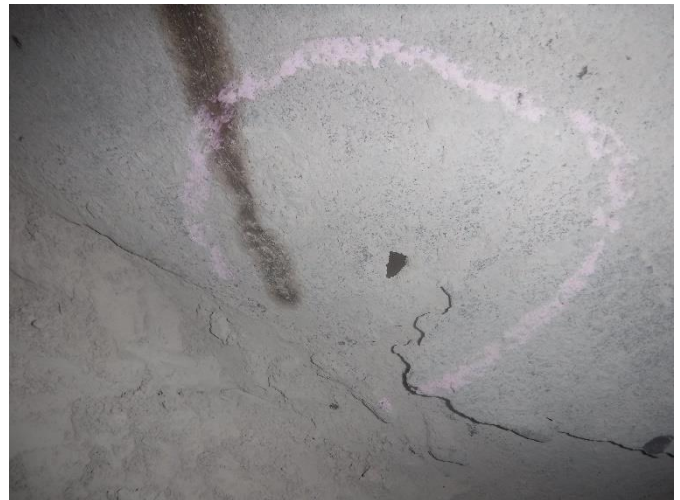
INT 14 – 13"± – 0.5" hole present in the east side of the duct

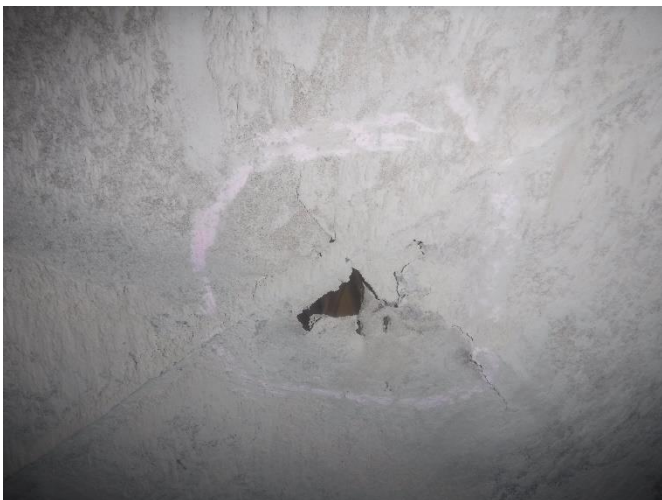
INT 15 – 13"± – 1.5" hole present in the east side of the duct

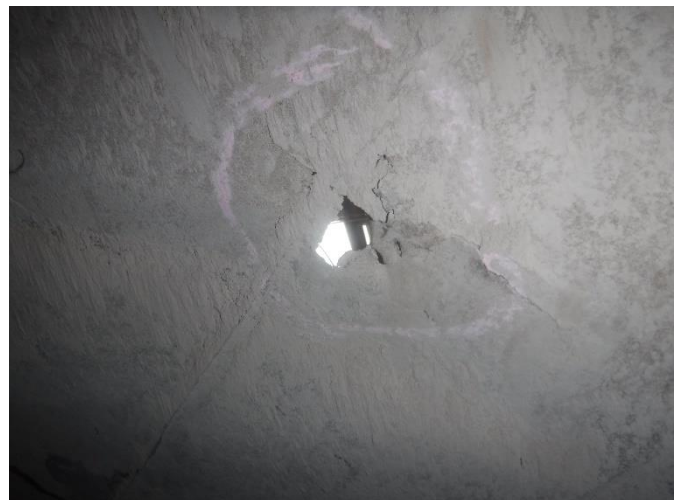
INT 16 – 13"± – 1.5" hole present in the east side of the duct

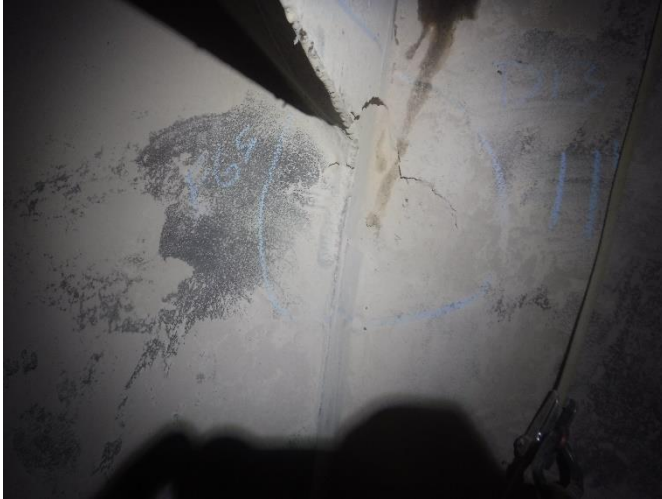
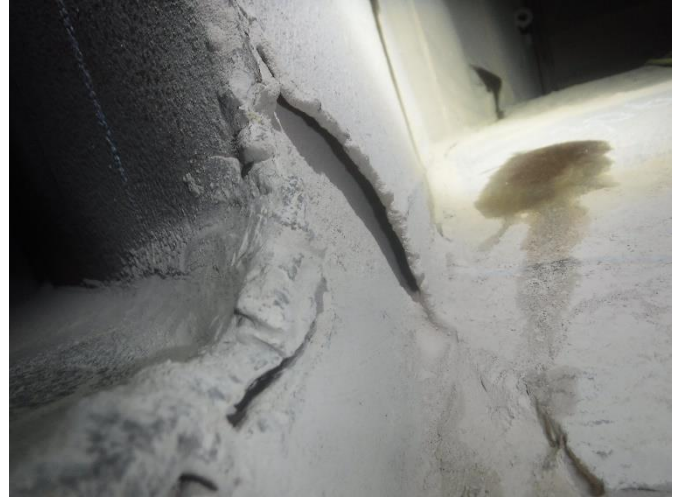
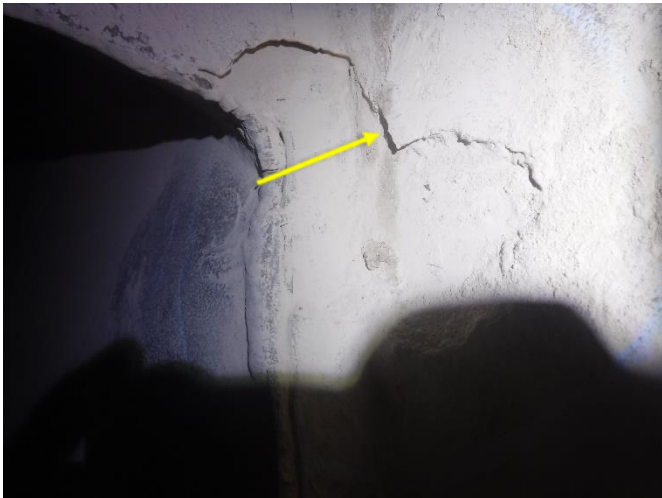
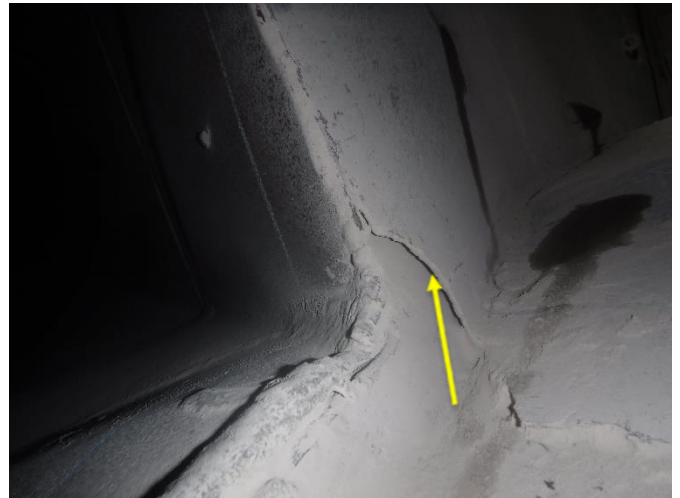
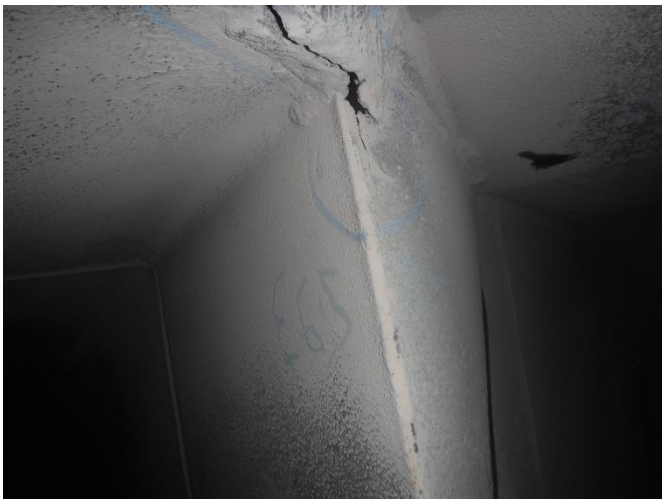
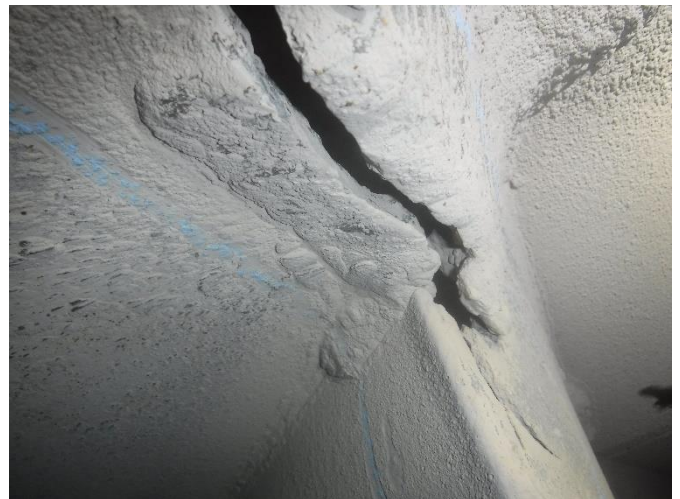
INT 17 – 11'± – The metal panel is torn on the floor of the West side

INT 18 – 11'± – The metal panel is torn on the floor of the West side

INT 19 – 11'± – The metal panel is torn on the floor of the West side

INT 20 – 11'± – The metal panel is torn on the floor of the West side

INT 21 – 11'± – The metal panel is torn on the floor of the West side

INT 22 – 11'± – The metal panel is torn on the floor of the West side

The damaged, torn, and peeling cladding panels within the duct should be removed and replaced with new panels. The current damaged allows for intrusive buildup, oxidation, and corrosion., so replacing the panels is essential to extend the duct's service life.

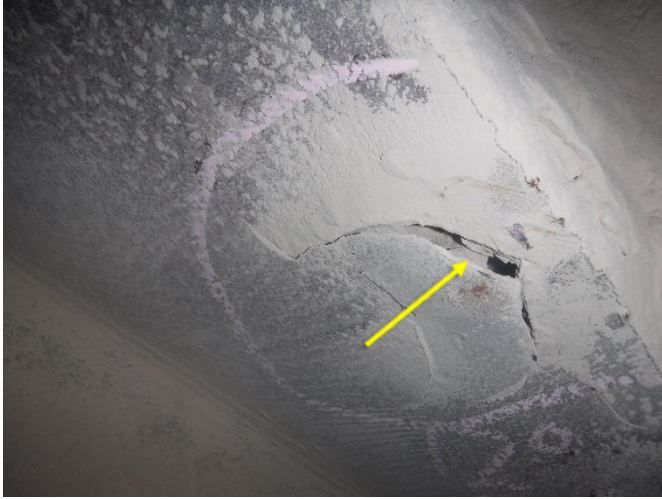
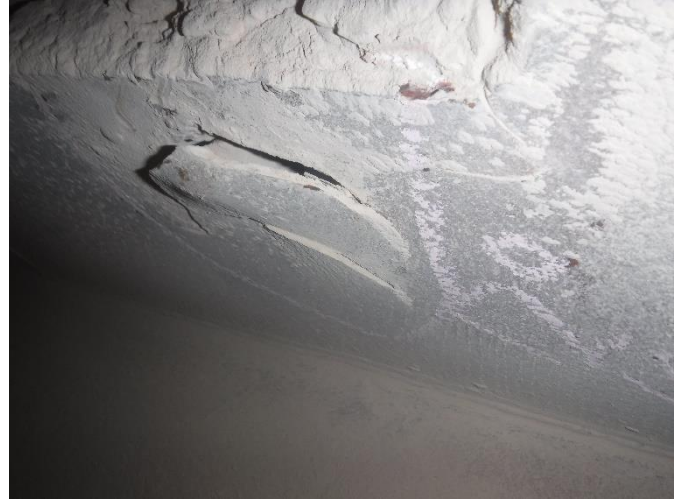
INT 23 – 16'± – The ceiling of the duct is damaged

INT 24 – 16'± – The ceiling of the duct is damaged

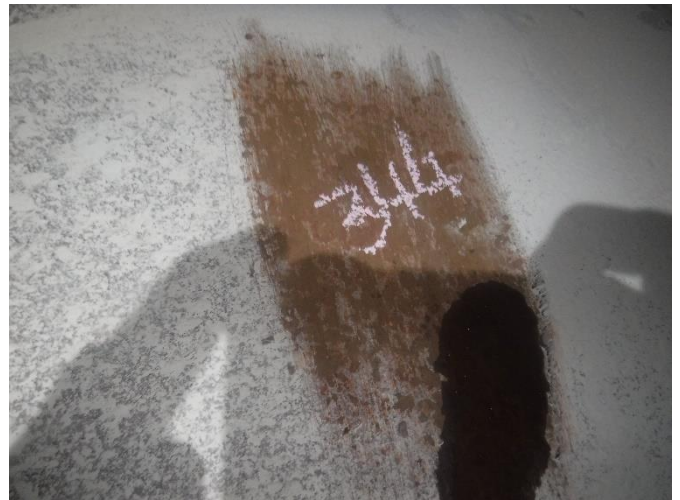
INT 26 – 20'± – Oxidation present behind buildup

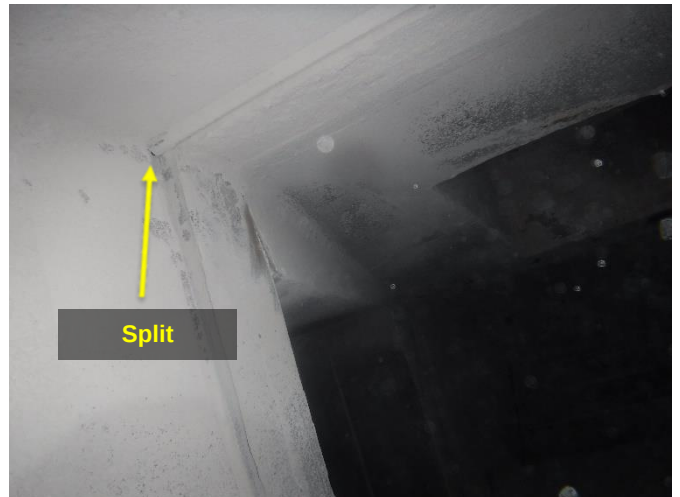
INT 28 – 16'± – The top West side of the duct is split

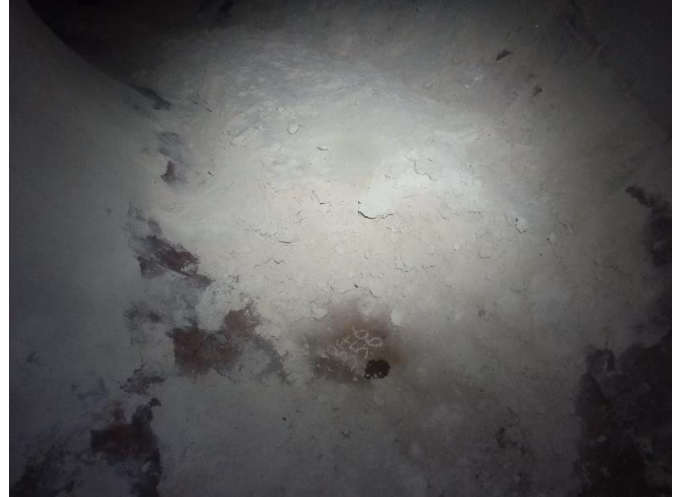
INT 30 – Looking forward duct; Debris and buildup present on duct floor

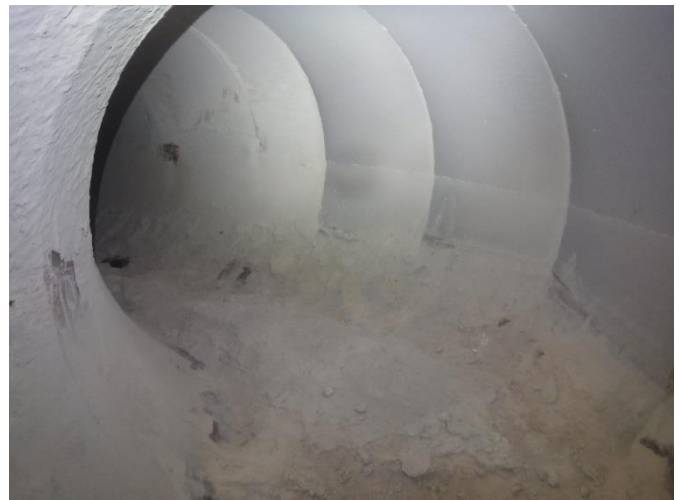
INT 32 – Heavy buildup and debris

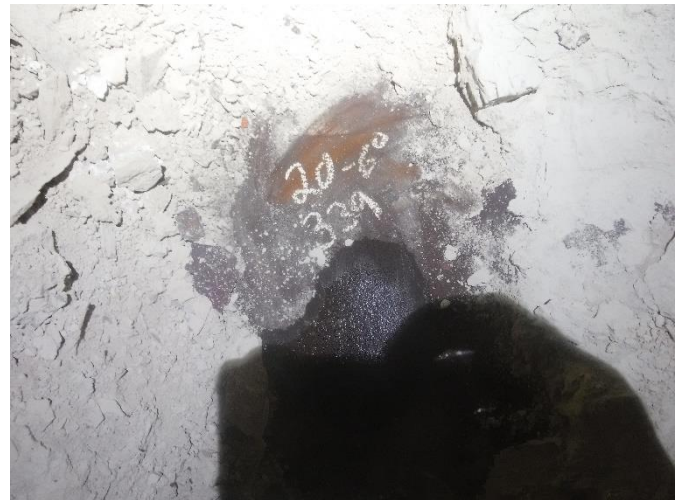
INT 38 – Heavy debris and buildup

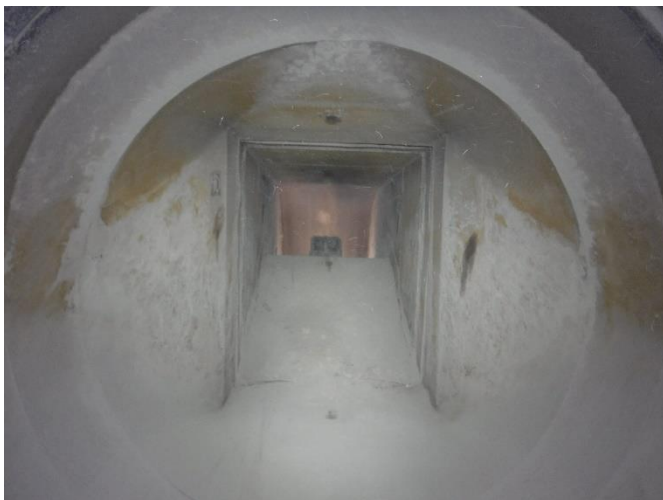
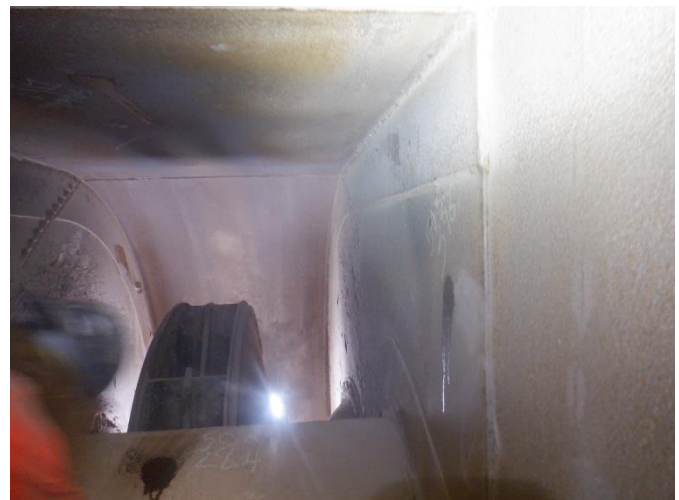
INT 39 – Duct curling downward

INT 40 – Duct curling downward

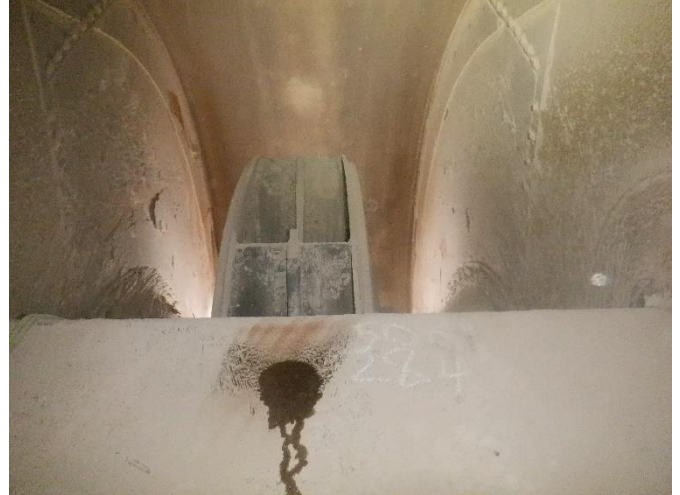
INT 42 – Duct curling down outside of the building going to fan

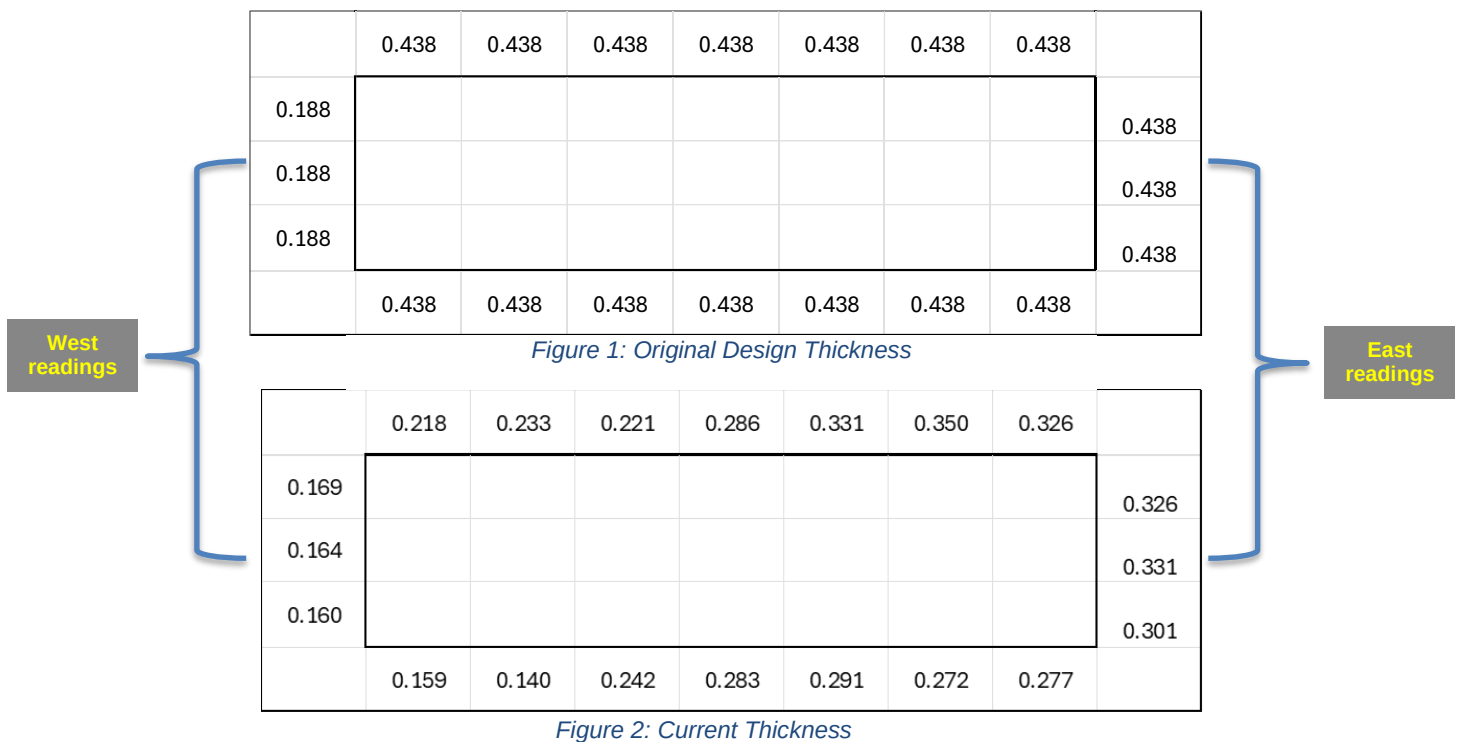
### Interior UT Readings: at Damper Blades

**\*Note:** The original thickness of the duct was 0.188 inches. However, in certain areas, the thickness measures 0.438 inches. This increased thickness indicates the presence of reinforcement patch plates that were previously installed to strengthen the steel in those sections. When evaluating the current thickness readings, any measurements below 0.188 inches (in unreinforced areas) or 0.438 inches (in areas with reinforcement) indicate a loss of material. The presence of these patch plates should be considered when assessing the condition and remaining thickness of the duct.

| Location | Original Thickness (in) | Current Thickness (in) | Percentage Loss (%) |
|---|---|---|---|
| Top | 0.438 | 0.218 - 0.350 | 20.09% - 50.73% |
| West | 0.188 | 0.160 – 0.169 | 10.11% - 14.89% |
| Bottom | 0.438 | 0.140 – 0.291 | 20.09% - 50.73% |
| East | 0.438 | 0.301 – 0.331 | 20.09% - 50.73% |

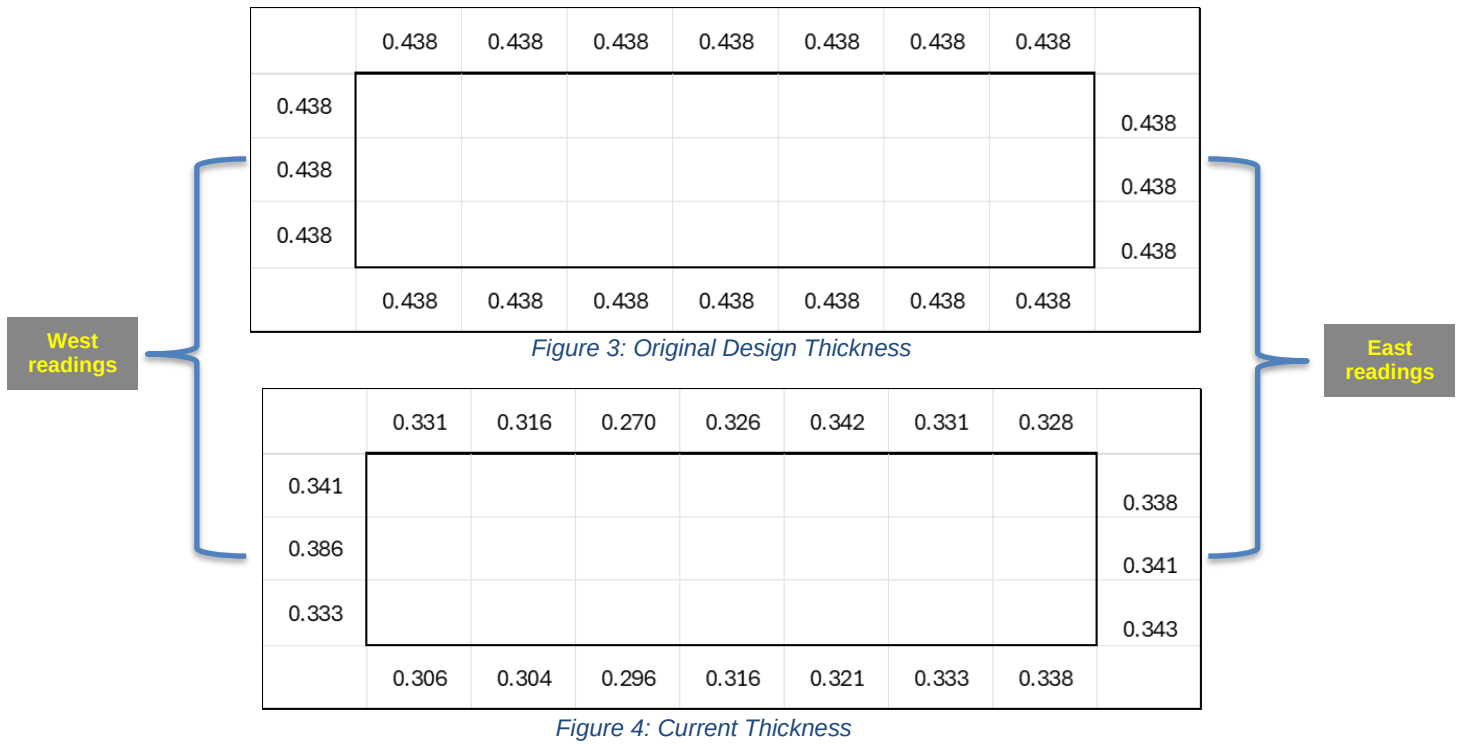
## Interior UT Readings: 10ft from Damper Blades

| Location | Original Thickness (in) | Current Thickness (in) | Percentage Loss (%) |
|---|---|---|---|
| Top | 0.438 | 0.270 - 0.342 | 21.92% - 38.36% |
| West | 0.438 | 0.333 – 0.386 | 11.87% - 23.97% |
| Bottom | 0.438 | 0.296 – 0.338 | 22.83% - 32.42% |
| East | 0.438 | 0.338 – 0.343 | 21.69% - 22.83% |

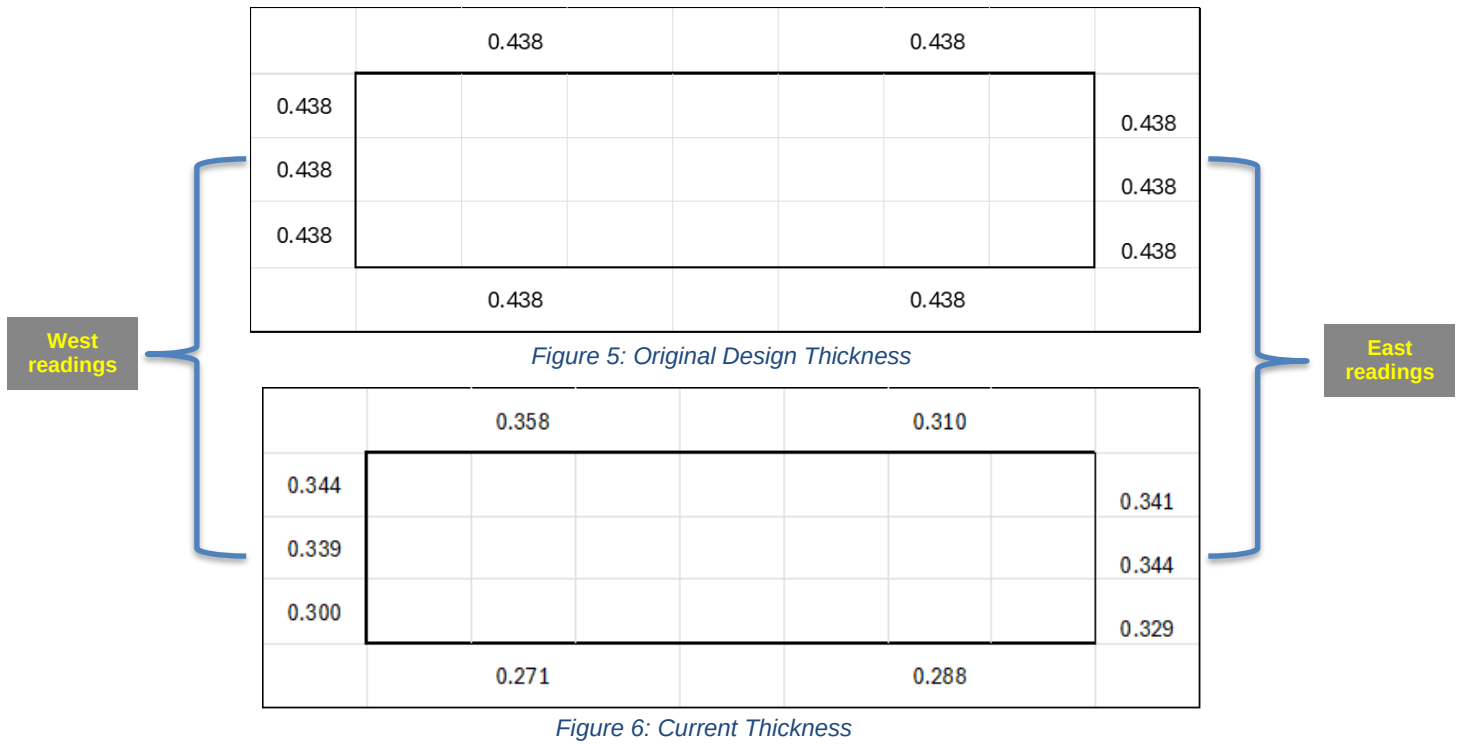
## Interior UT Readings: 20ft from Damper Blades

| Location | Original Thickness (in) | Current Thickness (in) | Percentage Loss (%) |
|---|---|---|---|
| Top | 0.438 | 0.310 - 0.358 | 18.26% - 29.22% |
| West | 0.438 | 0.300 – 0.344 | 21.46% - 31.51% |
| Bottom | 0.438 | 0.271 – 0.288 | 34.25% - 38.13% |
| East | 0.438 | 0.329 – 0.344 | 21.46% - 24.89% |

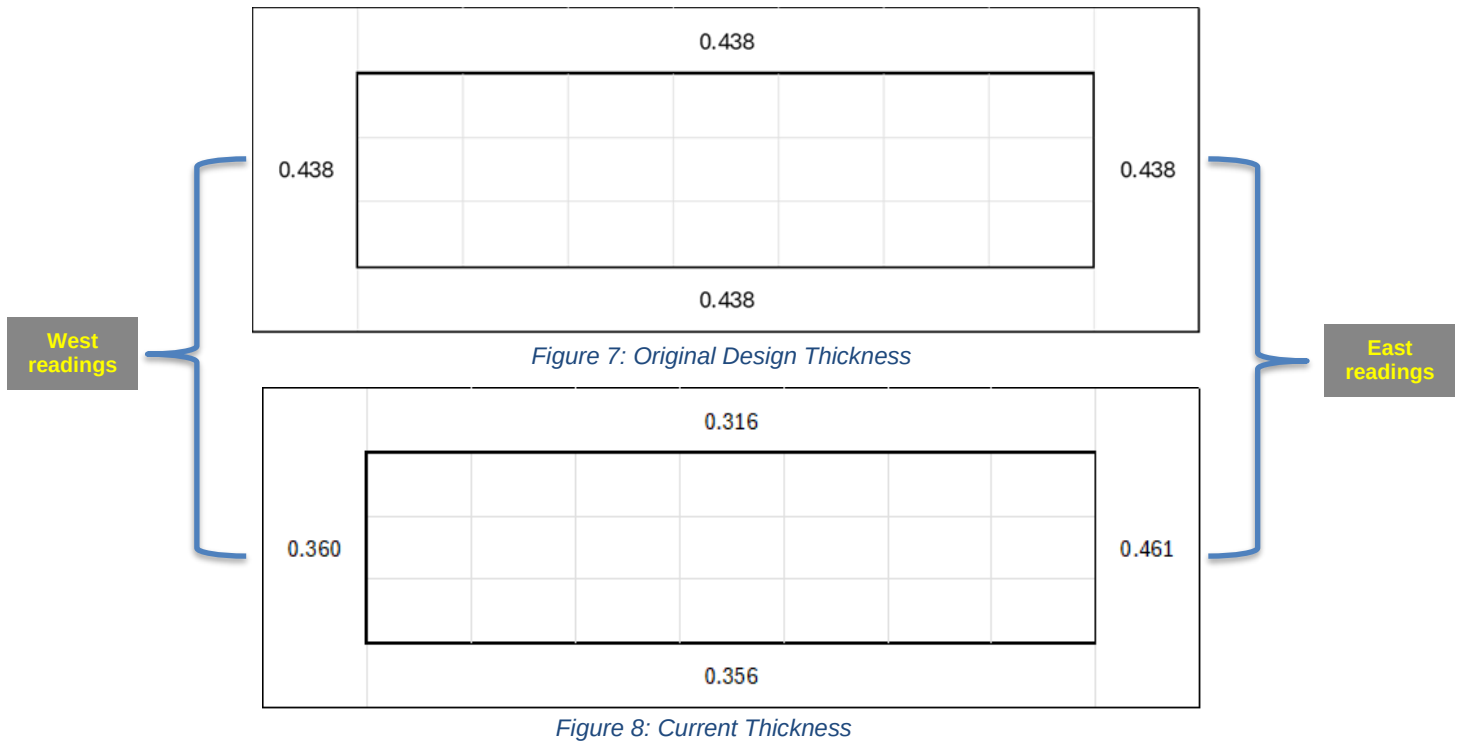
**Interior UT Readings: 10ft from Bottom Access Door**

| Location | Original Thickness (in) | Current Thickness (in) | Percentage Loss (%) |
|---|---|---|---|
| Top | 0.438 | 0.316 | 27.85% |
| West | 0.438 | 0.360 | 17.81% |
| Bottom | 0.438 | 0.356 | 18.72% |
| East | 0.438 | 0.461 | (+) 5.25% |
