SAN XAVIER DEL BAC

CONSERVATION MANAGEMENT PLAN OVERVIEW

PREPARED BY: PENN PRAXIS
THE CENTER FOR ARCHITECTURAL CONSERVATION

February 2020

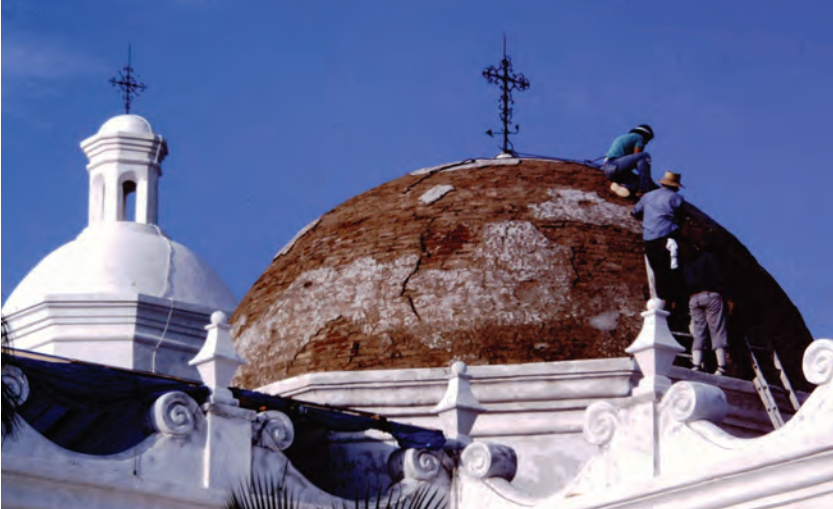
[Image 43] After a large piece of plaster fell from the ceiling in 1989, it was determined that impermeable cement-based and synthetic coatings were accelerating the deterioration of the underlying brick and creating dangerous conditions inside the Mission. Beginning with the roof's dome and vaults, impermeable cement-based coatings were systematically removed, the substrate repaired, and the whole re-coated with a more compatible lime-based mixture. Removal of the existing coatings revealed large, deep cracks in the central dome. Work was supported by numerous grants and has been ongoing for more than 30 years. All images on this page were taken circa 1993 by architect Robert Vint, who oversaw this work.

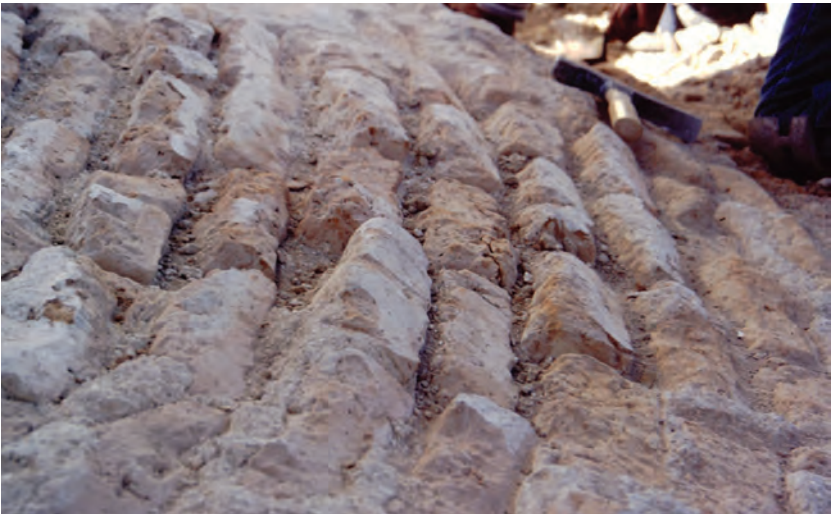
[Image 48] Due to decades of deterioration from water infiltration, some portions of the low-fired brick comprising the vaults, dome, and walls have substantially eroded, as seen in this photograph. In other areas the substrate was very much intact and traces of well-adhered original plaster still remained and were left in place. (Robert Vint)

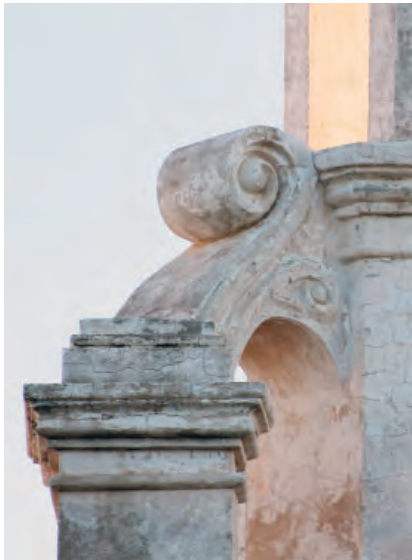
[Image 74] The East Tower is the only remaining portion of the exterior where the cement-based render has not been removed.

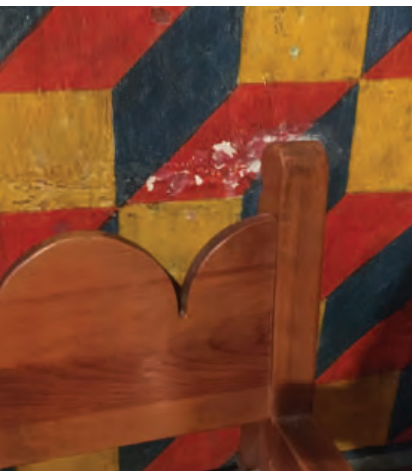
[Image 76] Daily wear takes a toll on the lower walls, baseboards and furnishings.

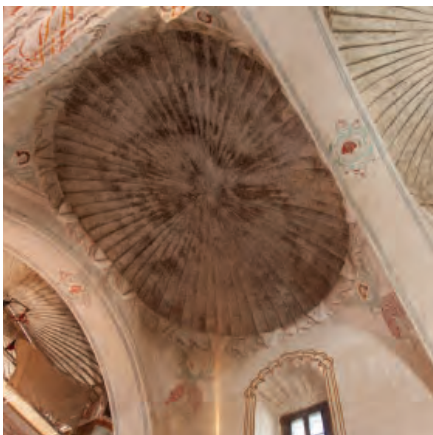
[Image 78] Evidence of prior water damage is present on some of the vaults, but the current extent and patterns of infiltration and moisture movement are not well understood.

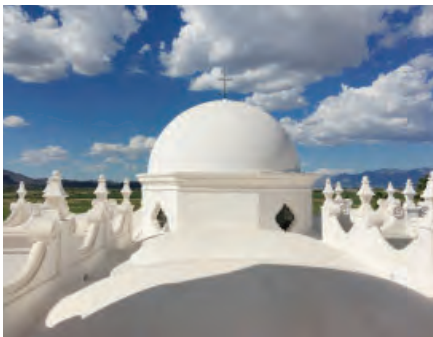
[Image 79] Maintaining a watertight roof membrane has proven to be one of the biggest challenges at San Xavier.

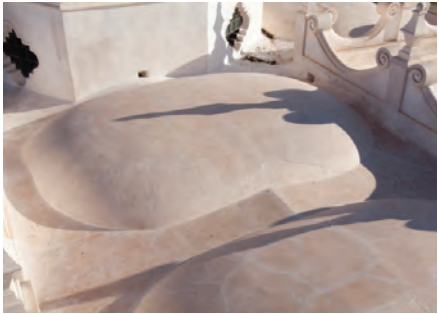
[Image 80] Webbed cracking in the render of the roof vaults is caused by natural cycles of expansion and contraction. Despite the inclusion of expansion joints in the surface render, cracking has persisted and some delamination has occurred.

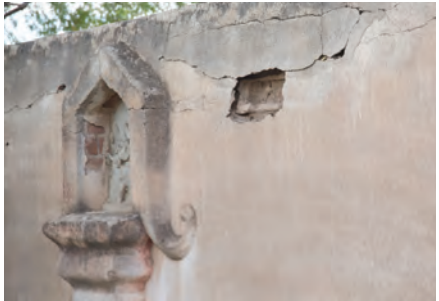
[Image 81] Some lower priority areas and features, such as the atrium and cemetery walls, show signs of deferred maintenance, such as cracking and delamination.

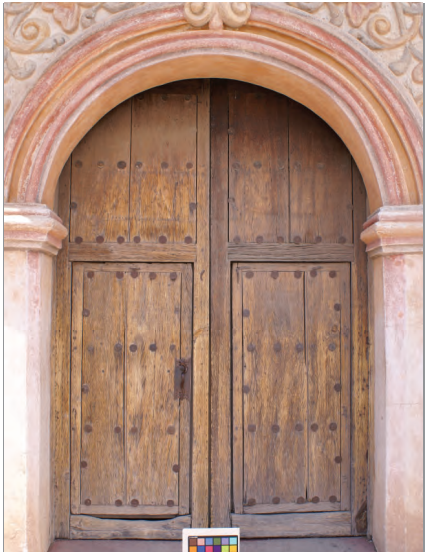
[Image 82] The original yellow pine doors are still in place, though they have deteriorated from exposure to the elements. They have never undergone conservation treatment.

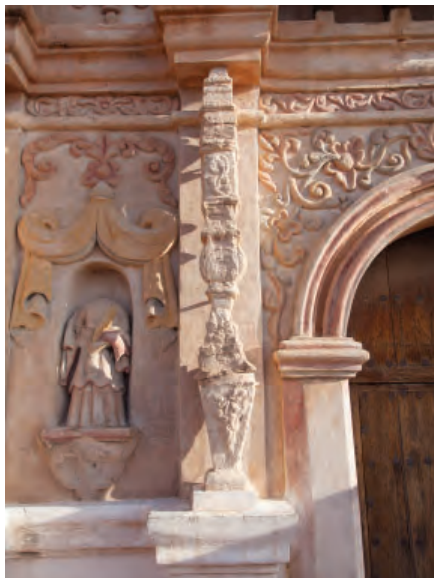
[Image 92] Further investigation of the underlying condition of the facade and its original structure and finishes must inform future conservation.

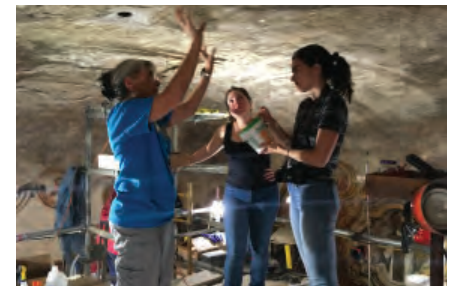
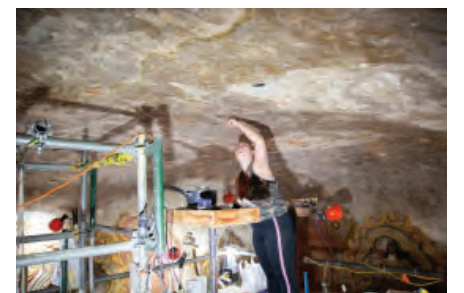
[Images 97, 98] Monitoring and updating conservation approaches is central to practice. Current stabilization efforts on the interior include removing a past repair campaign that included Rhoplex, a material that was thought to be compatible at the time it was implemented, but has proven to shrink and pull away from the historic fabric, taking traces of original material with it.
