# A PERFECT SHOT

Considered New Zealand's most photographed building, Dunedin Railway Station is again ready for its close-up

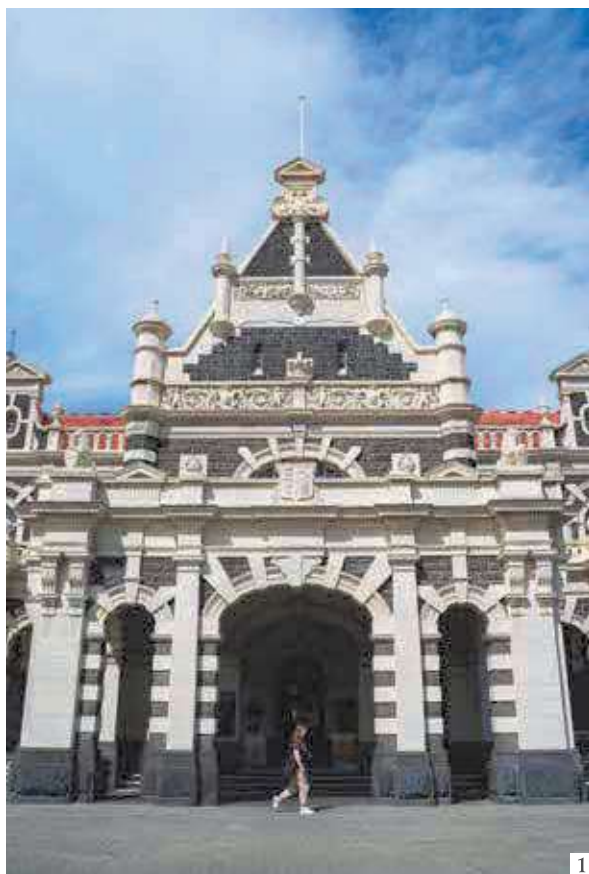
1. The restoration project focused on conservation repair, with much of the original building fabric retained.

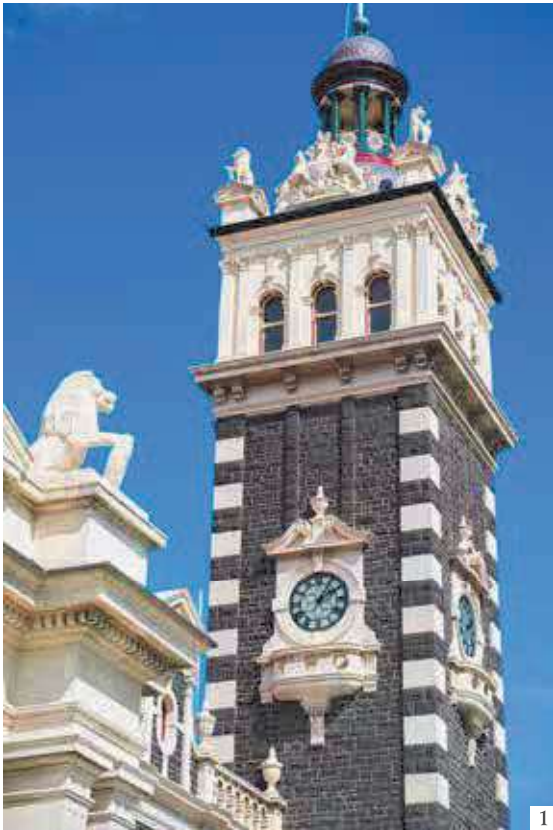
1

1. The minute hands on two clock faces were replaced, while the capitals were recarved and reinstated.  
*Image: DunedinNZ*

Other important details were also painstakingly restored: two old timber flagpoles, including the one on the clocktower, were refurbished, while two that had been removed were replaced in modern stainless steel; the minute hands on two of the clocktower clock faces had to be replaced and weighting was crucial for the mechanism to function properly.

“The capitals [the top parts of columns] on the clocktower were eroded, so they were removed, recarved and reinstated,” he says.

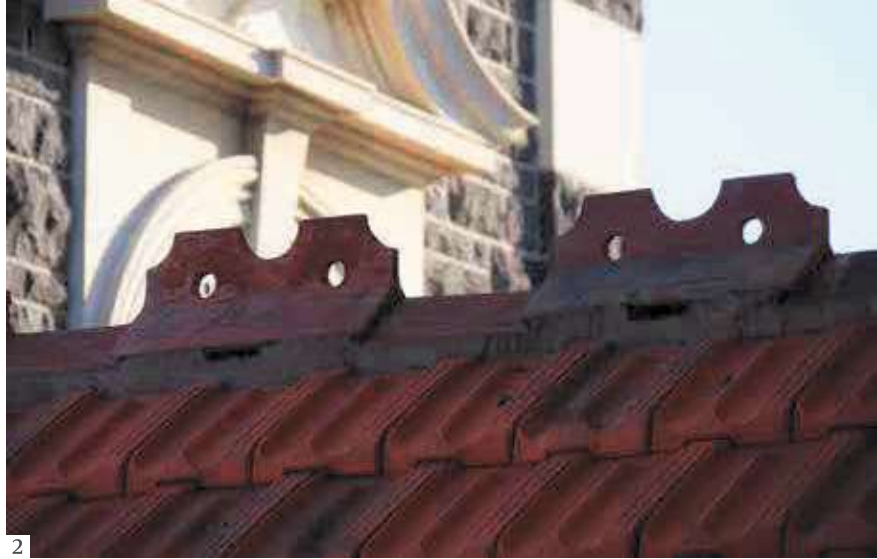
2

2. Many of the roof's terracotta tiles were cleaned and reused; the rest were sourced from the original manufacturer in France.

The roof was another significant part of the restoration. Around 75 percent of the original Marseille terracotta tiles were salvaged, with the reusable ones carefully removed, cleaned and used to re-cover the roof of the single-storey addition, as well as the main building’s west-facing roof slopes and dormer and north- and south-central gable roof slopes. Phillip says it was an important conservation decision.

To replace the 25 percent that were too degraded to be reused, 15,000 Marseille terracotta tiles in two finishes – plain and aged – were sourced from Tereal, the original manufacturer in France.

Terry Shearstone of Naylor Love says these were fixed to the south and east roof slopes – the areas less visible to the public.

“We used a ratio of one aged tile to two plain tiles; using this pattern produced a look similar to that of the salvaged tiles, which are all different colours due to their age.”

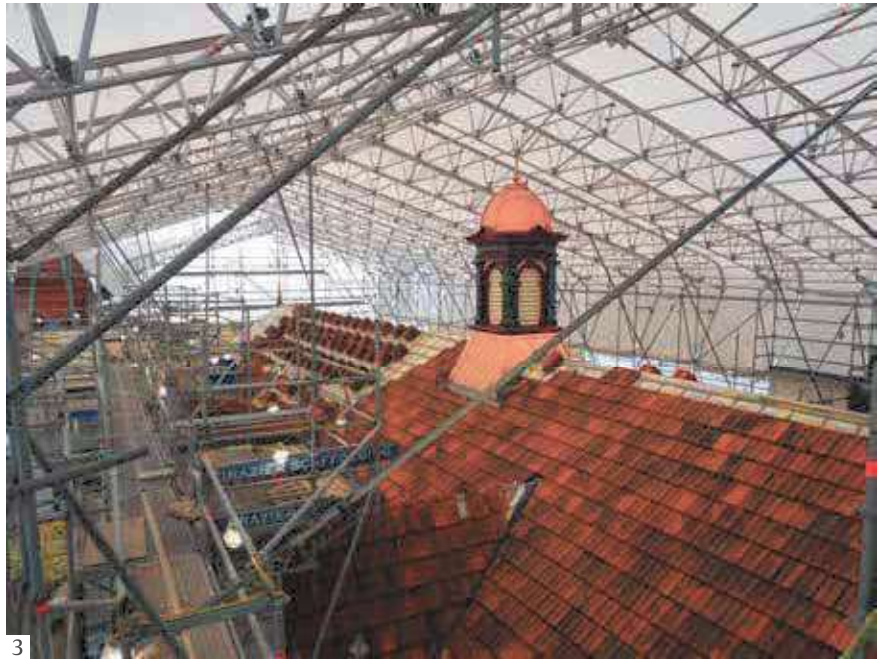
3

3. Manufacturing and installing the copper tiles of the roof domes was one of the most difficult parts of the restoration.  
*Imagery: Samuel White*

In stepped Allan's Sheetmetal & Engineering Services – conveniently based just behind the station. Metalworker Greg Pritchard says copper was selected to make the new tiles for its durability and to match the clocktower domes.

"The two different tile shapes required different processes: the lozenge tiles were folded, while the fish-scale tiles were pressed using wooden dyes that we had made."

Greg says installing the fish-scale tiles was one of the most difficult parts of the job, along with

recreating the finial on the central domed turret. “It was made of a series of hand-formed, lathe-spun copper shapes – which we also created using wooden dyes – as well as hand-beaten spheres.”
