Ecological Restoration for the Central San Joaquin Valley

Productivity in the Central San Joaquin Valley came at the expense of its historic ecosystems

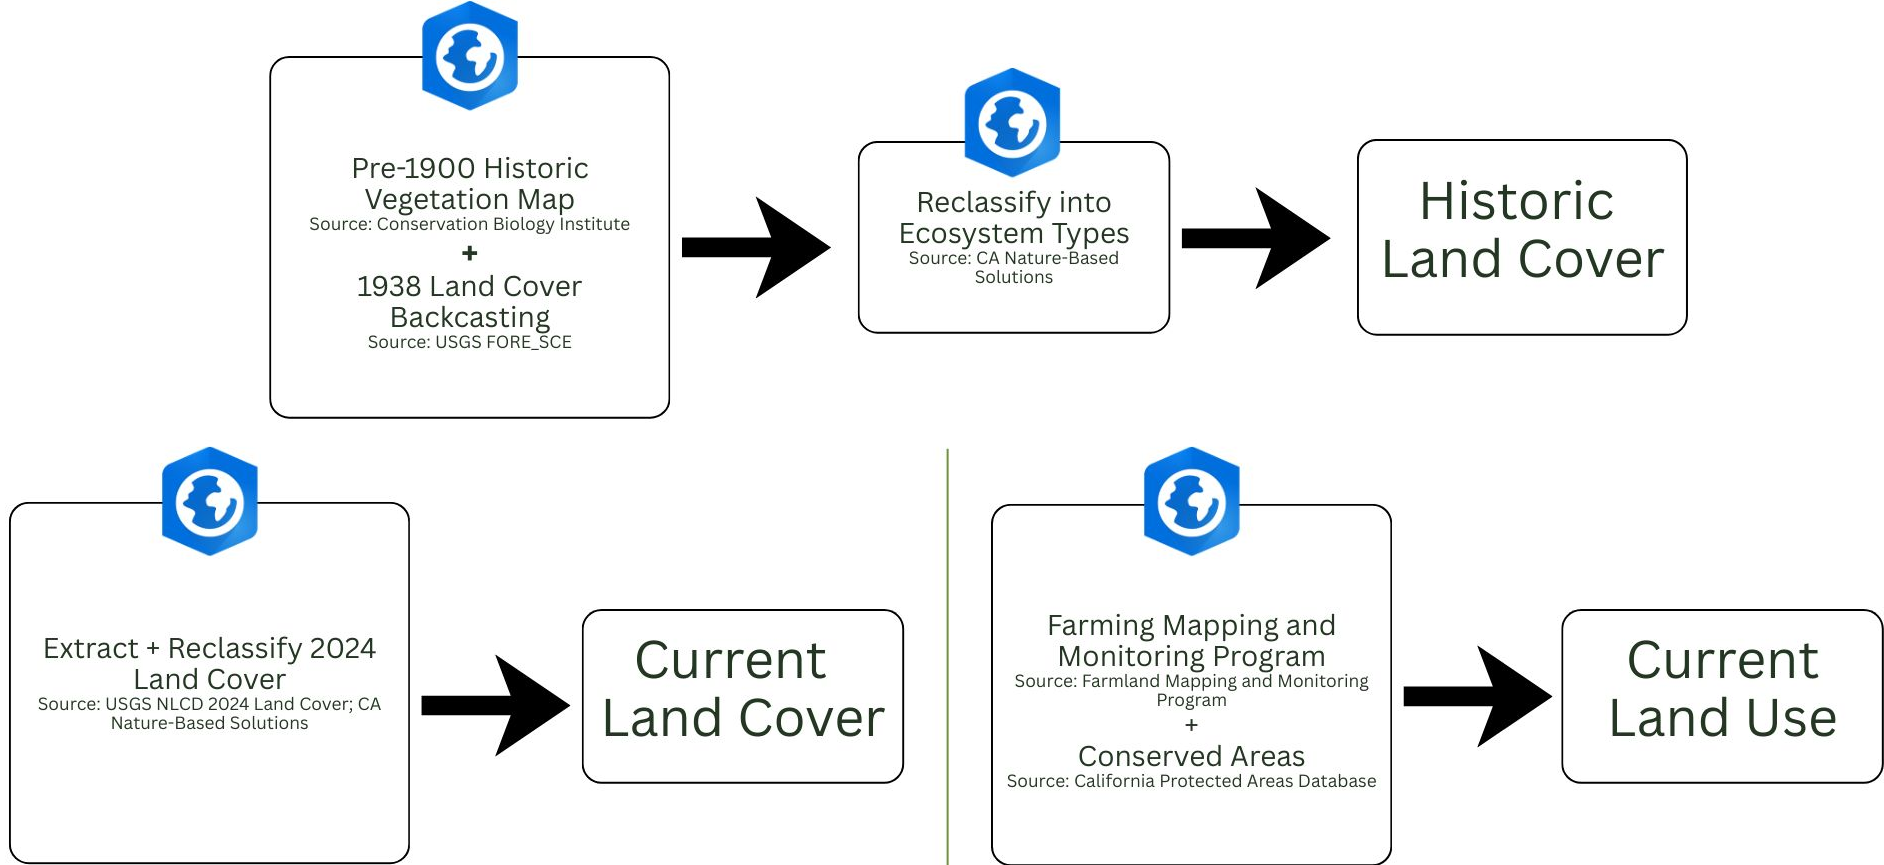
Spatial analysis visualizes historic landscapes, current conditions, and current land use

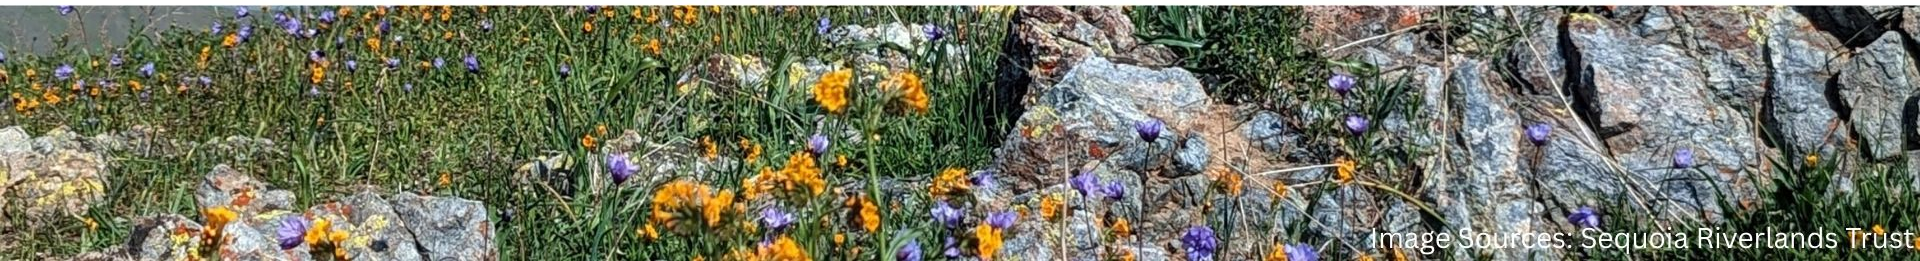
Habitat Suitability Modeling predicts habitats under the most severe climate change scenario (SSP585)

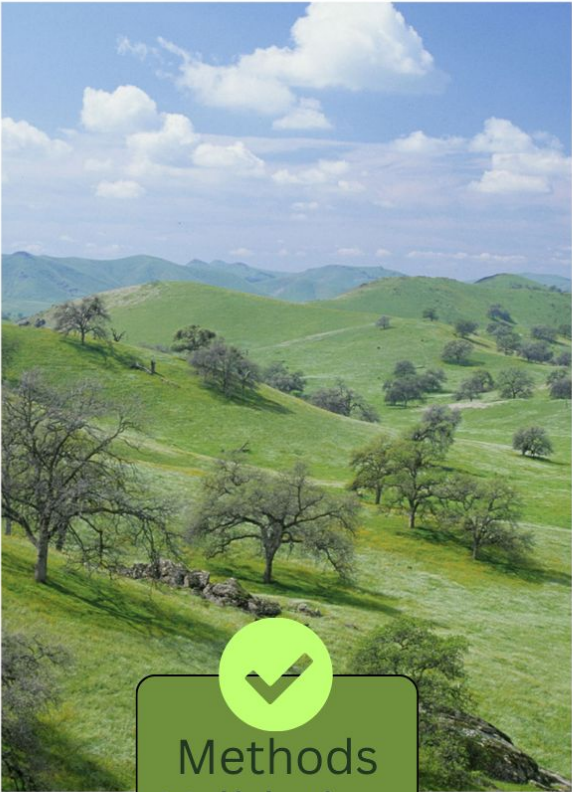
Preliminary results reveal restoration opportunities, with further analysis in progress

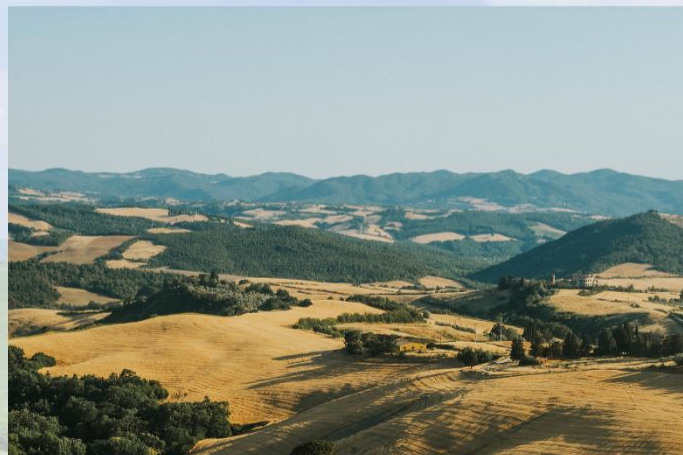
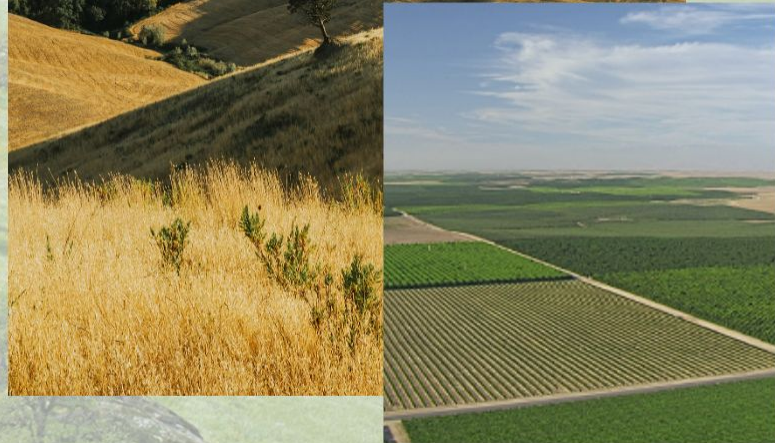
Land subsidence has occurred throughout the central valley due to groundwater consumption for agriculture.
