# **C. Cement Fireport Plant**

Buffalo, NY

**Kiln Stack Inspection and  
Repairs**  
March 2024

Subject: Kiln Stack Inspection and Repairs

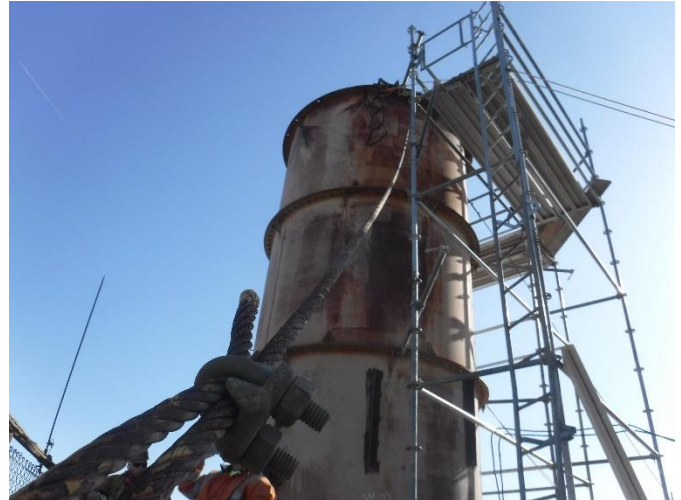
EXT 2 – View of the stack above the roof. Heavy oxidation present.

1. Stack has heavy oxidation throughout the exterior. This can be seen at the top of the stack (EXT 1 & 2) and throughout the stack on each floor. Much of the oxidation throughout the stack is the cause of leakage from the flue gasses.

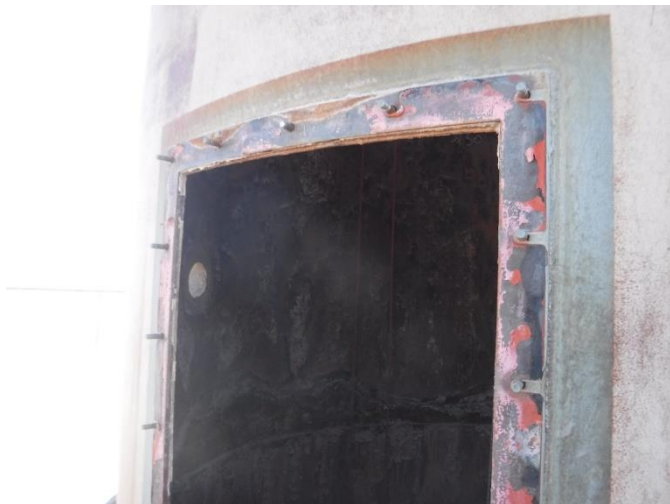
EXT 3 – EL. 200± - View of access door opening

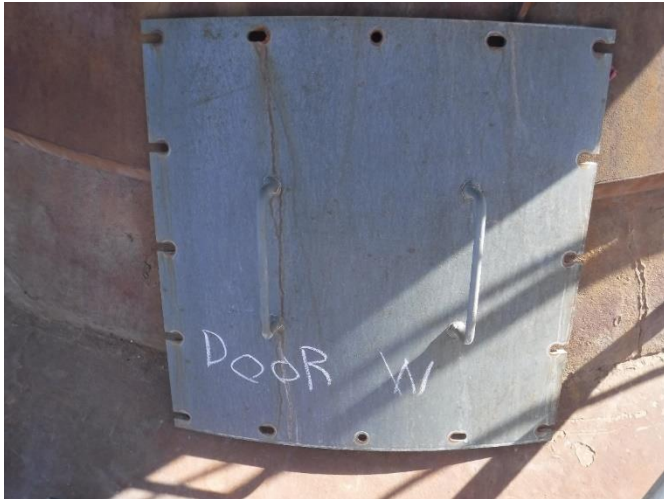
EXT 5 – Roof – Access door removed from access opening for inspection purposes

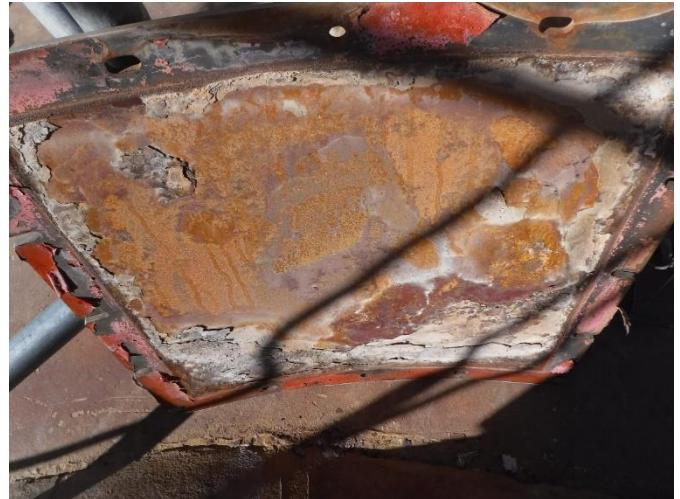
EXT 6 – Oxidation on the backside of the access door

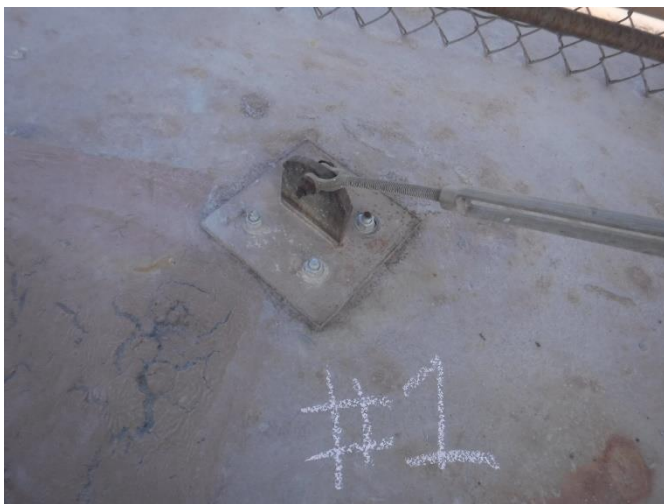
EXT 9 – Guy wire anchor

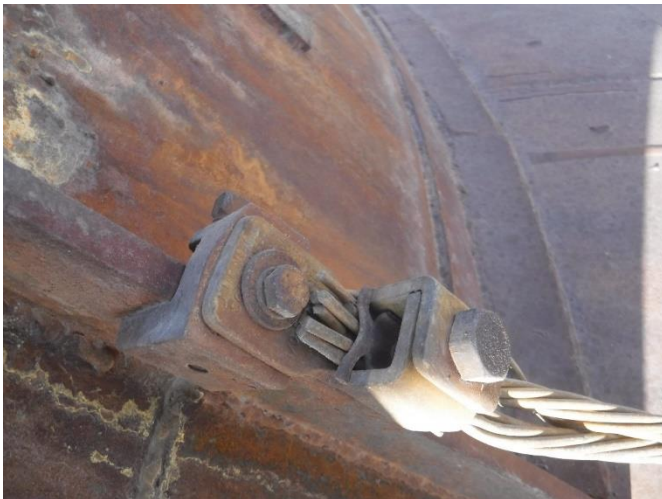
EXT 13 – Roof – LPS conductor

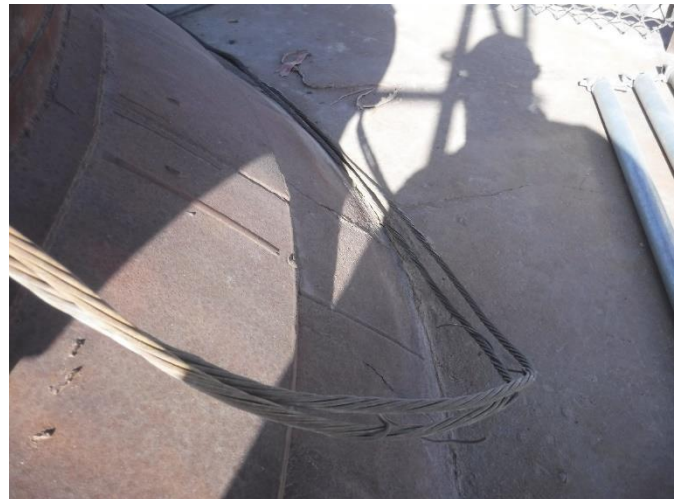
EXT 14 – Roof – Frayed LPS conductor

2. Cracks were found in various areas along the curb of the rain hood (EXT 14, 15, &19). \*
3. The guy wires around the anchors on the stack appear to be oxidizing and the coating present are failing. (EXT 10 & 11).

4. The LPS conductor near the roof is fraying (EXT 14 & 15).
5. There are flue leakage stains and oxidation around almost all splice flanges, but most noticeably on floors 7, 8, 9 , & 10. This is due to the gaps discovered on the splice flanges. (EXT 20, 21, 22, 23, 24, 25, 26, & 27).

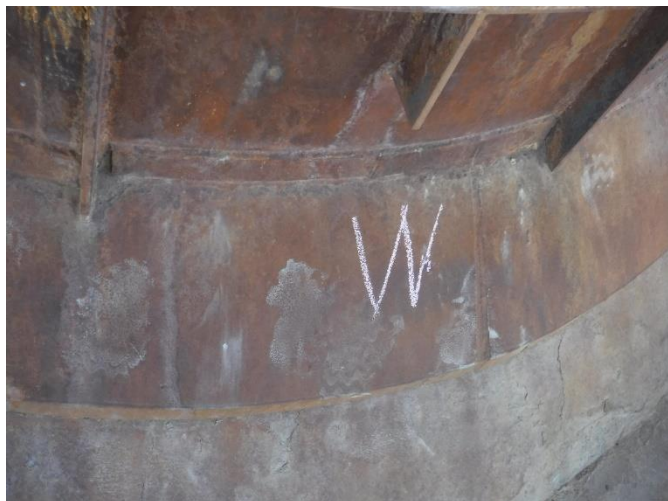
EXT 17 – Roof – West of rain hood

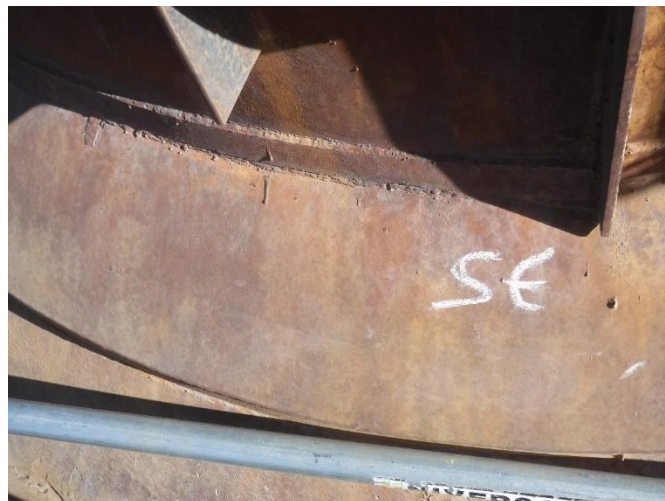
EXT 18 – Southeast of rain hood

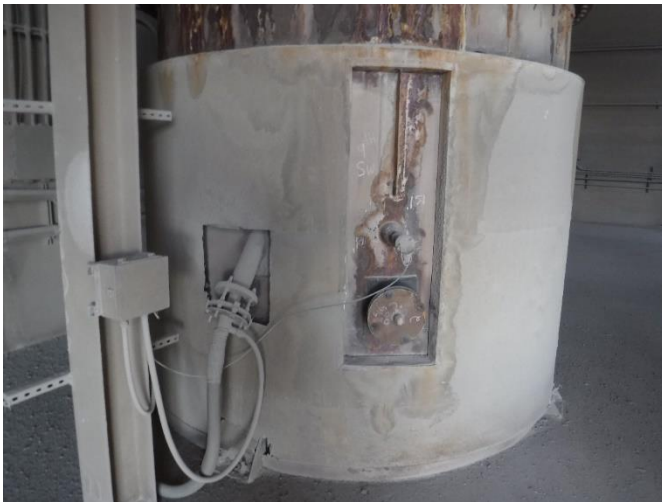
EXT 25 – 9<sup>th</sup> floor – oxidized test port and heat shield

6. 9<sup>th</sup> floor – There is heavy oxidation on the test port and mild oxidation on the heatshield. (EXT 25)
7. 9<sup>th</sup> floor – The welding on the splice flange appears to be cracked. (EXT 25) \*

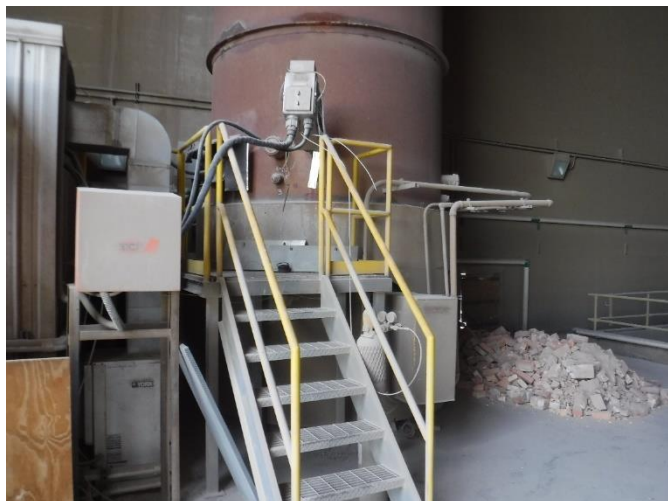
EXT 29 – View of test platform

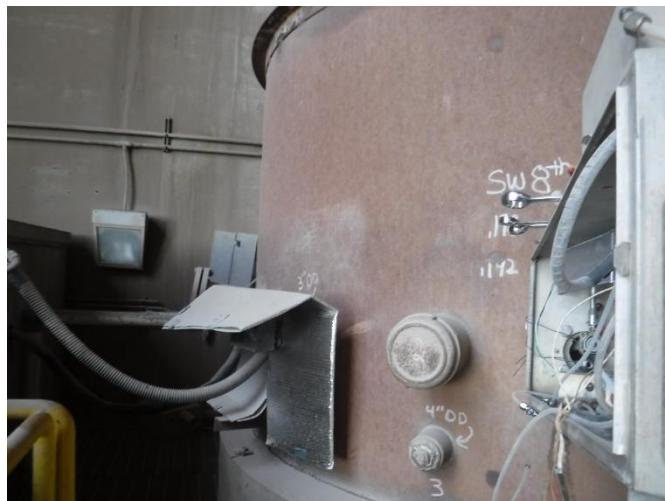
EXT 30 – Exposed wiring on instrument

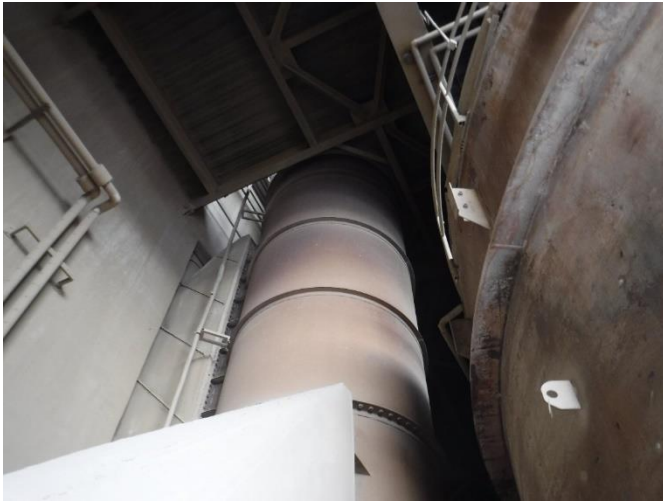
EXT 35 – 6<sup>th</sup> Floor – View of penetration point

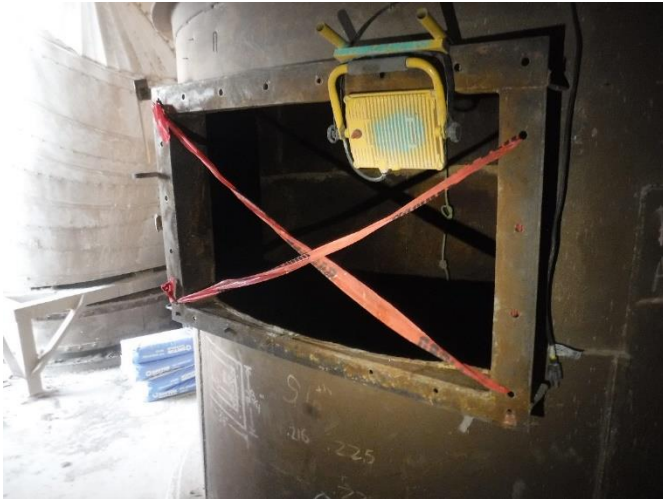
EXT 37 – Access point

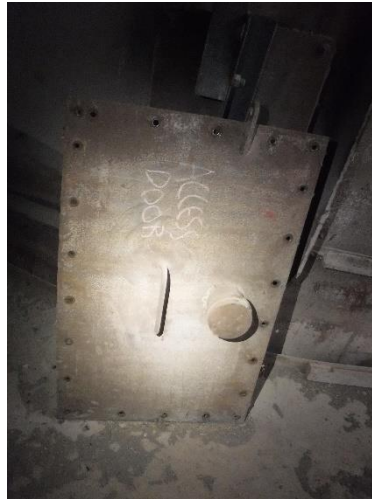
EXT 38 – Access door removed for inspection purposes

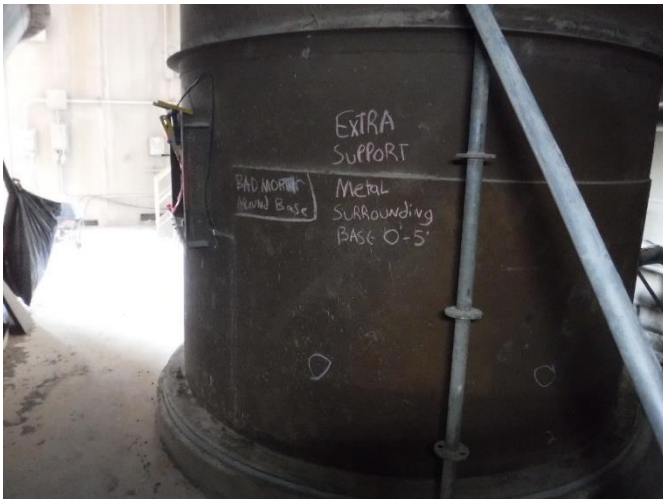
EXT 39 – View of stack

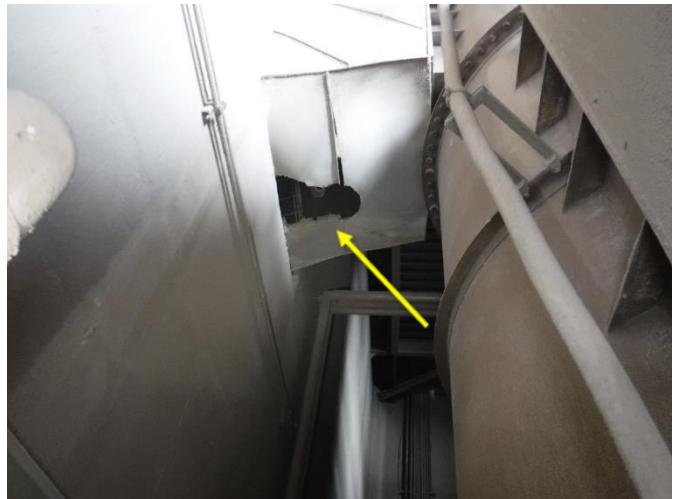
EXT 40 – View of duct with perforation on the bottom

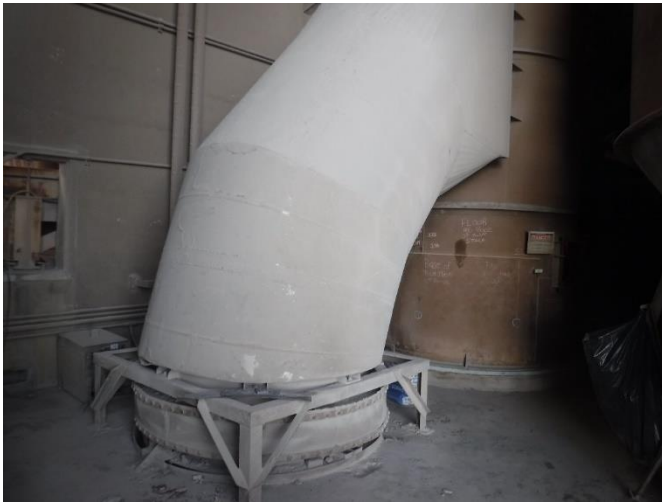
EXT 41 – 6<sup>th</sup> Floor – Breeching duct and support frame

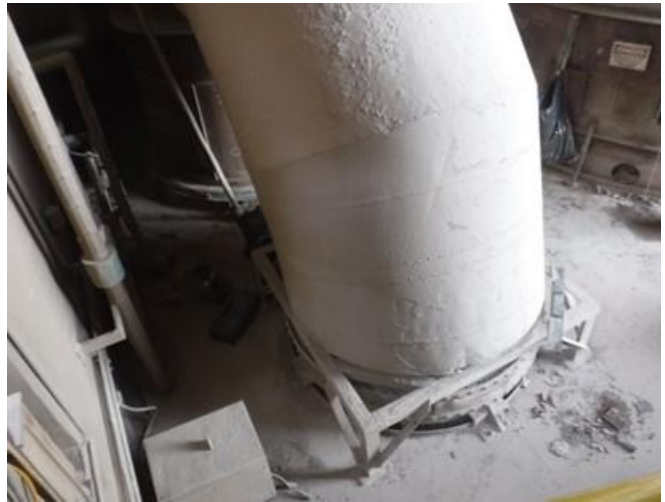
EXT 42 – 6<sup>th</sup> floor – Expansion joint and Breeching duct with mild debris on floor

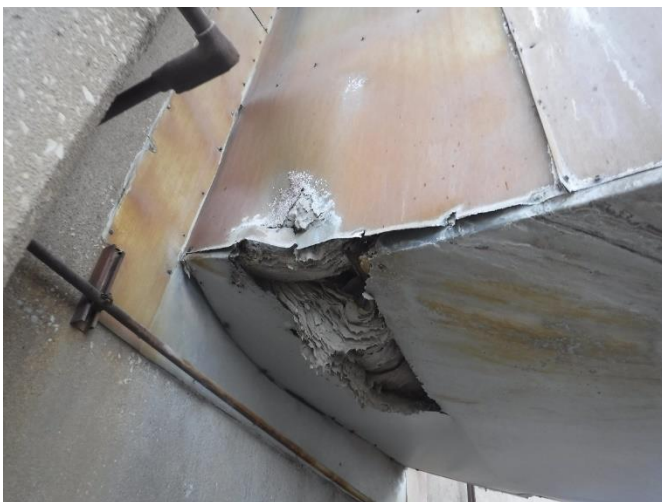
EXT 45 – Breeching duct with torn cladding on the underside

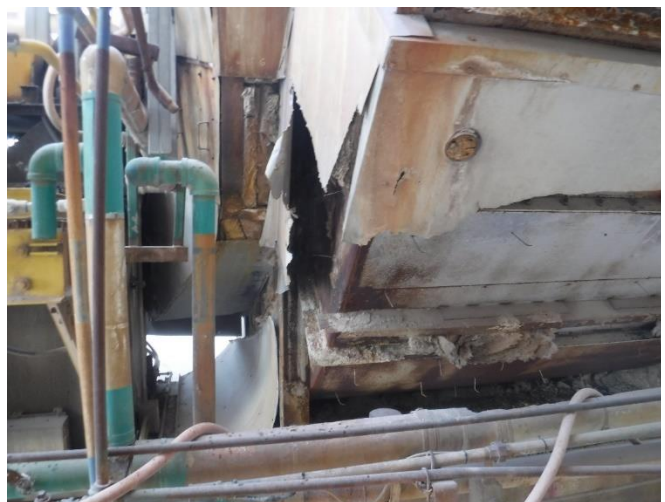
EXT 46 – Breeching showing oxidation and torn cladding

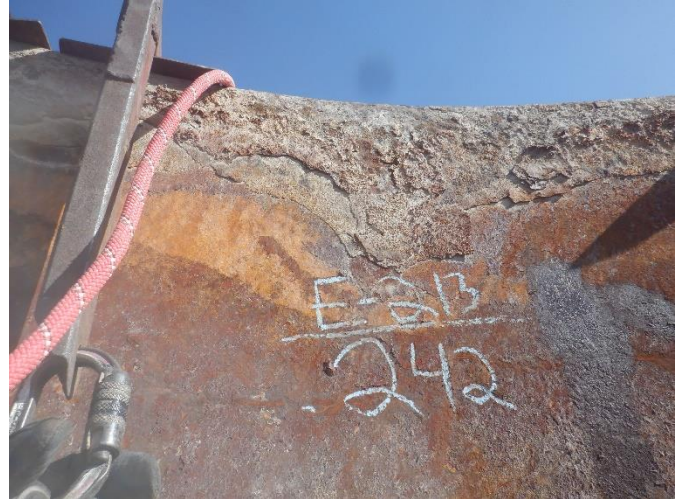
INT 2 – EL. 213'± – Top of the stack, buildup heavy oxidation

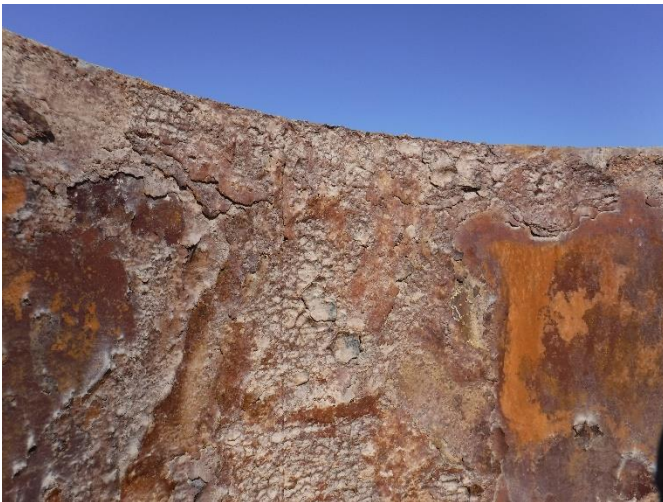
INT 3 – EL. 213'± – Top of the stack, buildup heavy oxidation

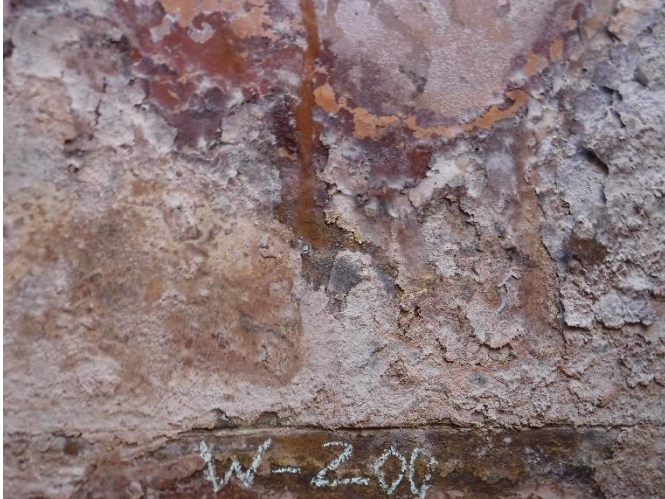
INT 5 – EL. 213'± – Buildup and oxidation present on surface

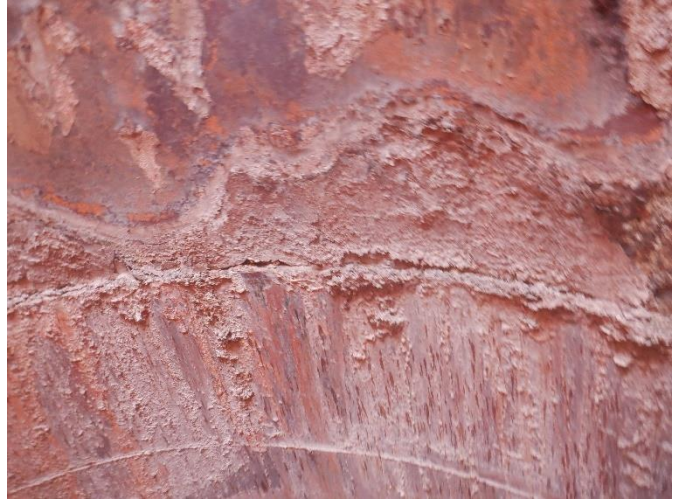
INT 6 – EL. 190'± – Buildup on steel plates

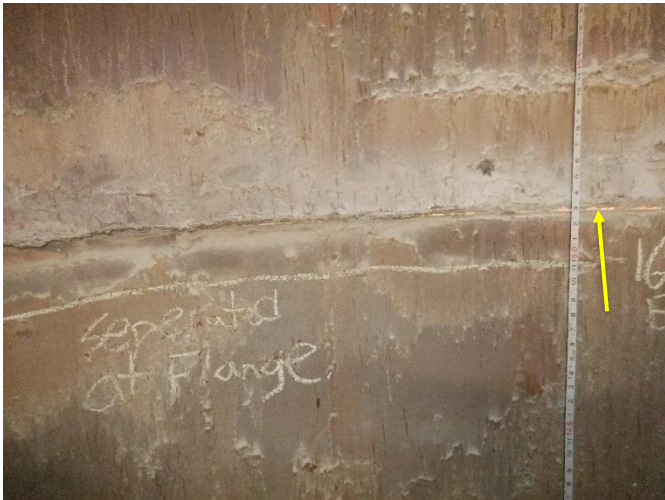
INT 13 – E EL. 170'± – Splice separated at flange

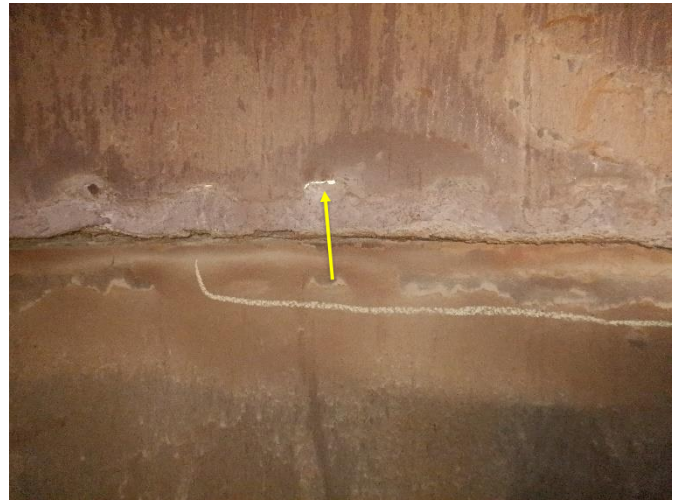
INT 14 – E EL. 170'± – Holes and gap near flanged joint

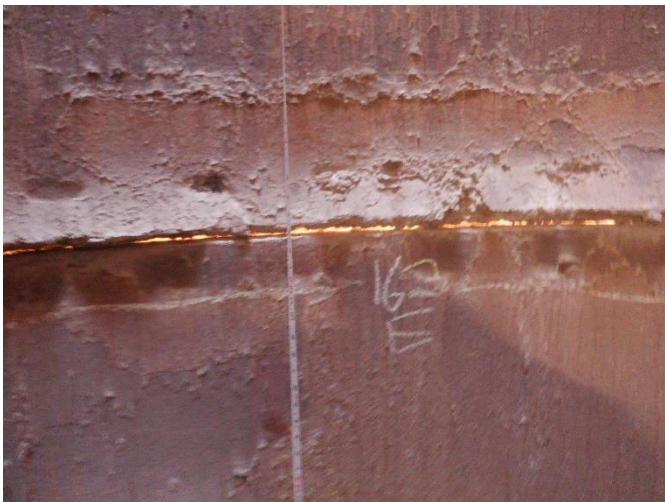
INT 15 – E EL. 170'± – Gap in flanged joint

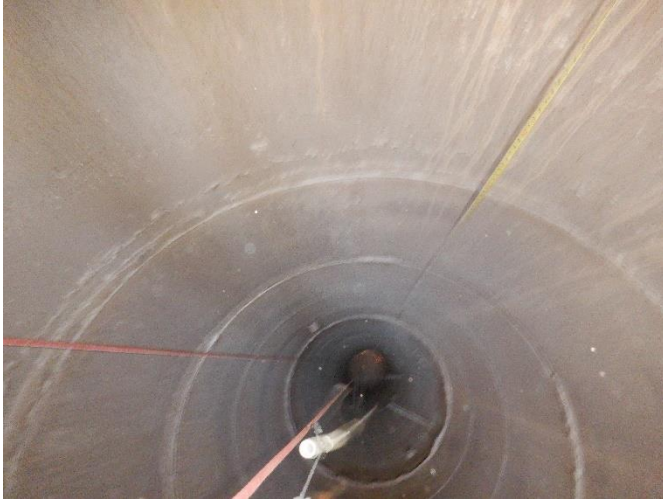
INT 17 – E EL. 160'± – Downward view of stack interior

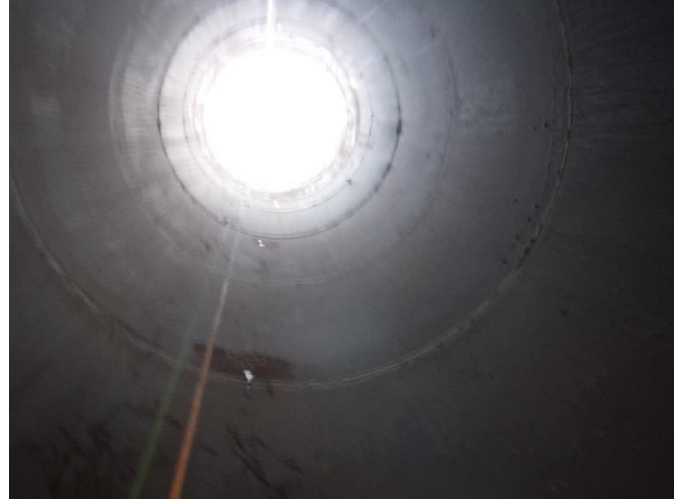
INT 18 – W EL. 160'± – Upward view of stack interior

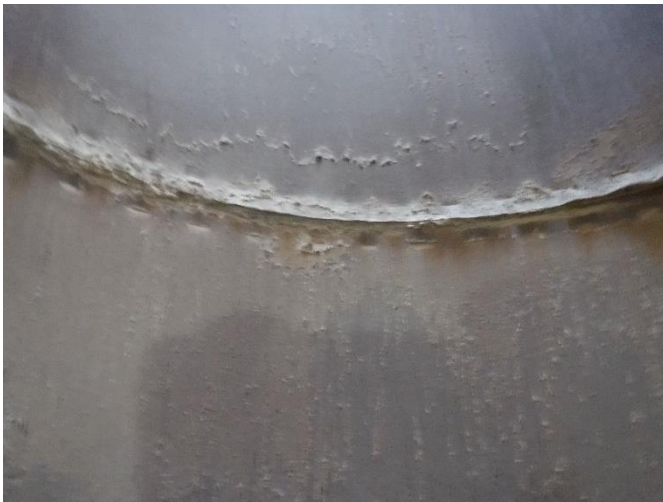
INT 19 – W EL. 160'± – Buildup/ warped flanged joint

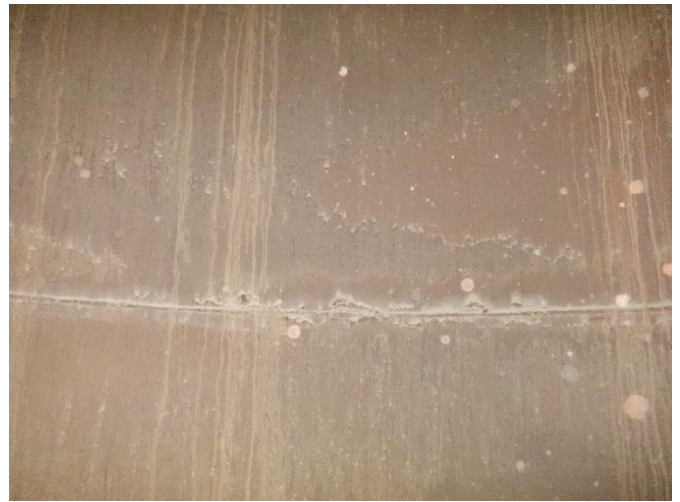
INT 20 – E EL. 160'± – Buildup on flanged joint

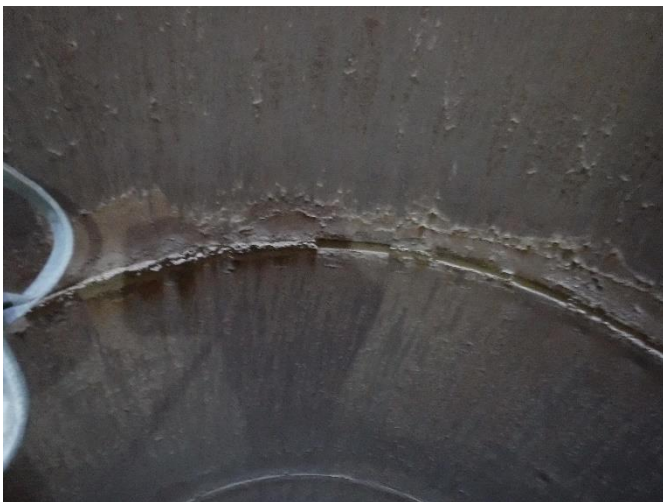
INT 21 – W EL. 150'± – Buildup on flanged joint

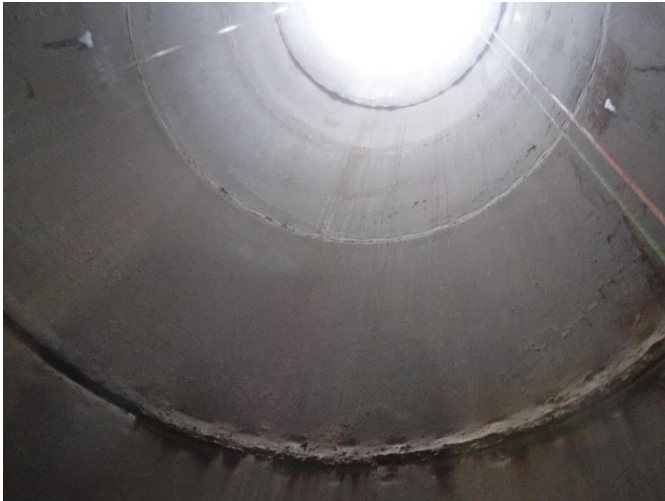
INT 23 – W EL. 140'± – Upward view of stack interior; flanged joint exhibiting buildup

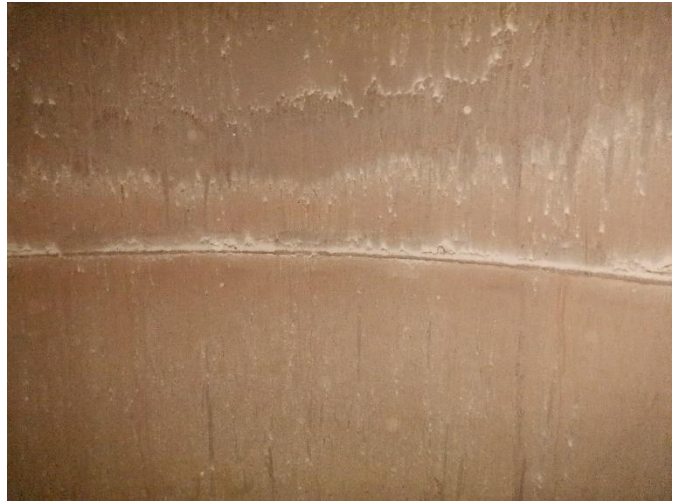
INT 24 – E EL. 140'± – View of flanged joint

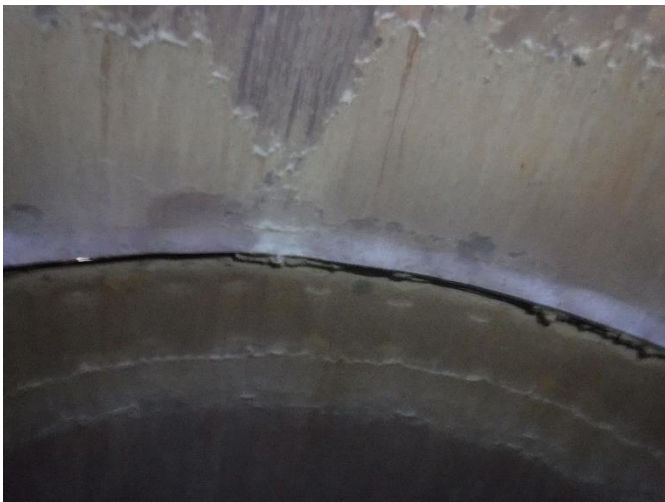
INT 25 – W EL. 130'± – Stack plate appears warped around flanged joint

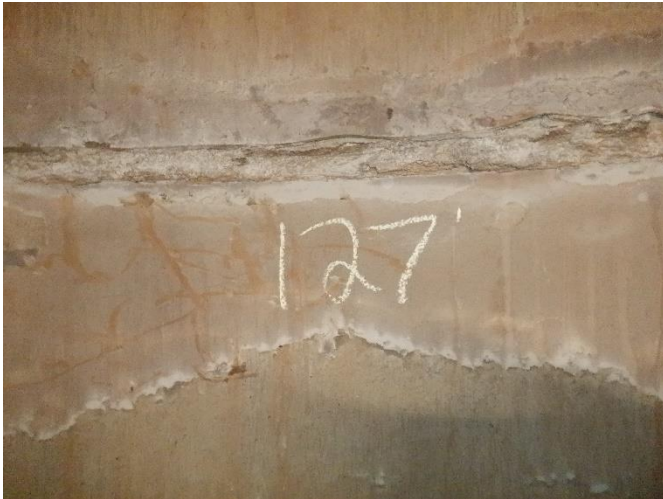
INT 29 – E EL. 127'± – Flanged joint exhibiting buildup

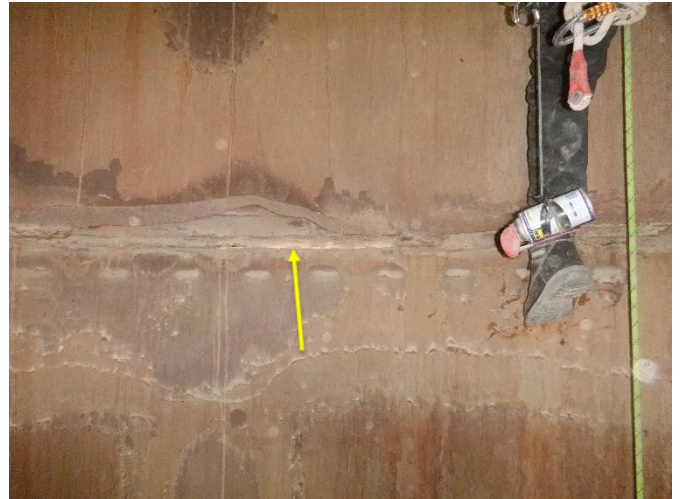
INT 30 – E EL. 127'± – Gap in flanged joint

3. Gaps were found at various flanged joints at EL 180'±, 170'±, 127'±, 115'±, 102'±, 60'±, (INT 8, 12, 13, 14, 15, 16, 28, 30, 32, 35, 36, 37, & 42).
4. Holes were discovered from the interior of the stack, noticeably around flanges (INT 14, 16, 26, 27, 33, & 34).

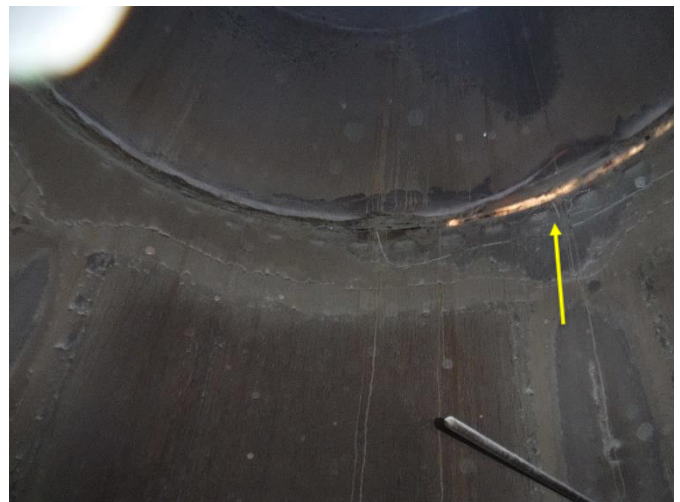
INT 32 –W EL. 115'± – Upward view of stack; gap in flanged joint

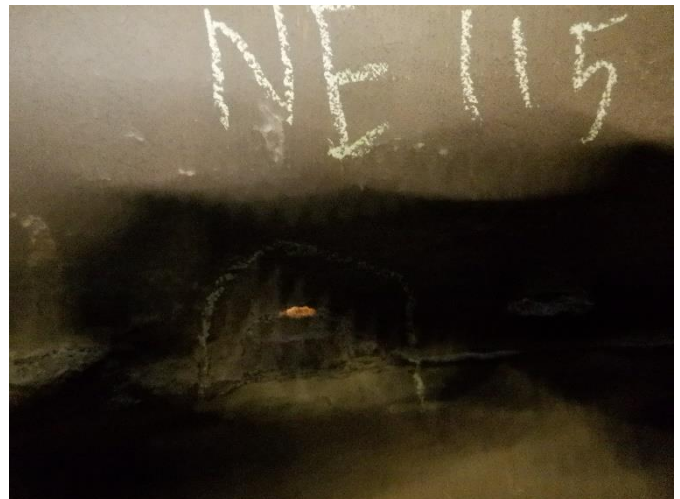
INT 34 –W EL. 115'± – Hole near joint

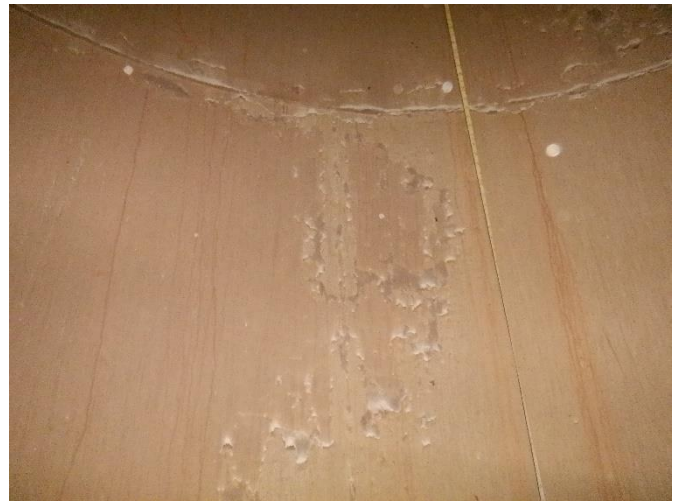
INT 38 – E EL. 90± – Upward view of weld joint and buildup

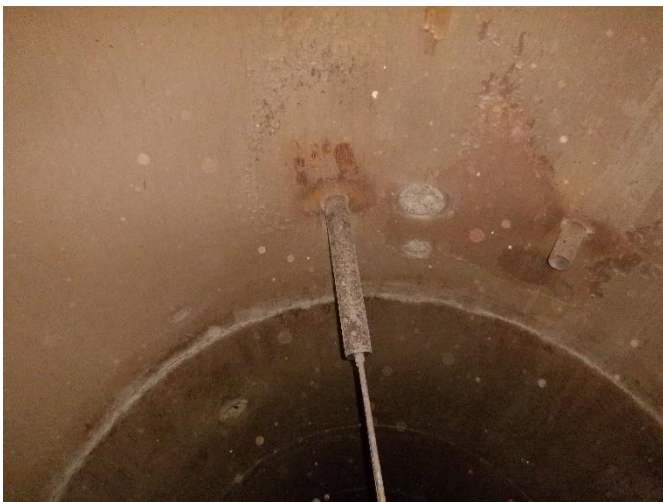
INT 39 – E EL. 85± – Port openings and test probe

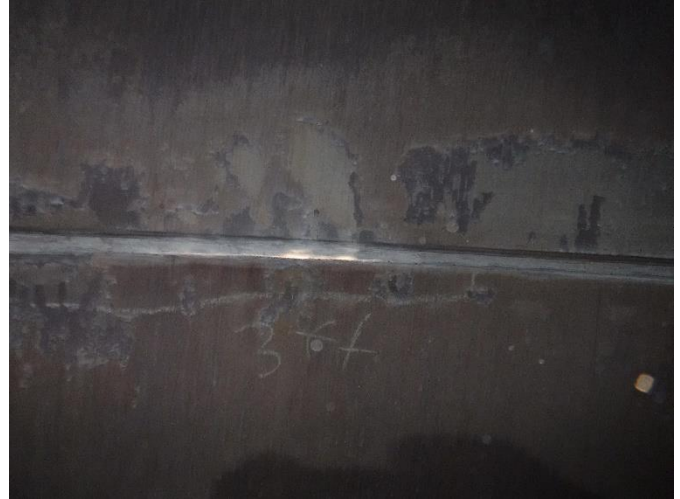
INT 42 – W EL. 60± – Gap in joint

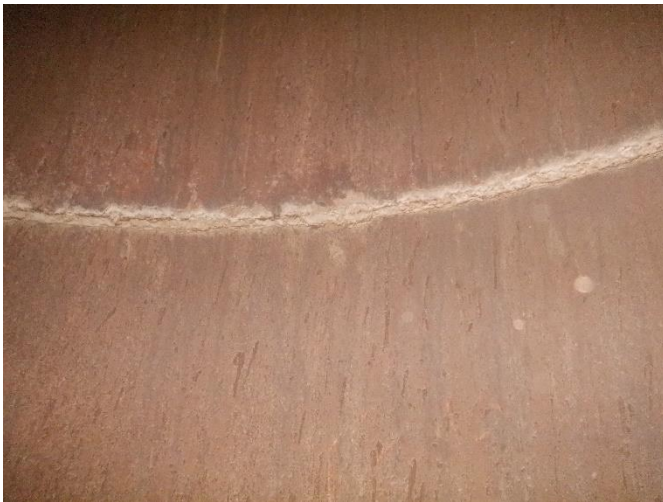
INT 43 – E EL. 40± – View of buildup at flanged joint

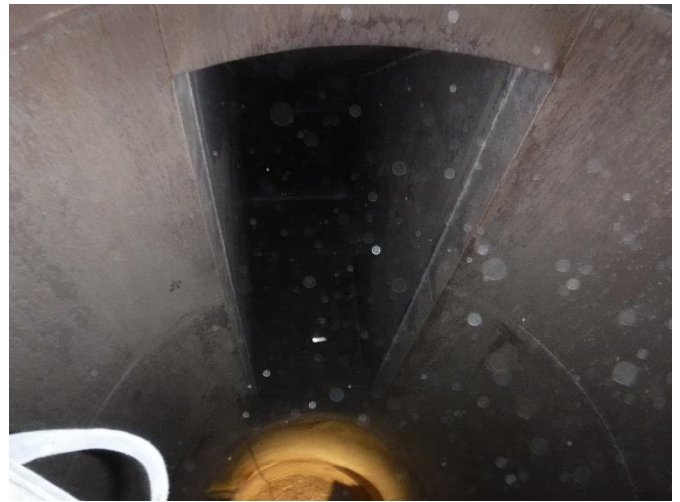
INT 44 – E EL. 40± – Breeching duct opening

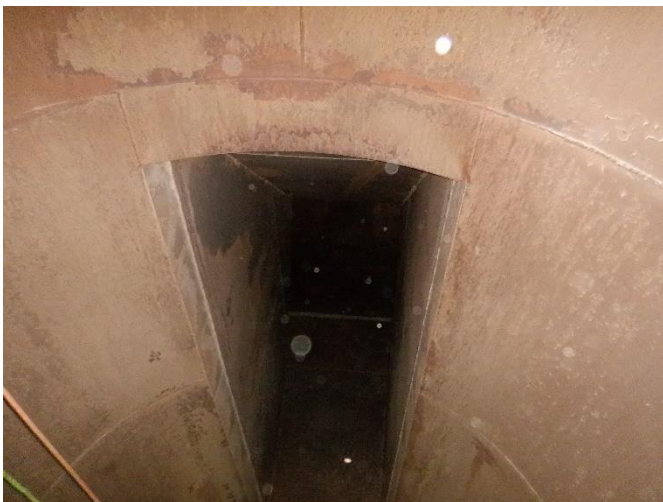
INT 45 – E EL. 40± – Breeching duct opening

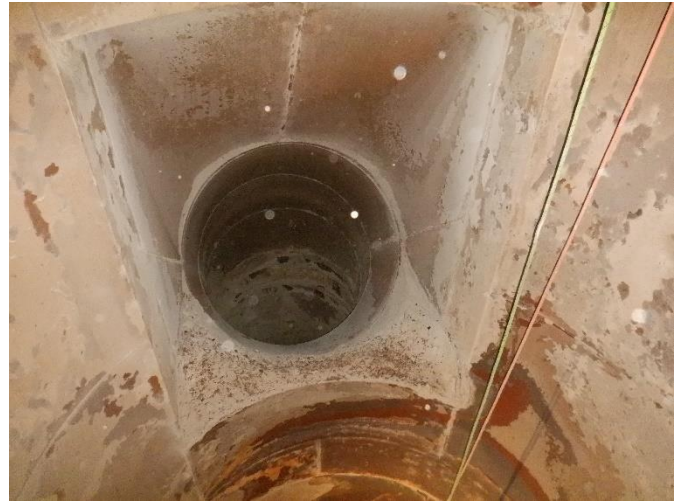
INT 48 – E EL. 20± – Interior of breeching duct

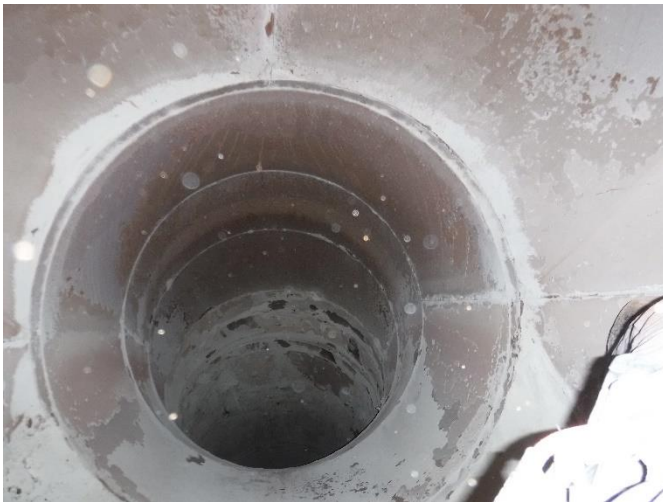
INT 49 – EL. 20'± – Interior of breeching duct

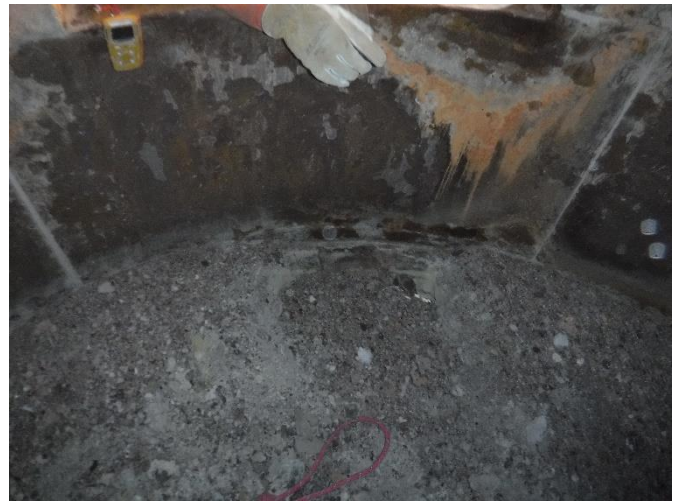
INT 50 – E EL. 0± – View of stack base with debris present

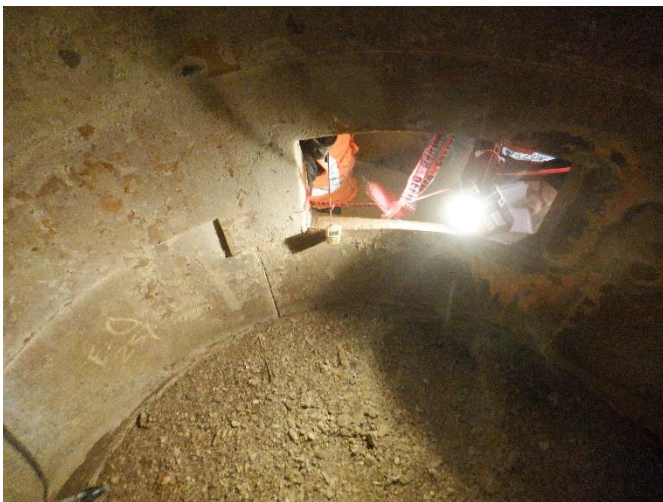
INT 51 – E EL. 0 ± – Stack floor and access opening

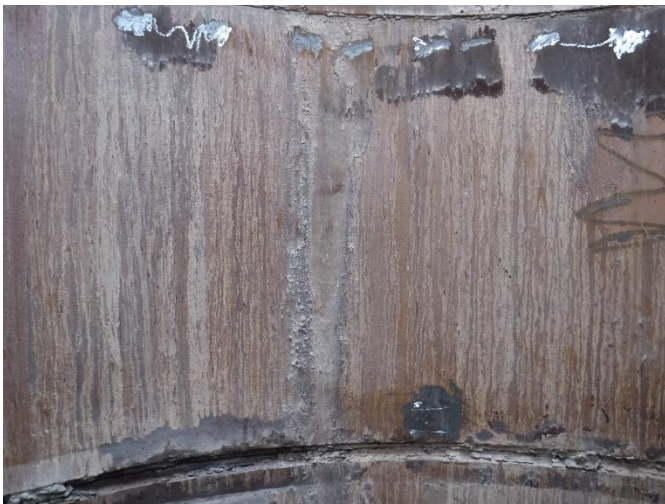
IMG 19 – View of interior before plate installation

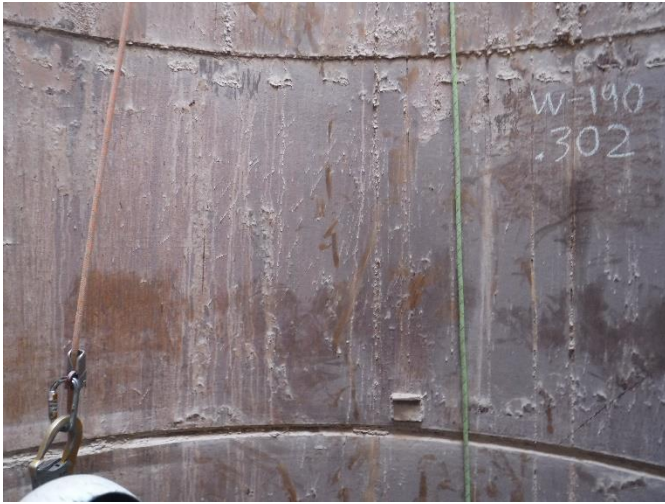
IMG 21 – View of interior before plate installation

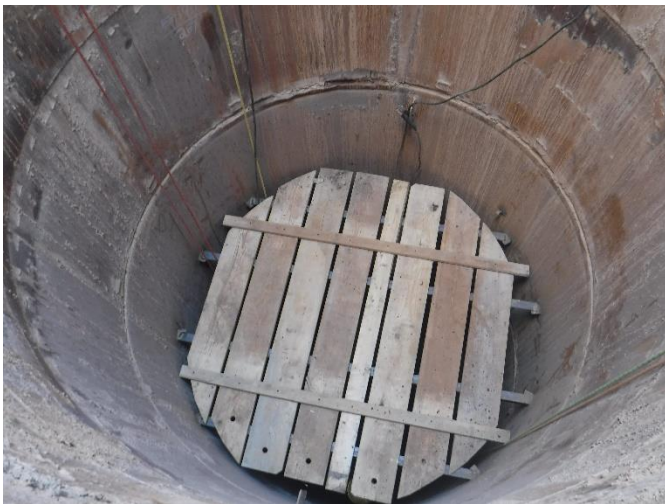
IMG 23 – View of interior before plate installation
