**F. Concrete Company  
Fayden Plant  
Lancaster, OH**

**D13 Duct  
Inspection Report  
April 2024**

Subject: D13 Duct Inspection

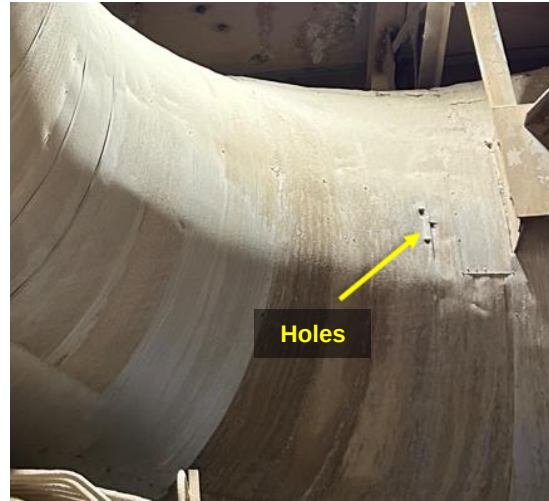
EXT 6 – Holes in the duct

The holes in the duct should be patched to prevent flue gas leaks within the confined space of the building.

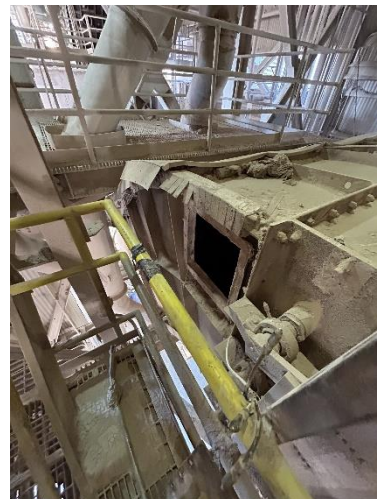
EXT 10 – Access door to the duct

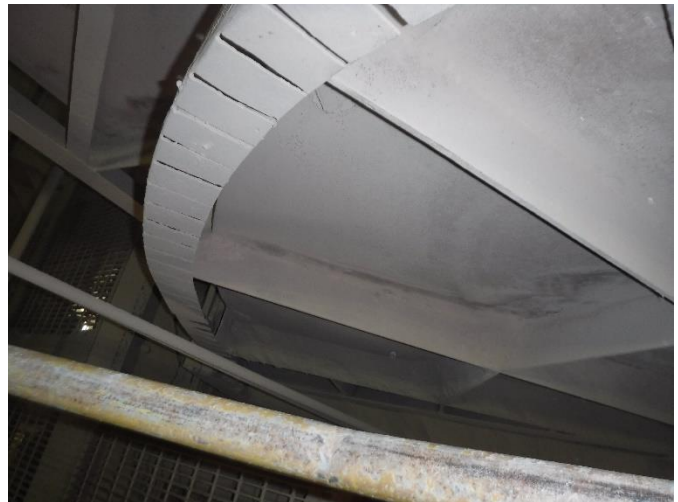
EXT 14 – Underside of the duct

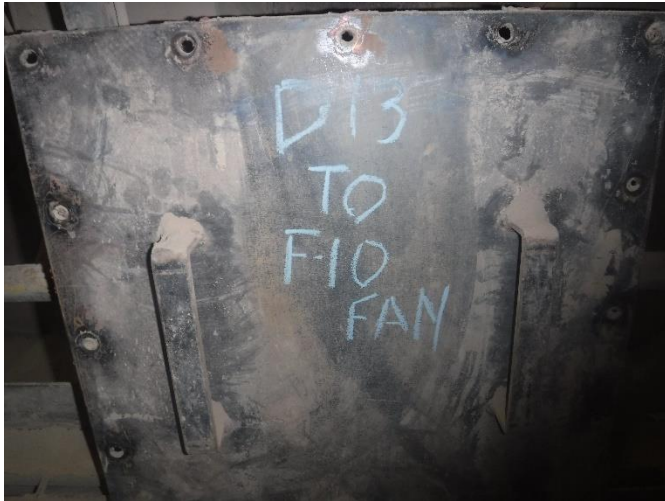
INT 1 – Access door leading to F10 fan

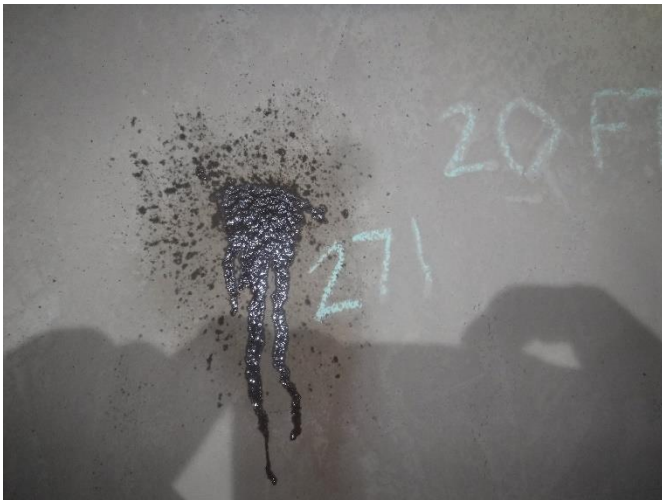
INT 25 – 20'± – View of duct wall

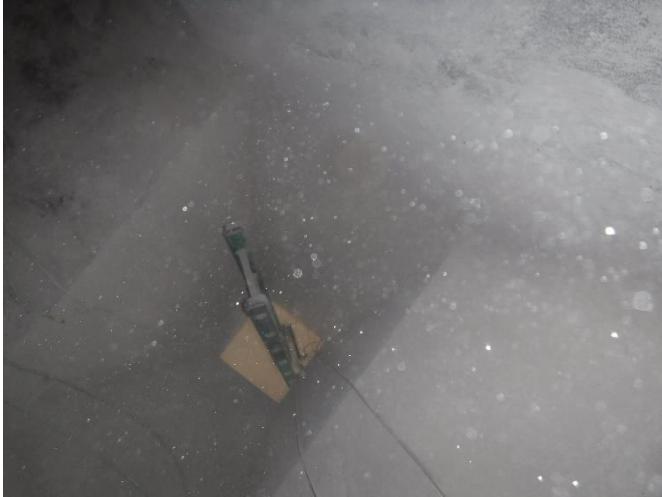
INT 29 – Ladder in the opening below the duct

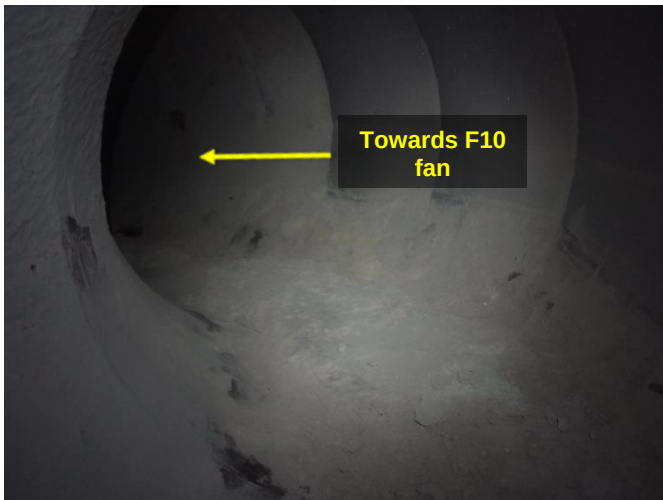
INT 31 – Looking forward towards f10 fan

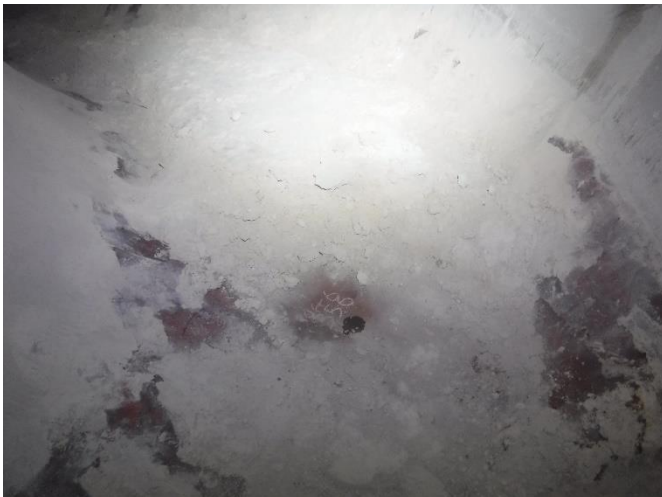
INT 33 – Heavy buildup and debris

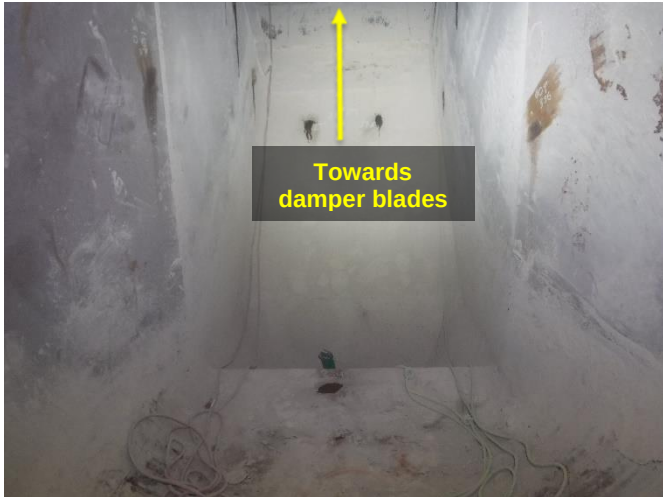
INT 35 – Looking back towards damper blades

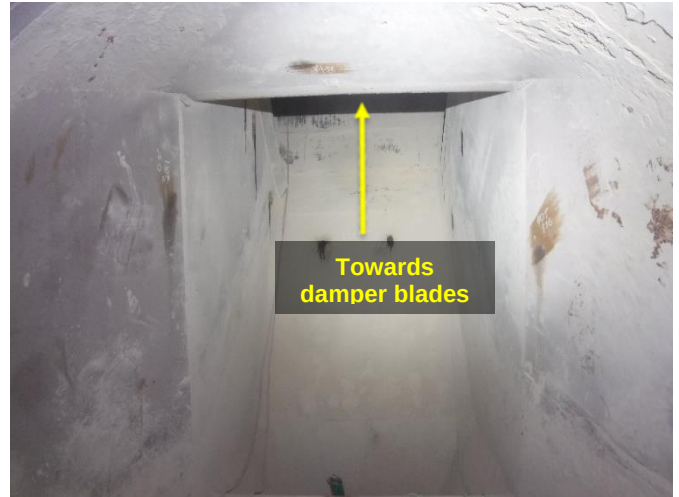
INT 36 – Looking back towards damper blades

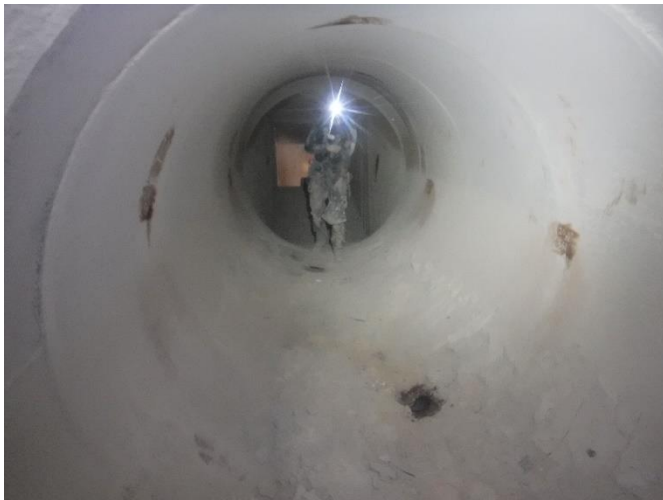
INT 37 – Looking through duct

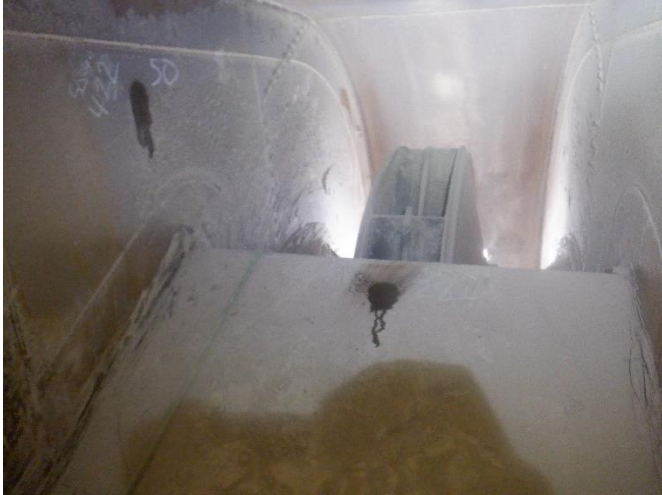
INT 41 – Duct curling down outside of the building going to fan
