SAN XAVIER DEL BAC

CONSERVATION MANAGEMENT PLAN OVERVIEW

PREPARED BY: PENN PRAXIS
THE CENTER FOR ARCHITECTURAL CONSERVATION

February 2020

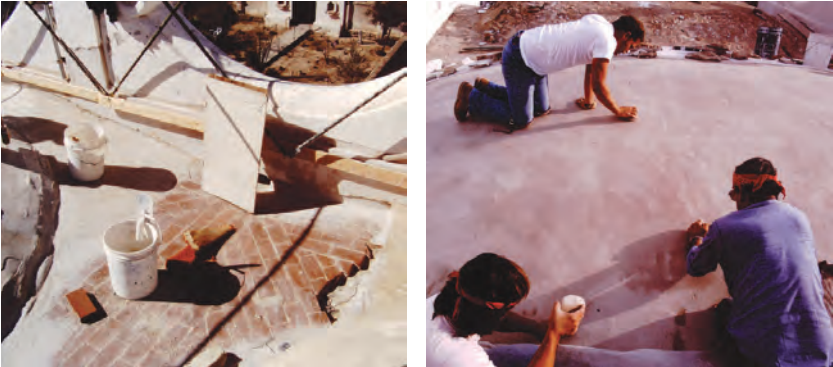
[Image 44] (left) Lower-lying areas of the roof were repaired with harder, higher-fired modern brick, to encourage water runoff and drainage. (Robert Vint)

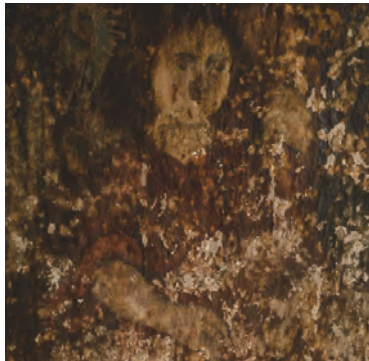
[Image 49] Angel on East (left) side of Mural of La Virgen con Nino on upper level of the west transept, prior to conservation (Helga Teiwes, 1993, UA Special Collections)

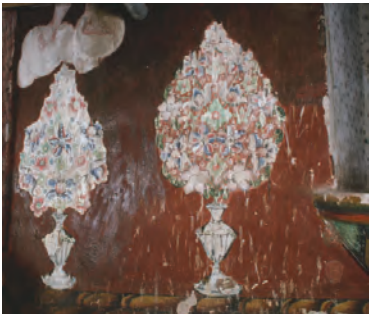
[Image 53] Flower vases in the West Transept prior to conservation. The colors are visibly darkened by the varnish. (Helga Teiwes, 1993, UA Special Collections)

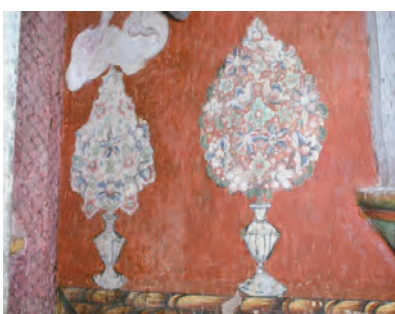
[Image 54] The same area following conservation. The varnish has been lifted and areas of loss have been subtly infilled. Helga Teiwes, 1993, UA Special Collections)

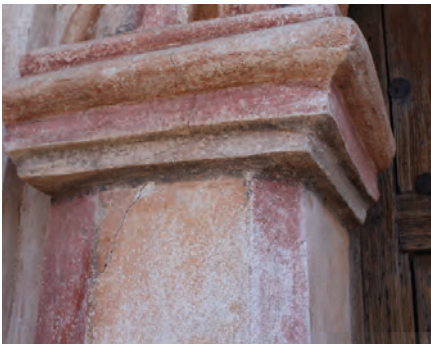
[Image 60] Portions of the facade retablo, like the arched surround framing the southern doors, were refinished during the 1950s restoration campaign with pigmented cement-based plaster.

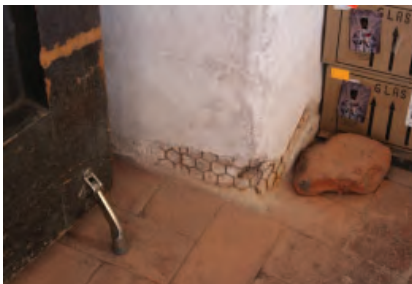
[Image 75] Exposed reinforcement wire beneath cement-based render in the South Convento Wing.

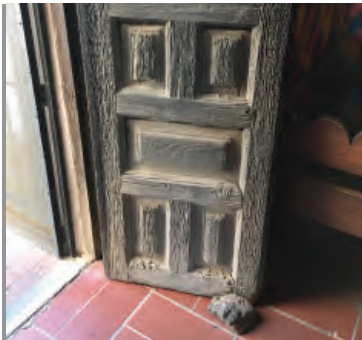
[Image 86] Some of the original wooden doors of the church are used daily and have withstood more than 200 years of weather and wear.

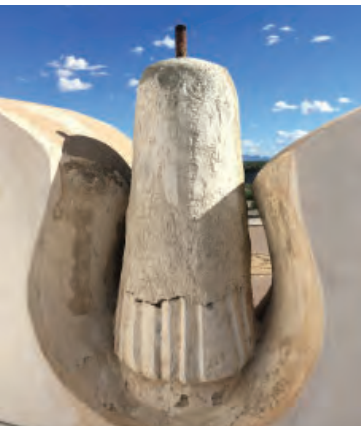
[Image 87] The statue at the pediment of the facade retains historic fabric, yet there is limited photographic evidence of it in its complete original state.
