# **C. Cement Fireport Plant**

Buffalo, NY

**Kiln Stack Inspection and  
Repairs**  
March 2024

Subject: Kiln Stack Inspection and Repairs

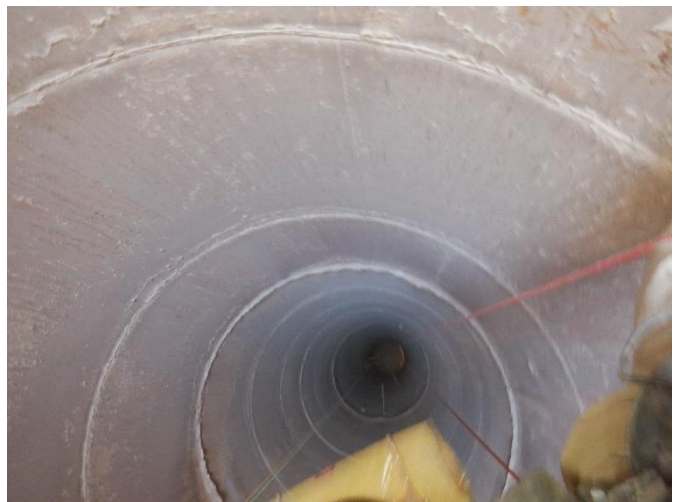
INT 10 – E EL. 180'± – Downward view

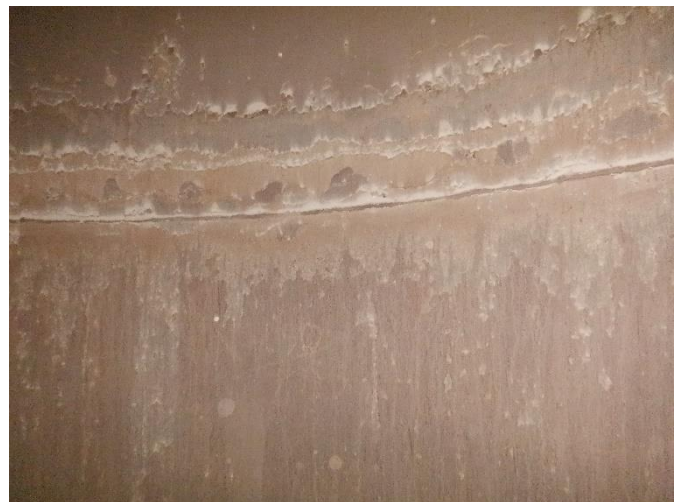
INT 22 – E EL. 150'± – Buildup on flanged joint

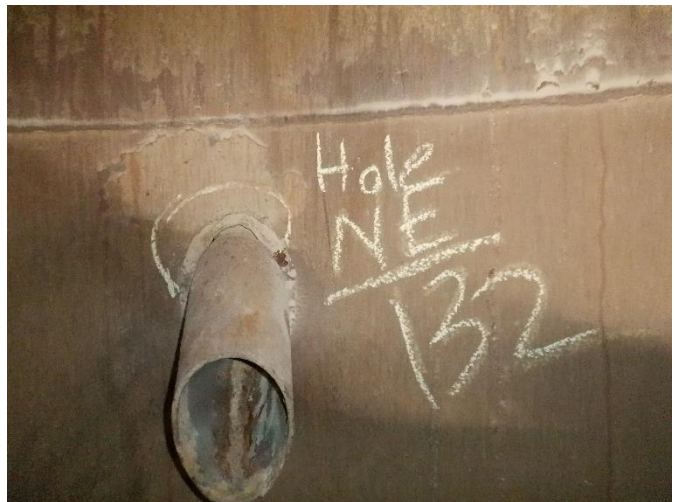
INT 26 – E EL. 140'± – Hole present in instrument port nozzle

3. Gaps were found at various flanged joints at EL 180'±, 170'±, 127'±, 115'±, 102'±, 60'±, (INT 8, 12, 13, 14, 15, 16, 28, 30, 32, 35, 36, 37, & 42).
4. Holes were discovered from the interior of the stack, noticeably around flanges (INT 14, 16, 26, 27, 33, & 34).

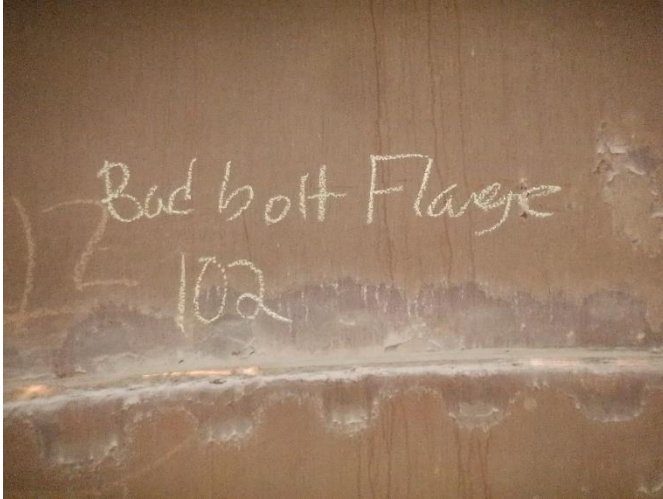
INT 35 – E EL. 102± – Gap in flanged

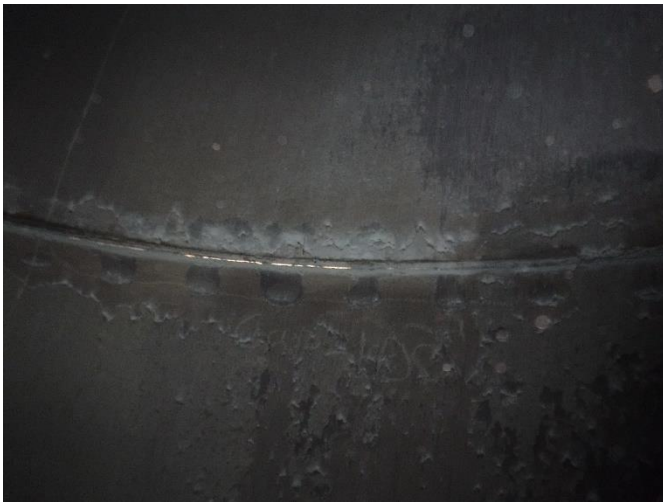
INT 37 – W EL. 102± – Gap in Flanged

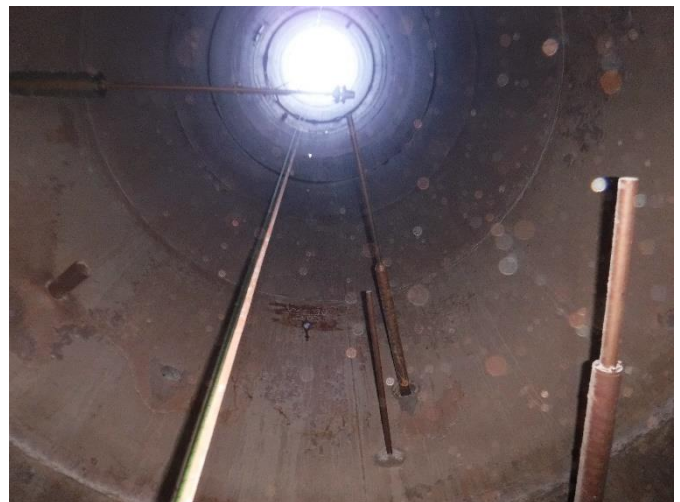
INT 40 – W EL. 85± – Test ports & probes

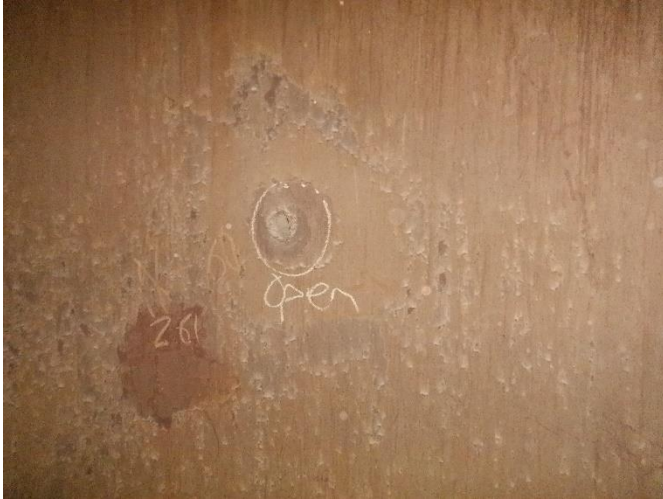
INT 41 – N EL. 80± – Perforation

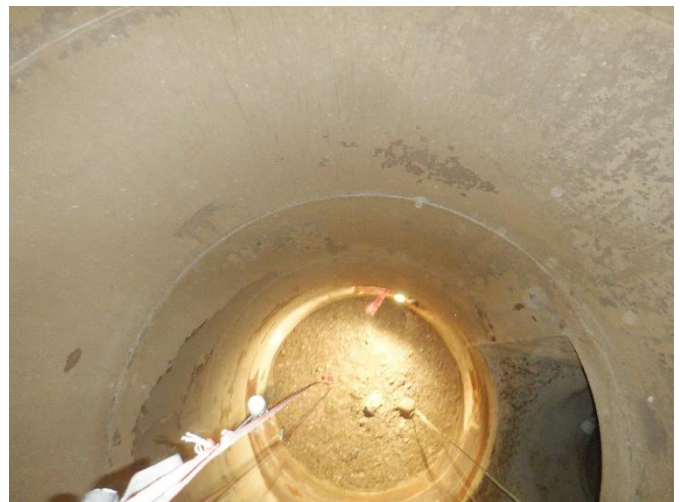
INT 46 – W EL. 85± – Downward view of false floor

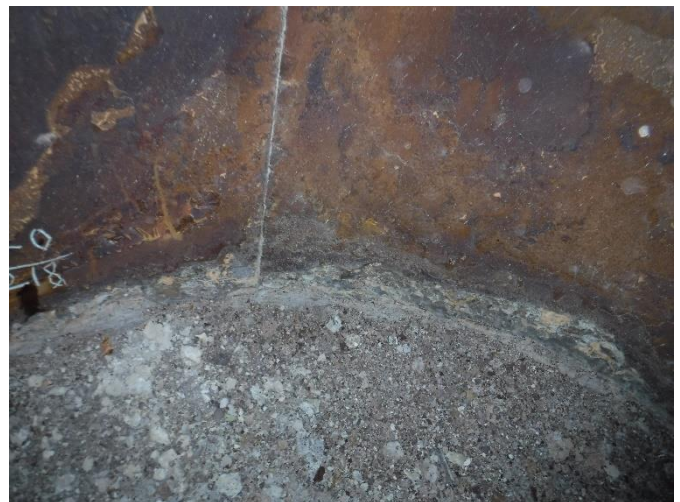
INT 52 – W EL. 0± – Stack floor
