**F. Concrete Company  
Fayden Plant  
Lancaster, OH**

**D13 Duct  
Inspection Report  
April 2024**

Subject: D13 Duct Inspection

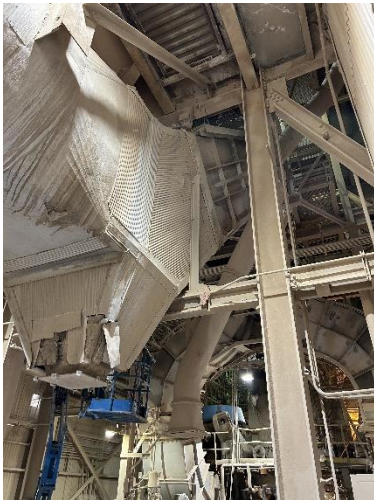
EXT 7 – General view

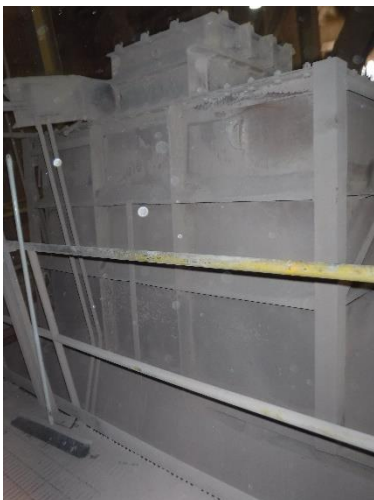
EXT 15 – Light buildup present

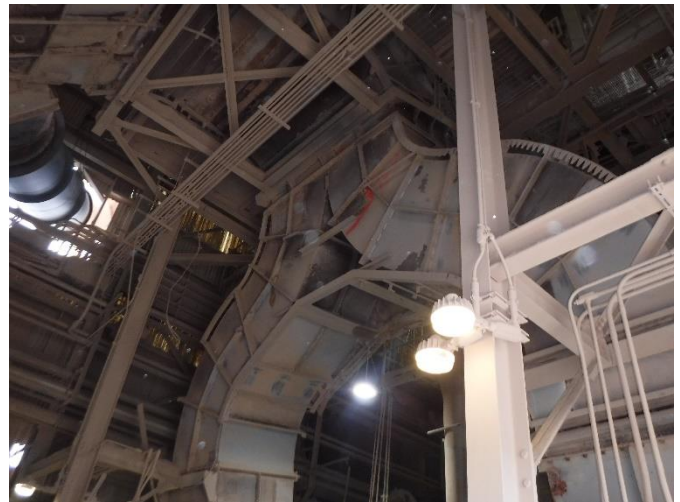
EXT 20 – East and west pantleg

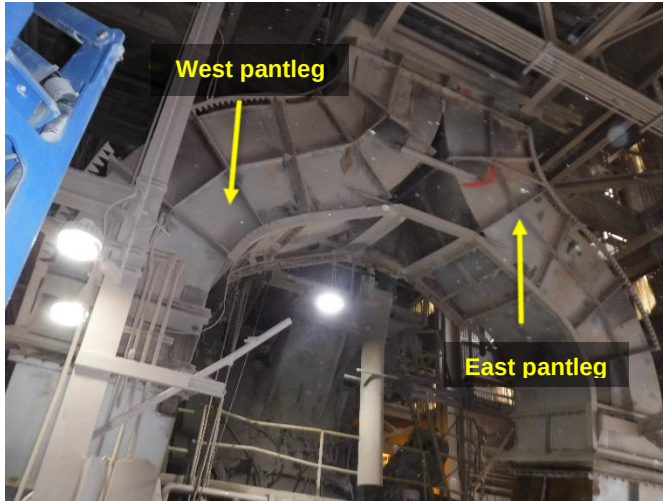
EXT 29 – Duct pant leg

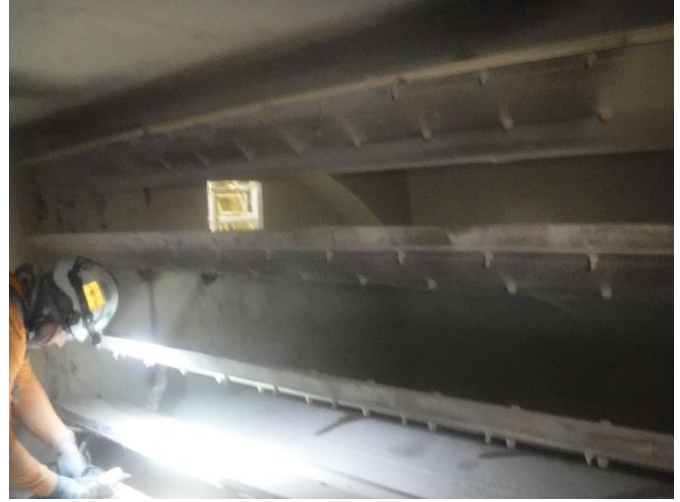
INT 6 – Damper blades

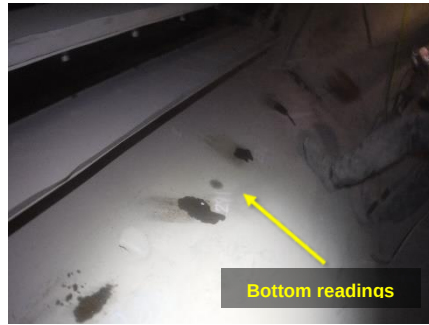
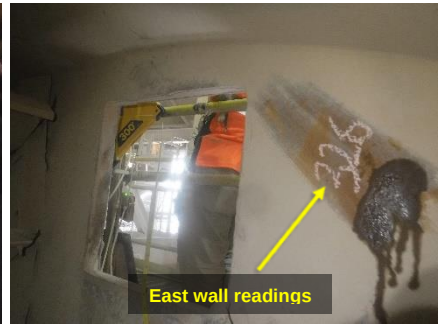
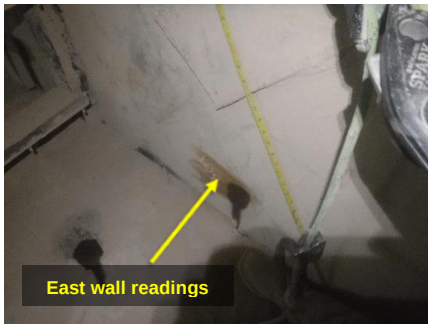
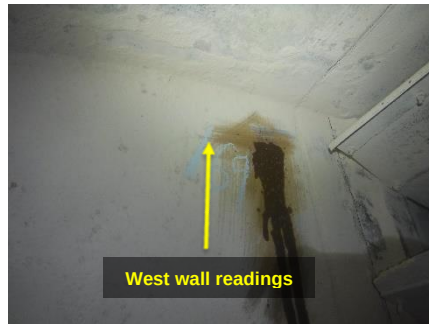
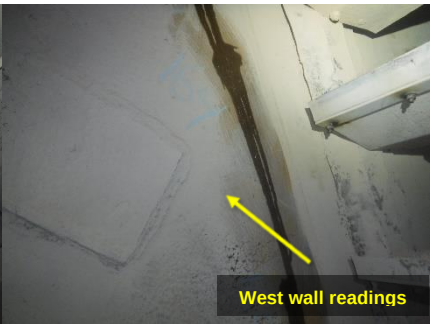
**Interior UT Readings: at Damper Blades (Photo Documentation)**

**\*Note:** The original thickness of the duct was 0.188 inches. However, in certain areas, the thickness measures 0.438 inches. This increased thickness indicates the presence of reinforcement patch plates that were previously installed to strengthen the steel in those sections. When evaluating the current thickness readings, any measurements below 0.188 inches (in unreinforced areas) or 0.438 inches (in areas with reinforcement) indicate a loss of material. The presence of these patch plates should be considered when assessing the condition and remaining thickness of the duct.
